Great Hall Skylight Investigation

September 2015 - June 2016

UNION STATION

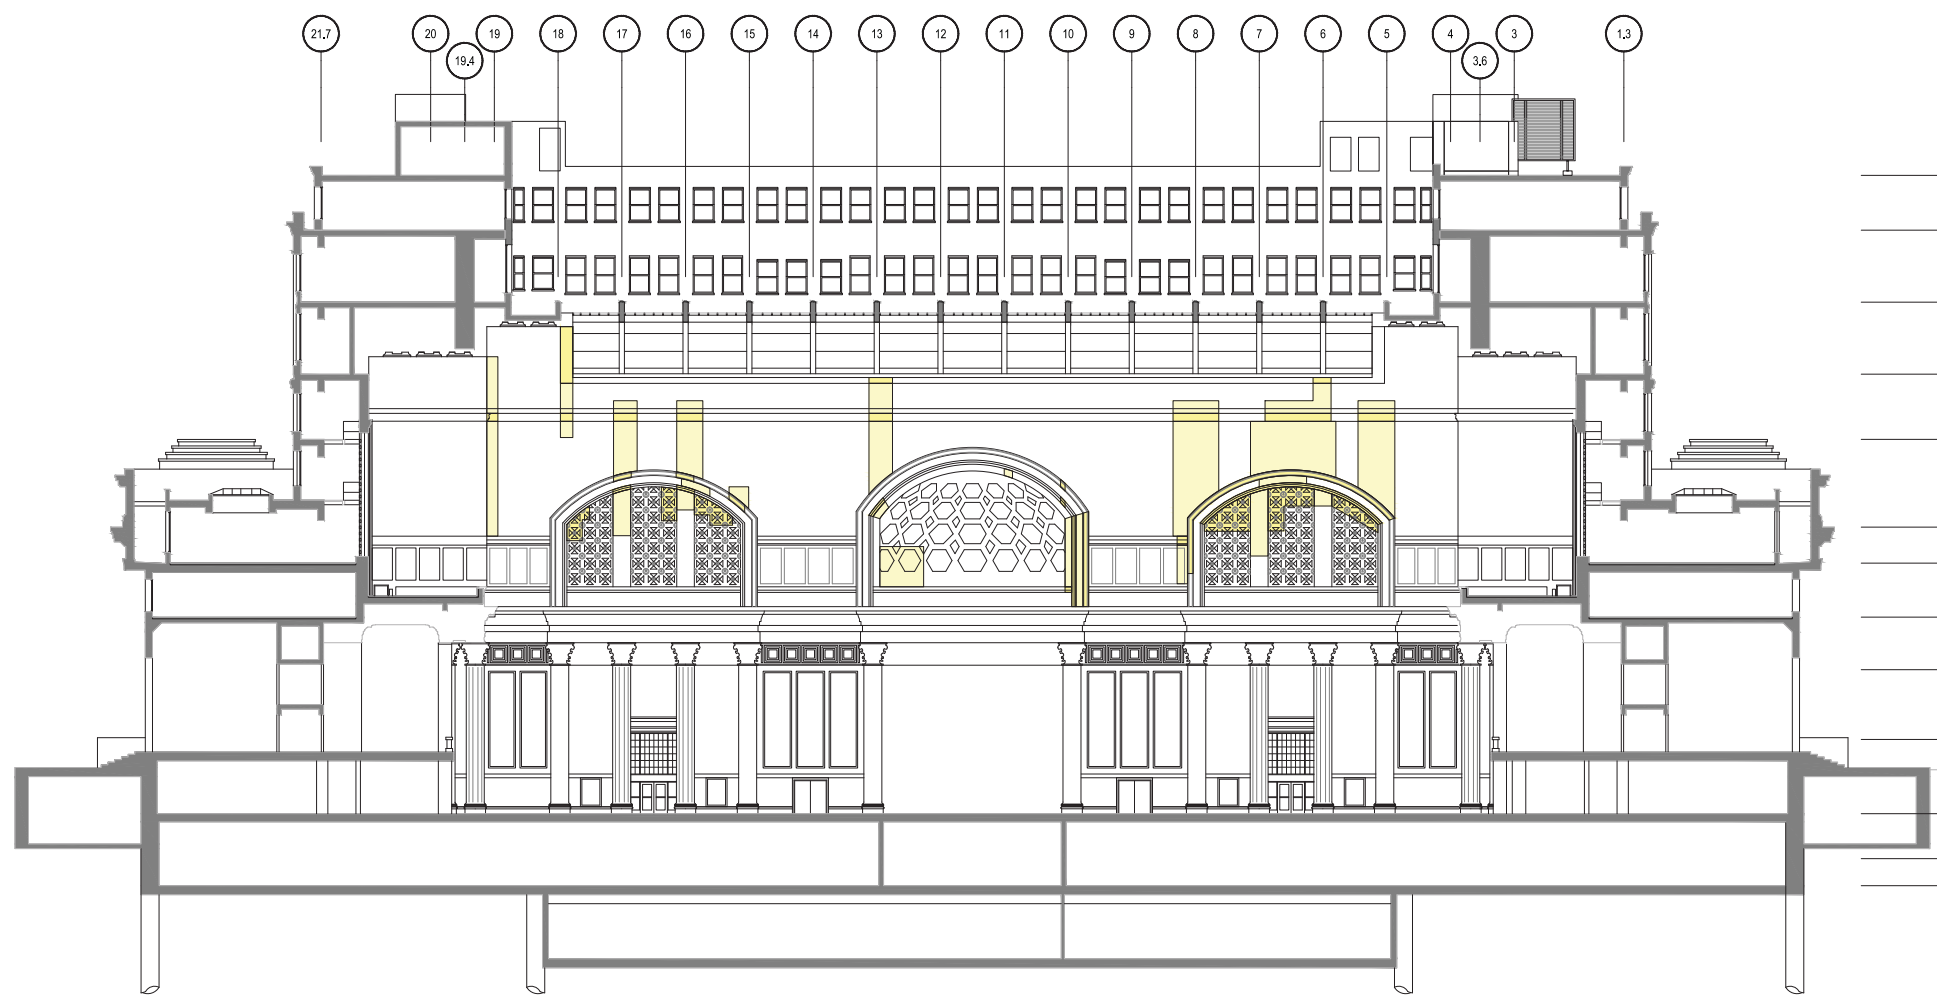
WEST GREAT HALL ELEVATION

Water damaged plaster areas

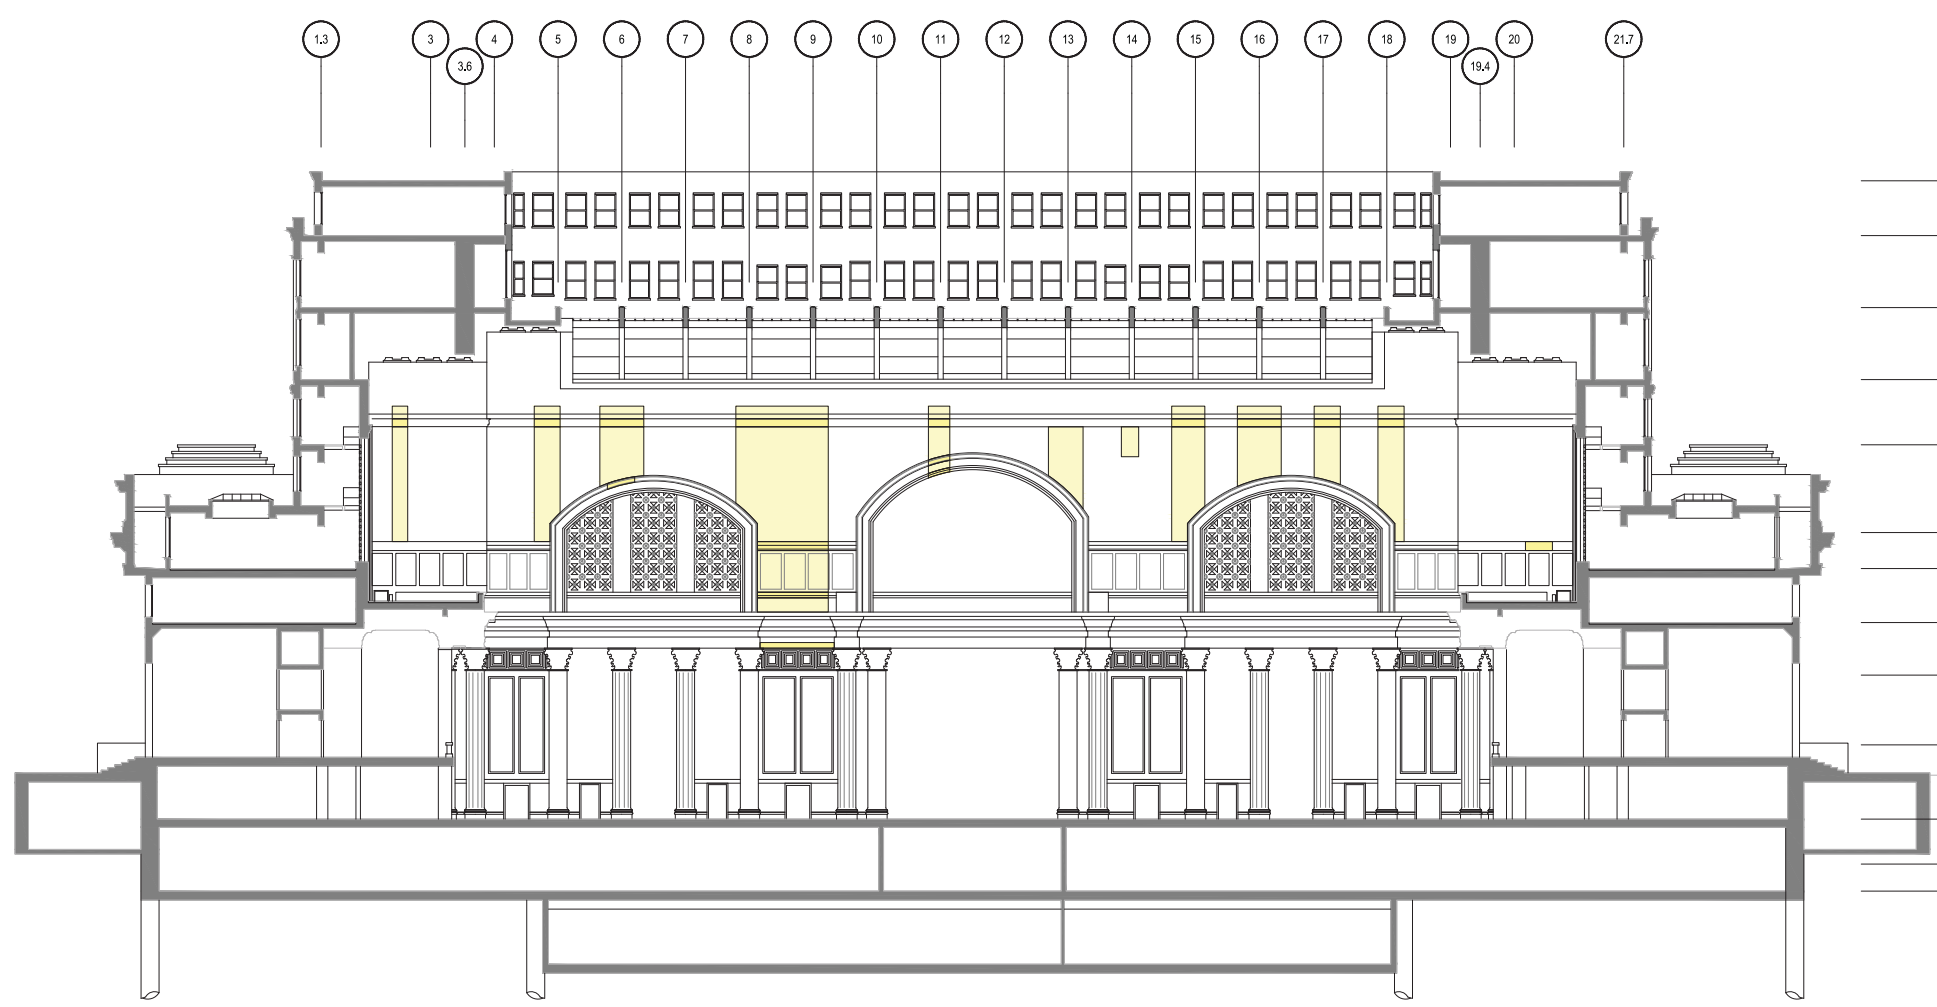
EAST GREAT HALL ELEVATION

Water damaged plaster areas

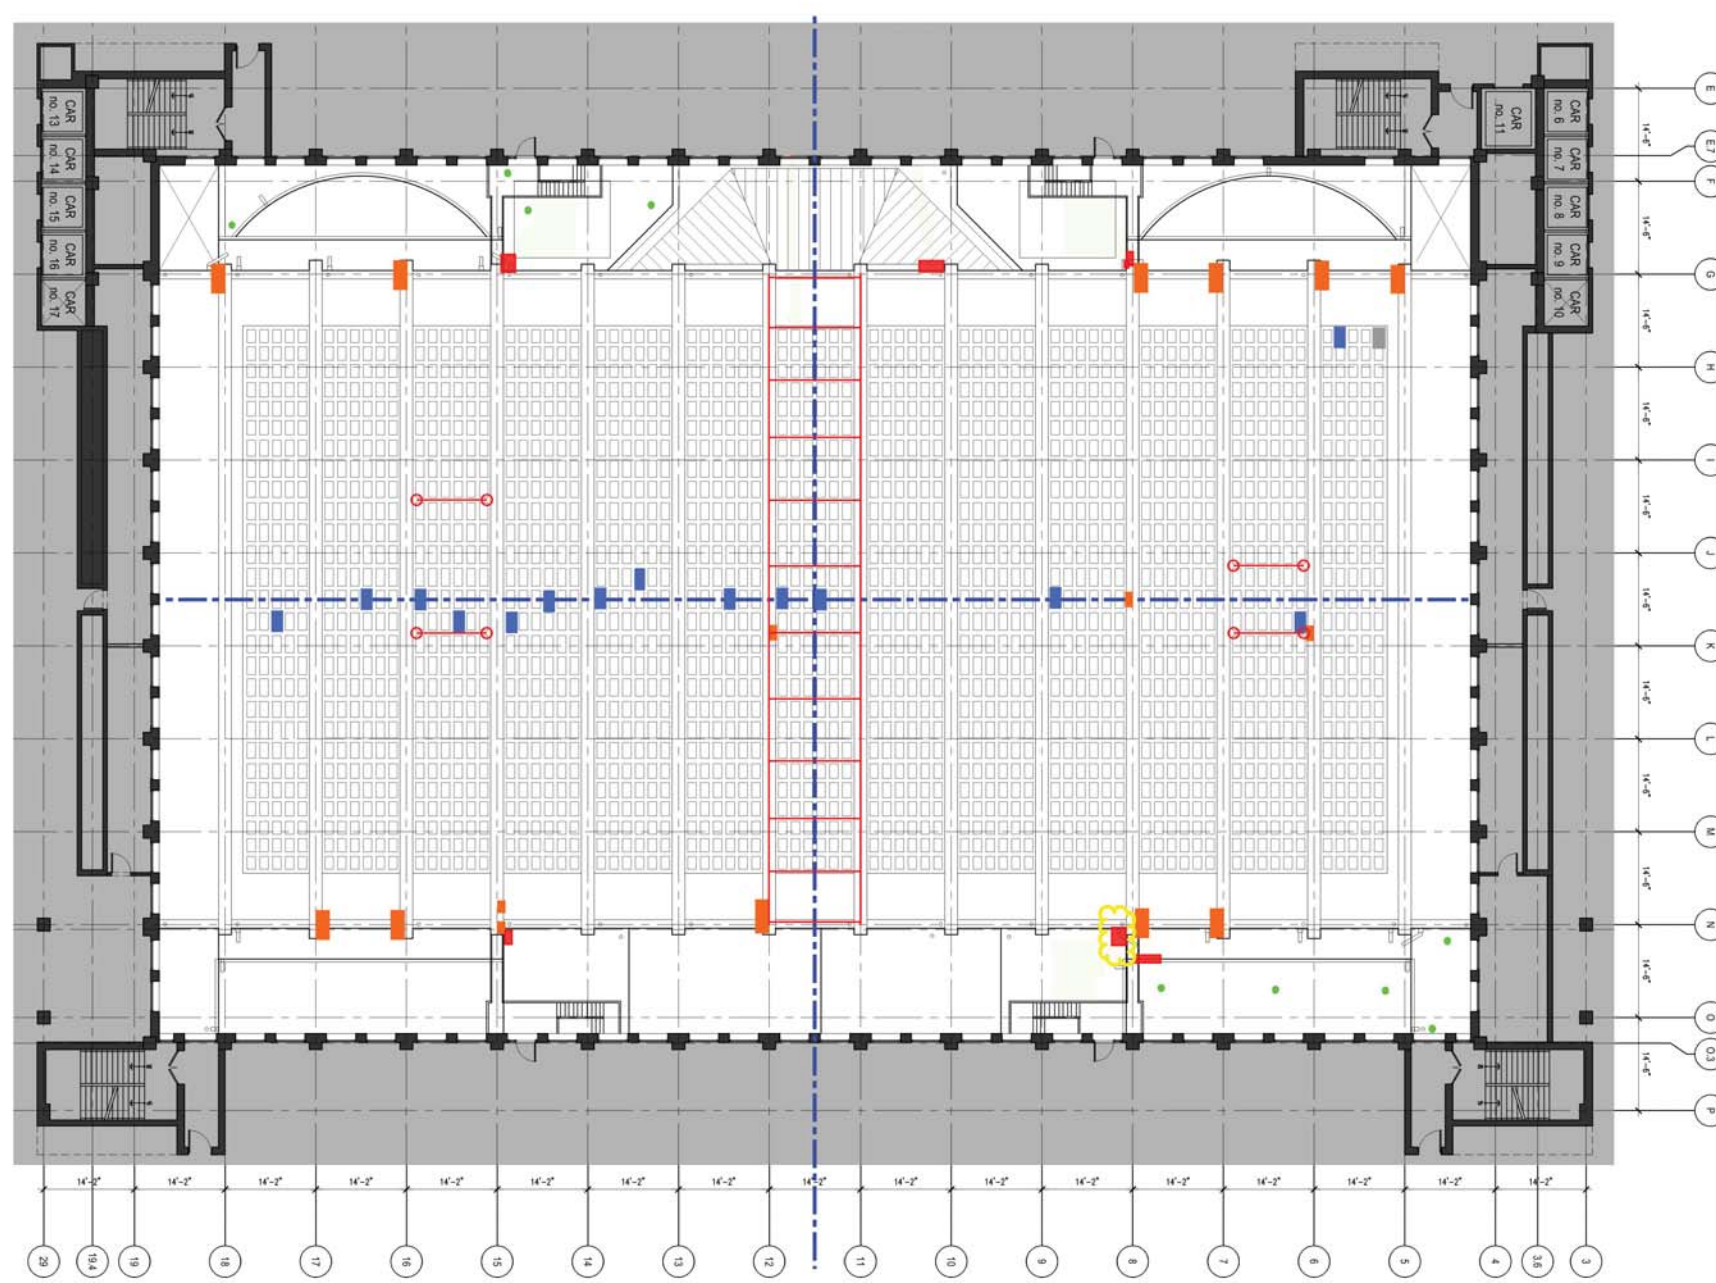
GREAT HALL SKYLIGHT INVESTIGATION PLAN

■ - Skylight Glass Removal Location. ○ - Alterations Observed at Existing Beam Connections to Girders
■ - Girder Cladding Openings
■ - Facade Opening at Exterior Drop.
■ - Low Roof Inspection Openings

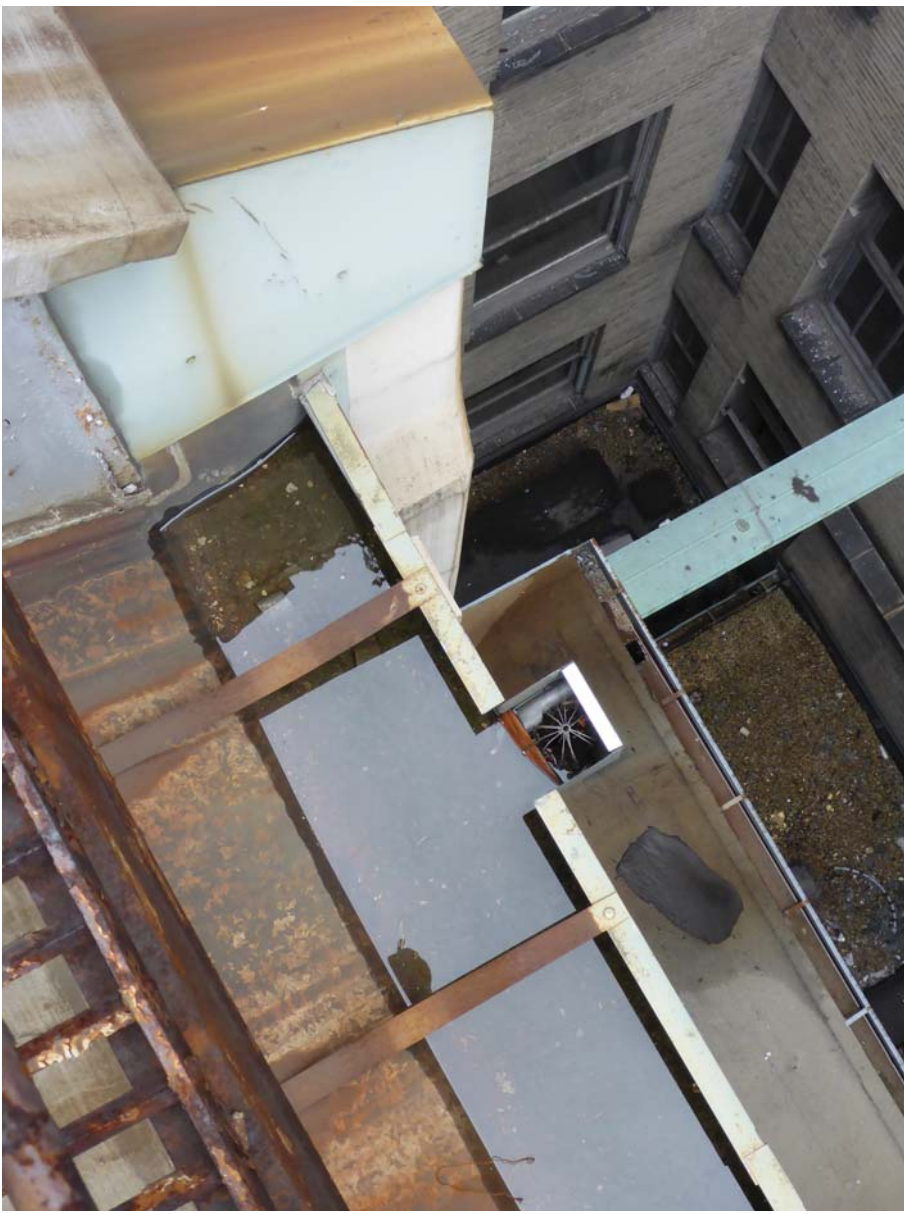
EAST GUTTER - STANDING WATER WHERE ORIGINAL DRAIN
FAILED AND EXTERNAL DOWNSPOUT WAS ADDED

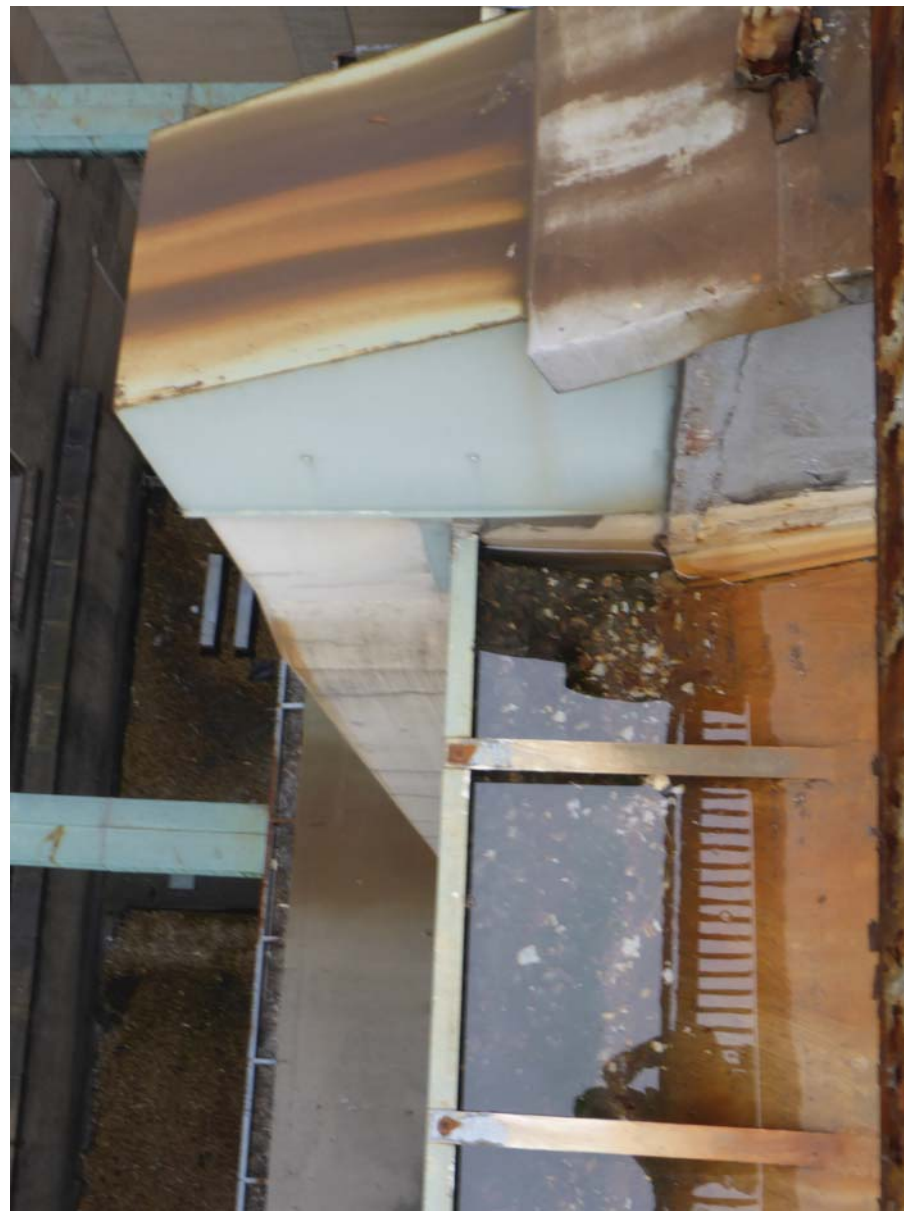
EAST GUTTER - STANDING WATER
WHERE GUTTER HAS FAILED

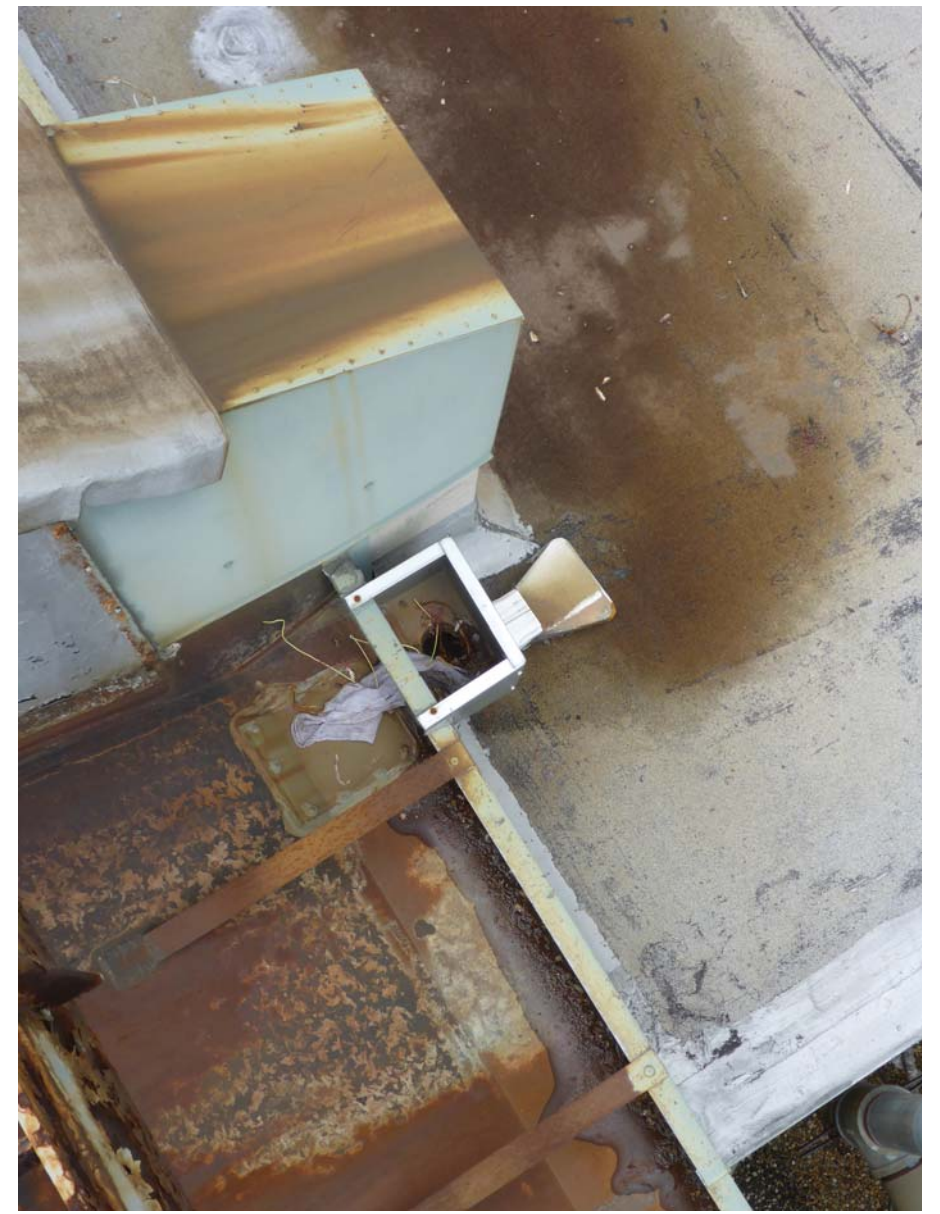
EAST GUTTER - STANDING WATER WHERE ORIGINAL DRAIN
FAILED AND EXTERNAL DOWNSPOUT WAS ADDED

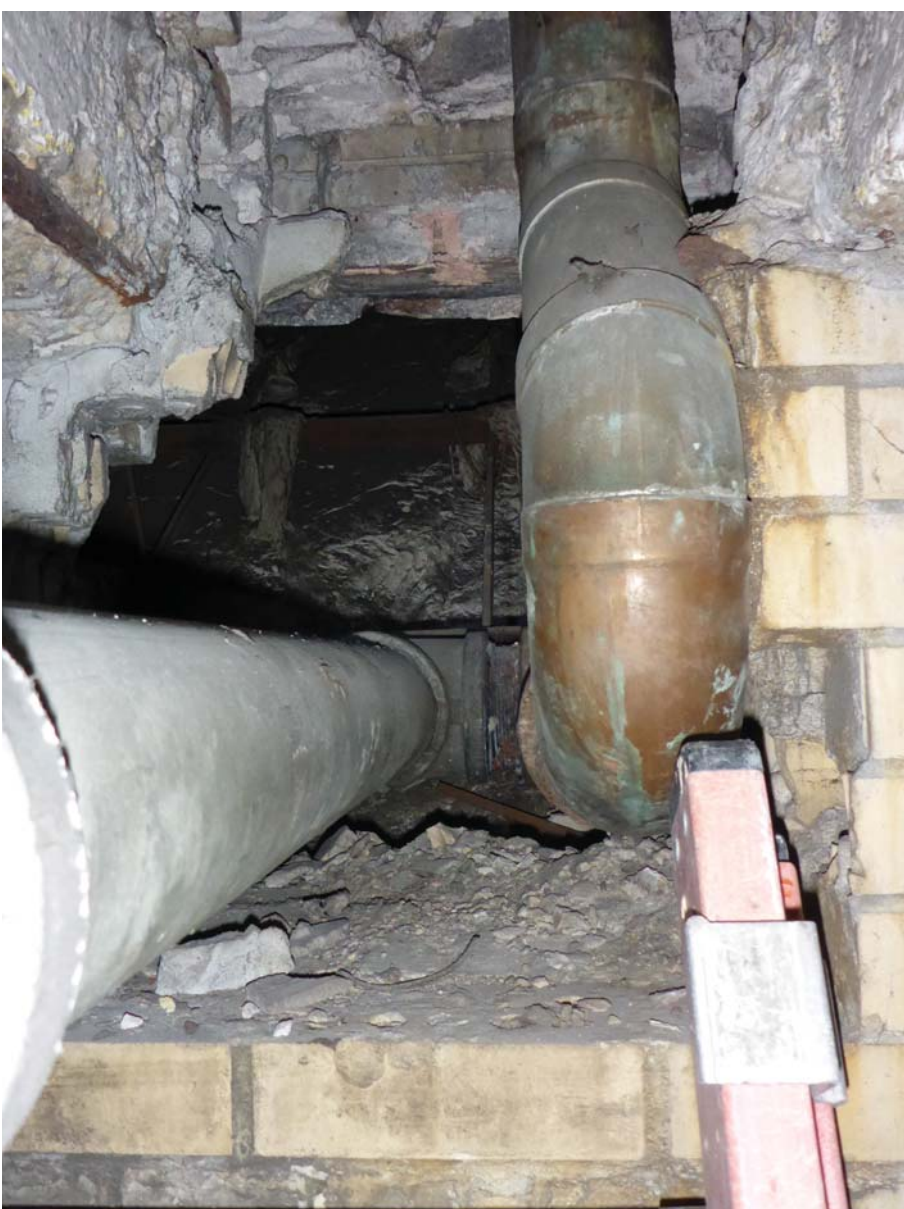
ORIGINAL CAST IRON DRAIN PIPE WITH TRAP AND VENT - SECTIONS
REPLACED WITH COPPER AND GALVANIZED PIPE OVER TIME

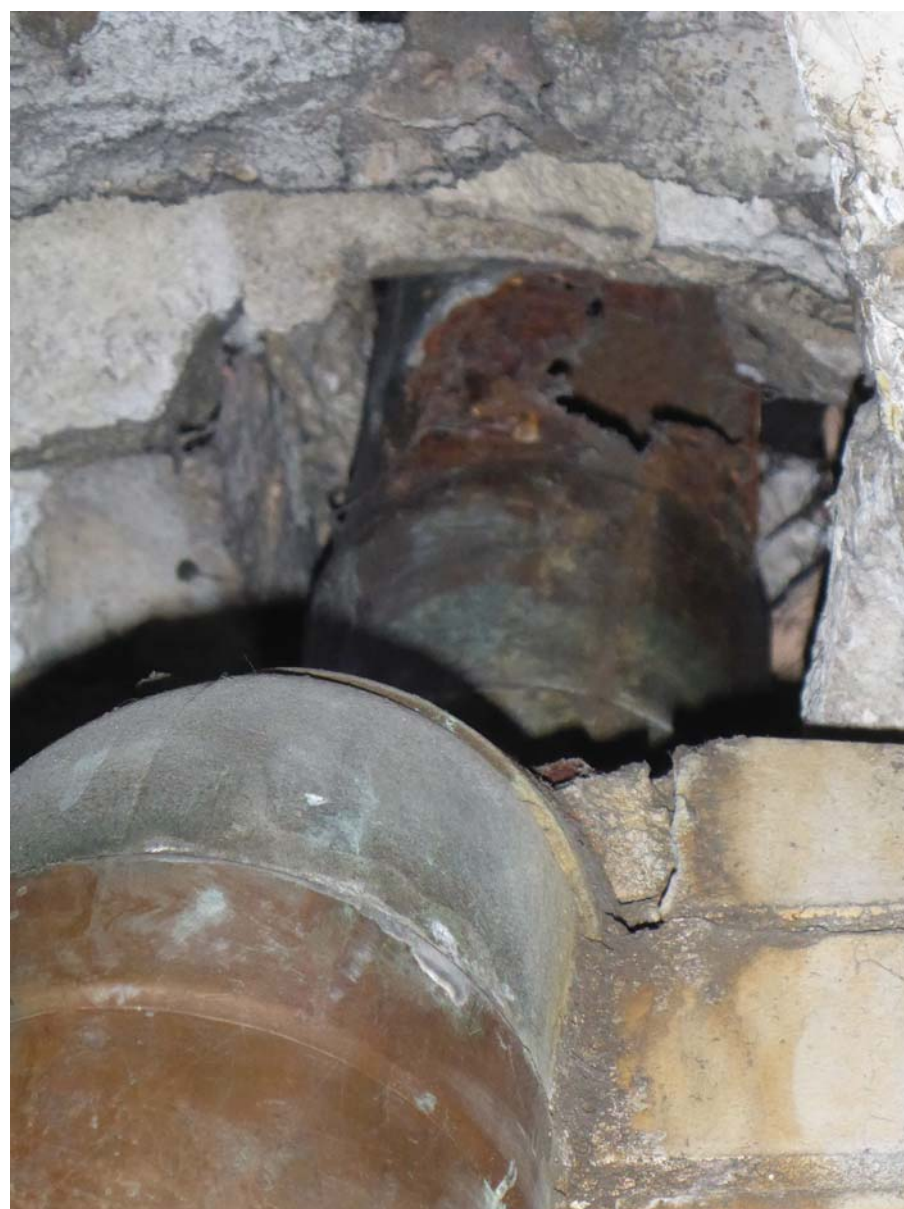
gutters fail to direct water down from the roof, drain pipes have deteriorated due to galvanic action from dissimilar metals used in repairs, and lower roofs are saturated and beyond their service life. As a result the deterioration of interior plaster and stonework will continue and accelerate until a permanent solution is implemented.

GALVANIZED DRAIN PIPE DETERIORATION
DUE TO GALVANIC CORROSION

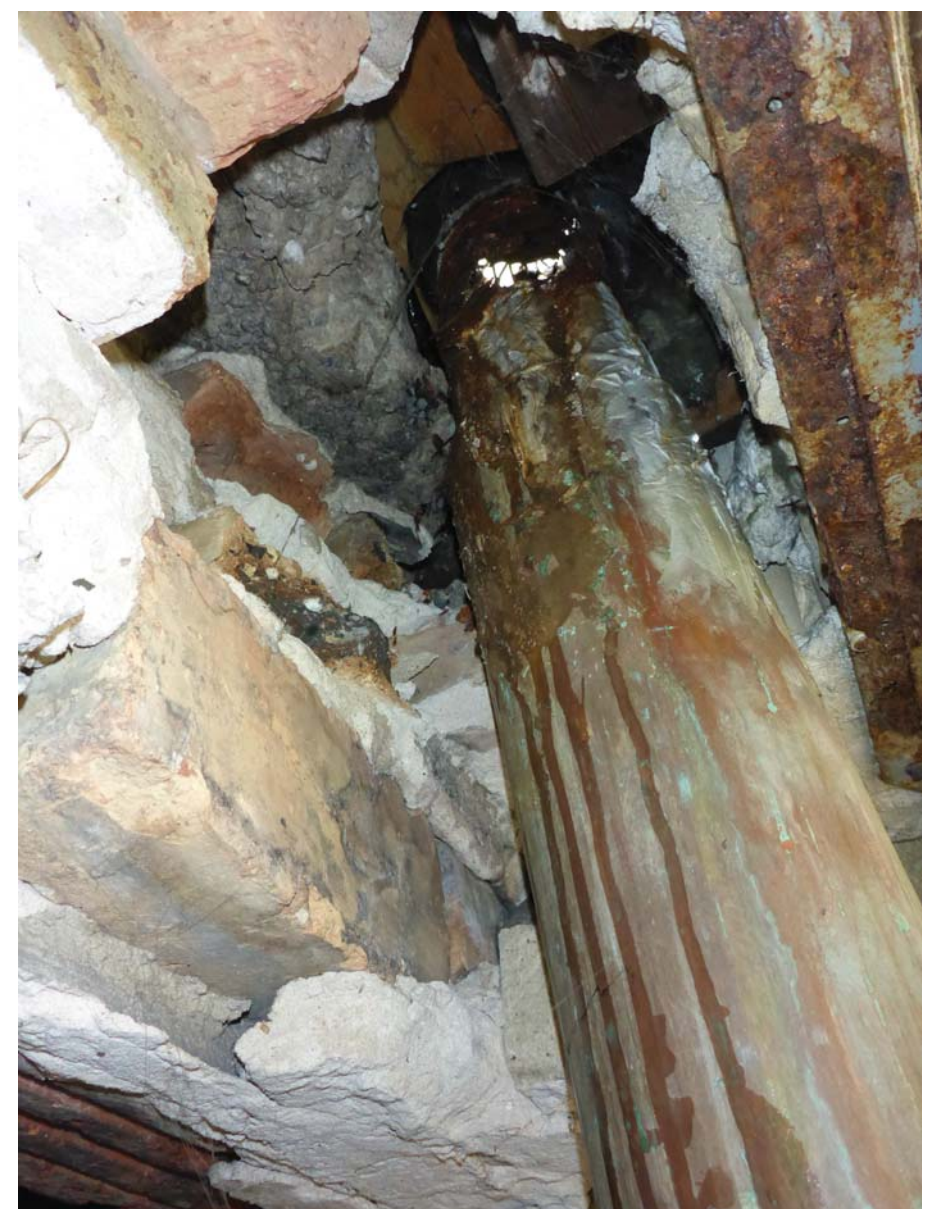
GALVANIZED DRAIN PIPE DETERIORATION
DUE TO GALVANIC CORROSION

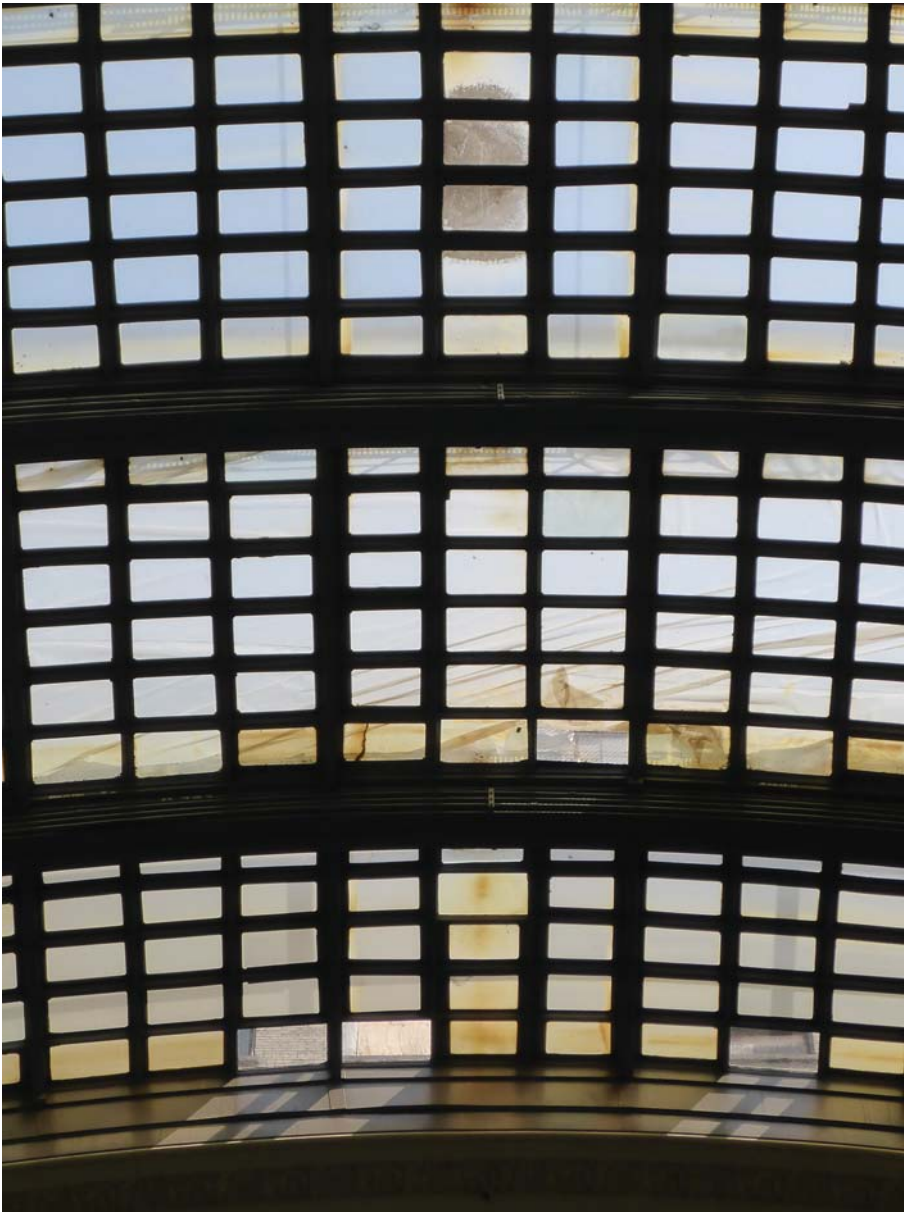
Looking up at the upper walls of the Great Hall today quickly reveals the flaws of the system. Wide flashing strips placed over the joints between glass on the mullions, beams, and girders to fend against leakage have marred the light airy

EXISTING SKYLIGHT FROM BELOW SHOWING EFFECTS OF WATER PONDING AND ADDED FLASHING BANDS

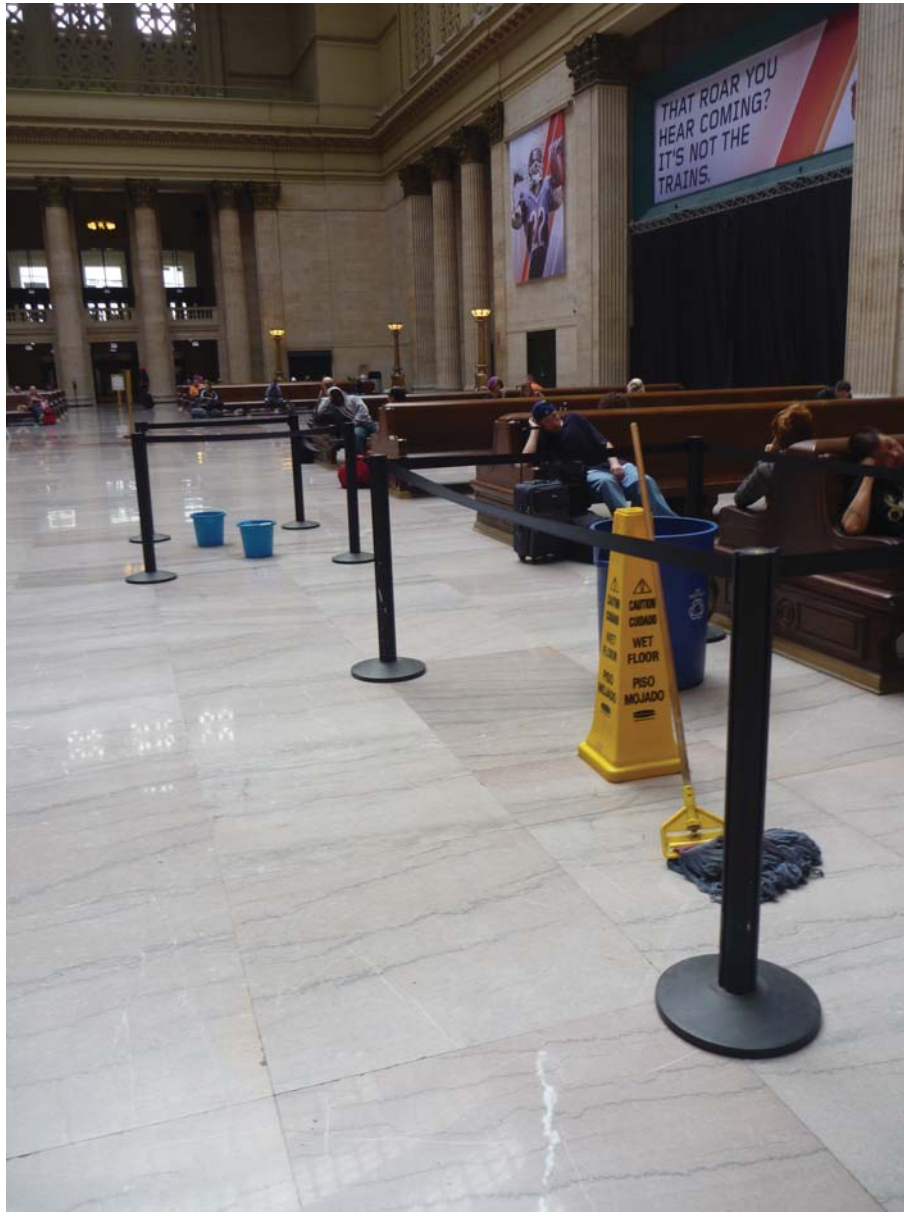
SIGNS OF CONTINUED SKYLIGHT LEAKAGE

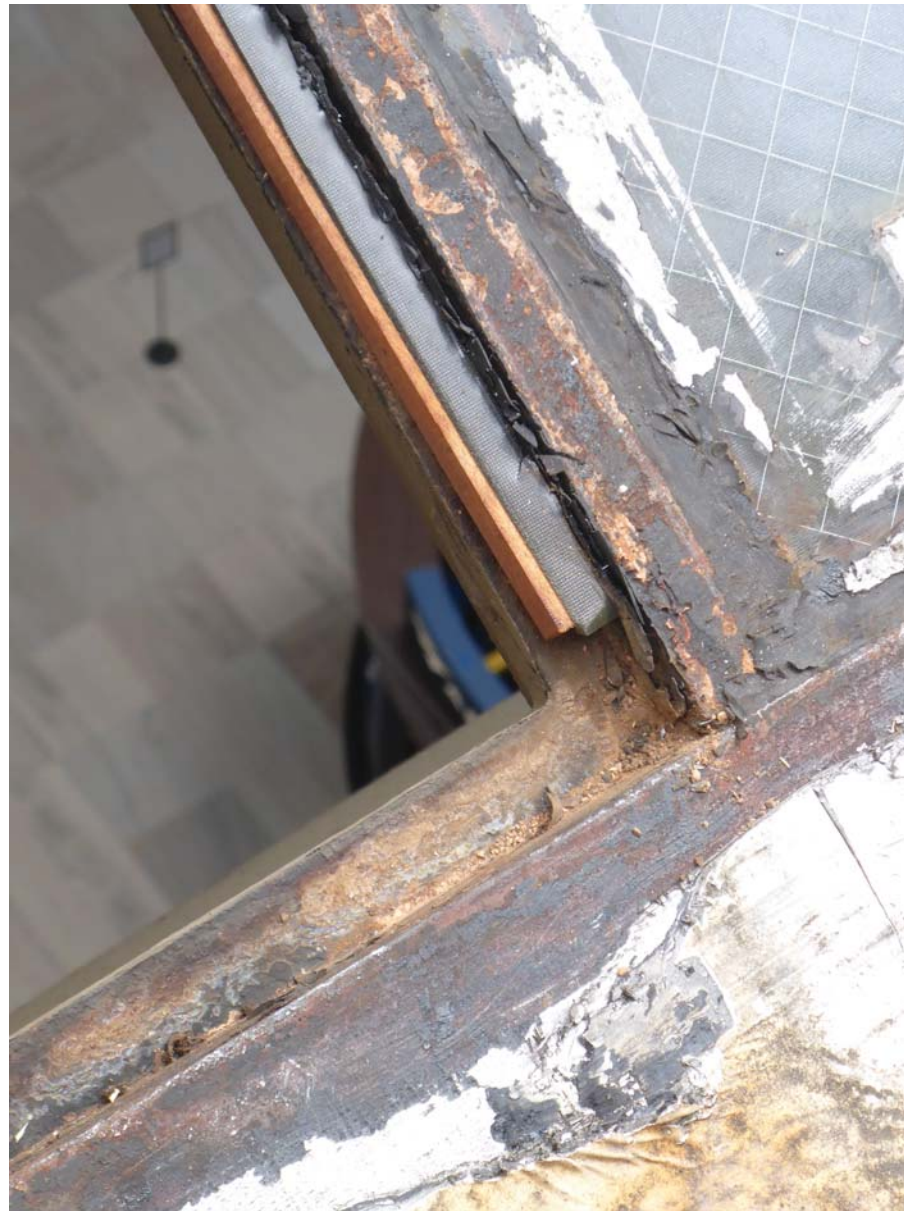
TYPICAL GLAZING POCKET WITH WOOD BLOCKING

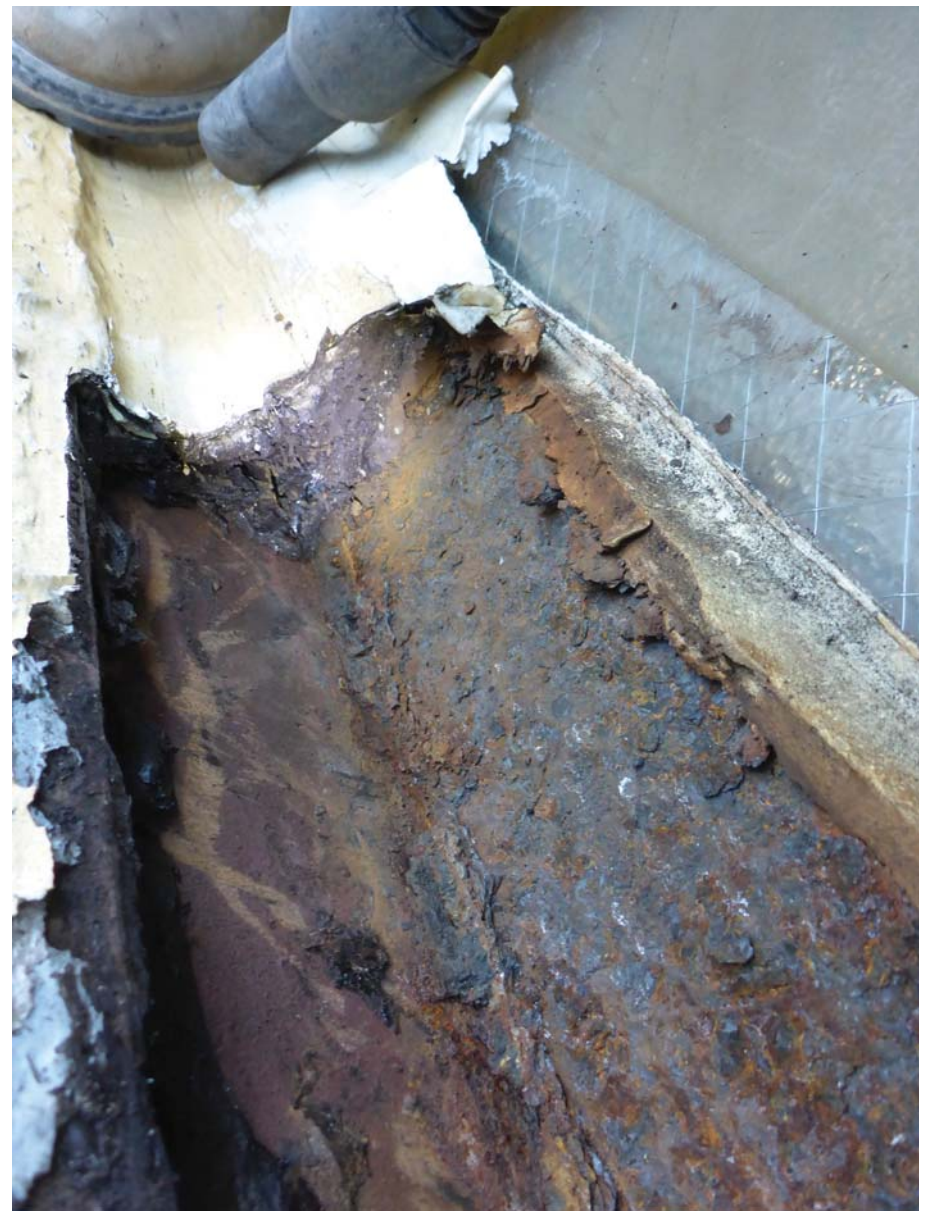
The investigation concluded that the skylight system as designed will not adequately keep water out, and the current wire glass — replaced in the early 1980s — does not meet current codes. Flashings are saturated with water and rusting,

SATURATED EDGE FLASHINGS BETWEEN GIRDER AND SKYLIGHT GLASS

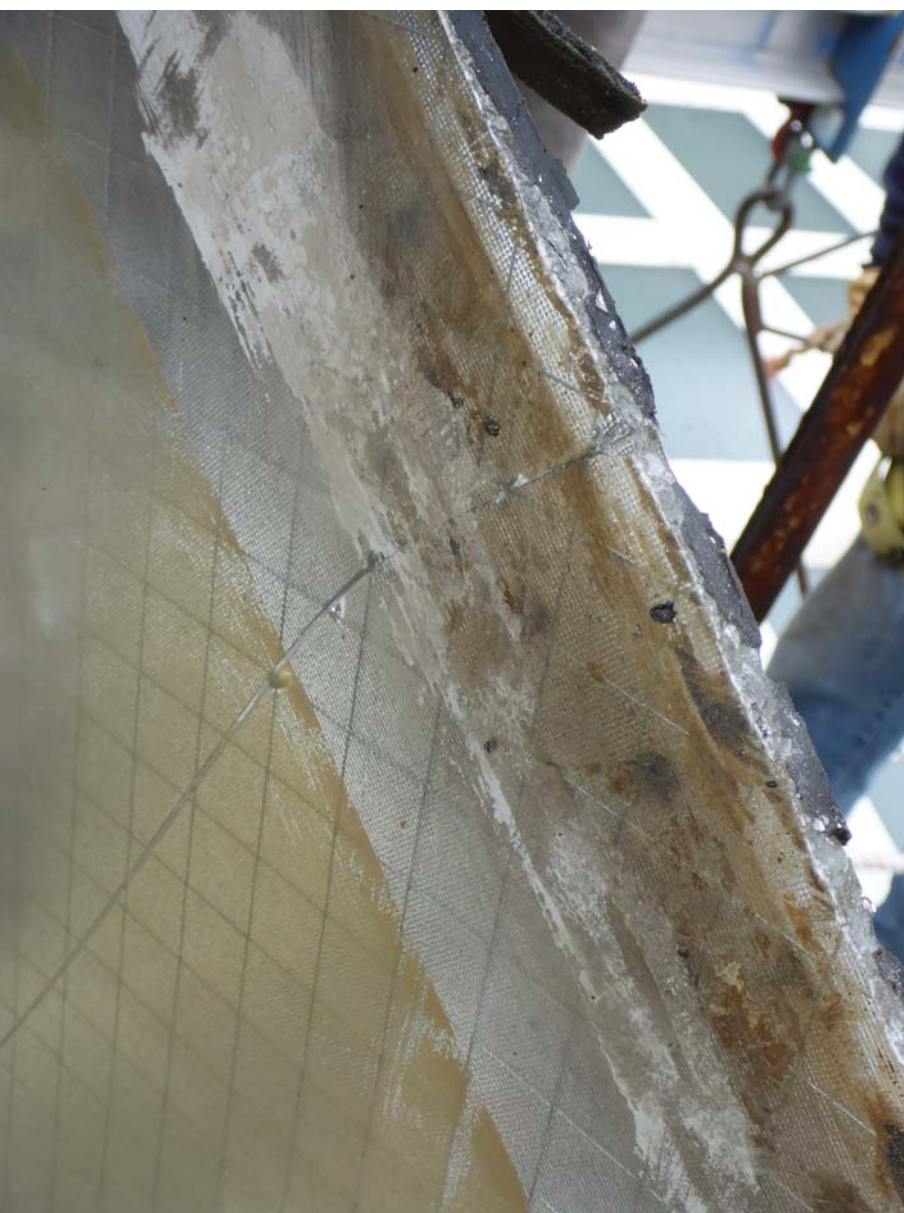
BROKEN WIRE GLASS

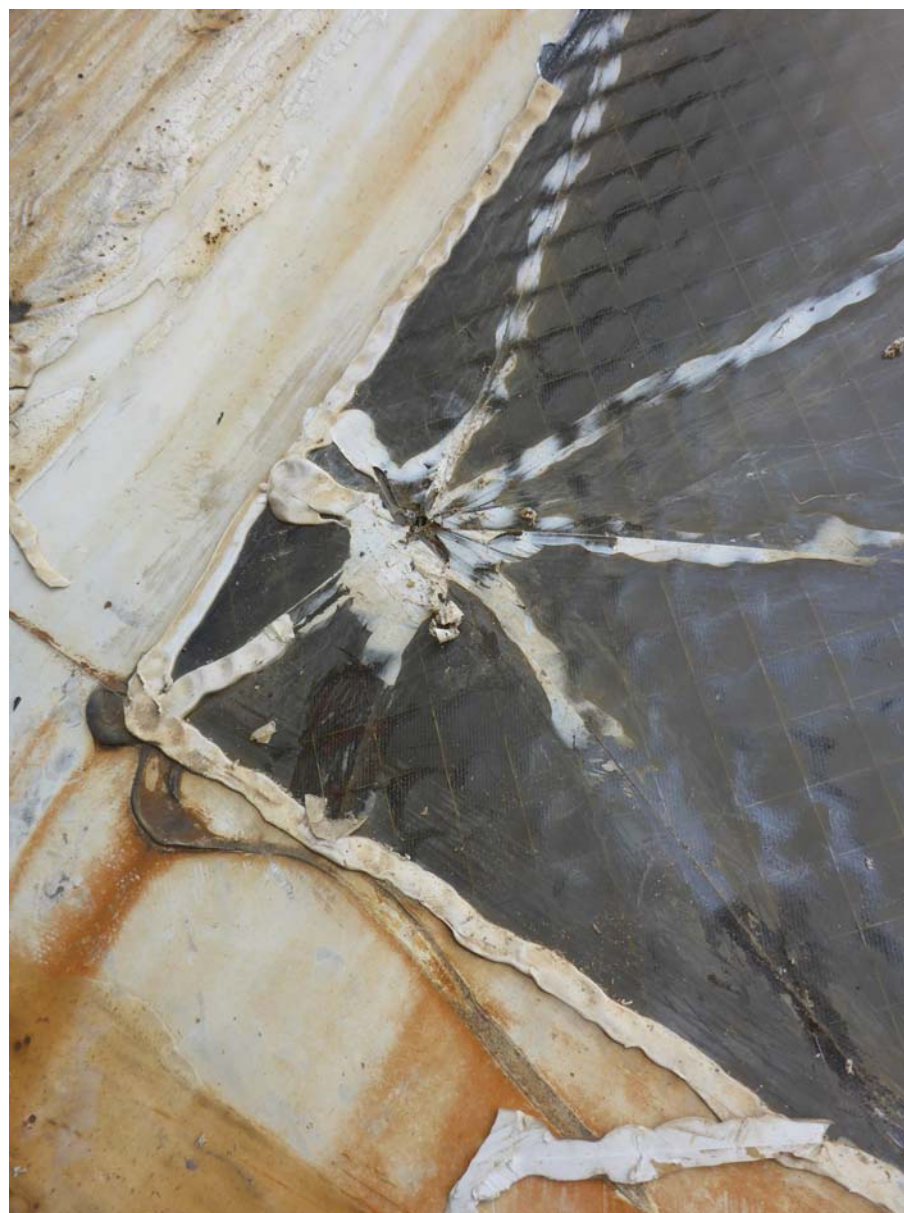
EXISTING WIRE GLASS WITH IMPACT DAMAGE

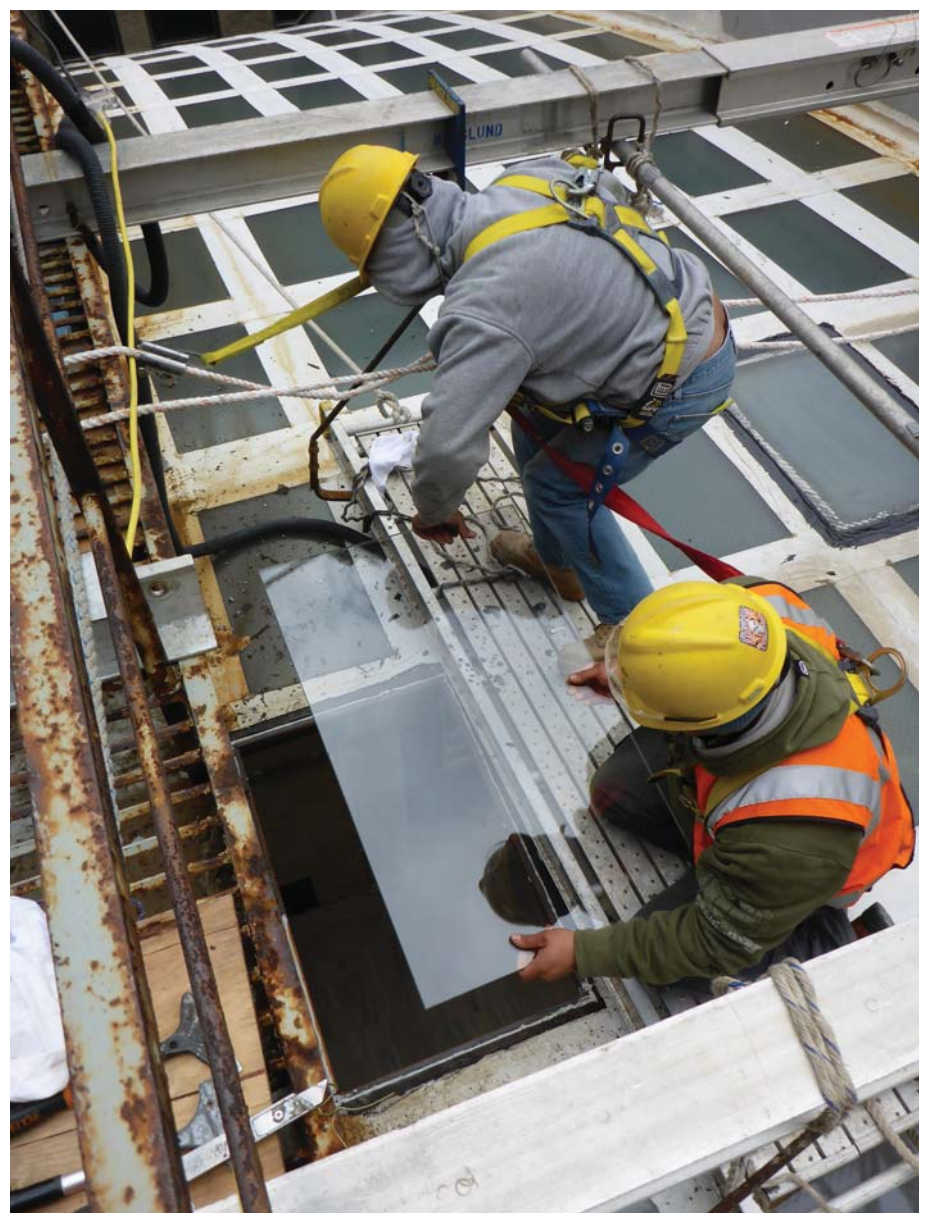
INSTALLING TEMPORARY REPLACEMENT GLASS

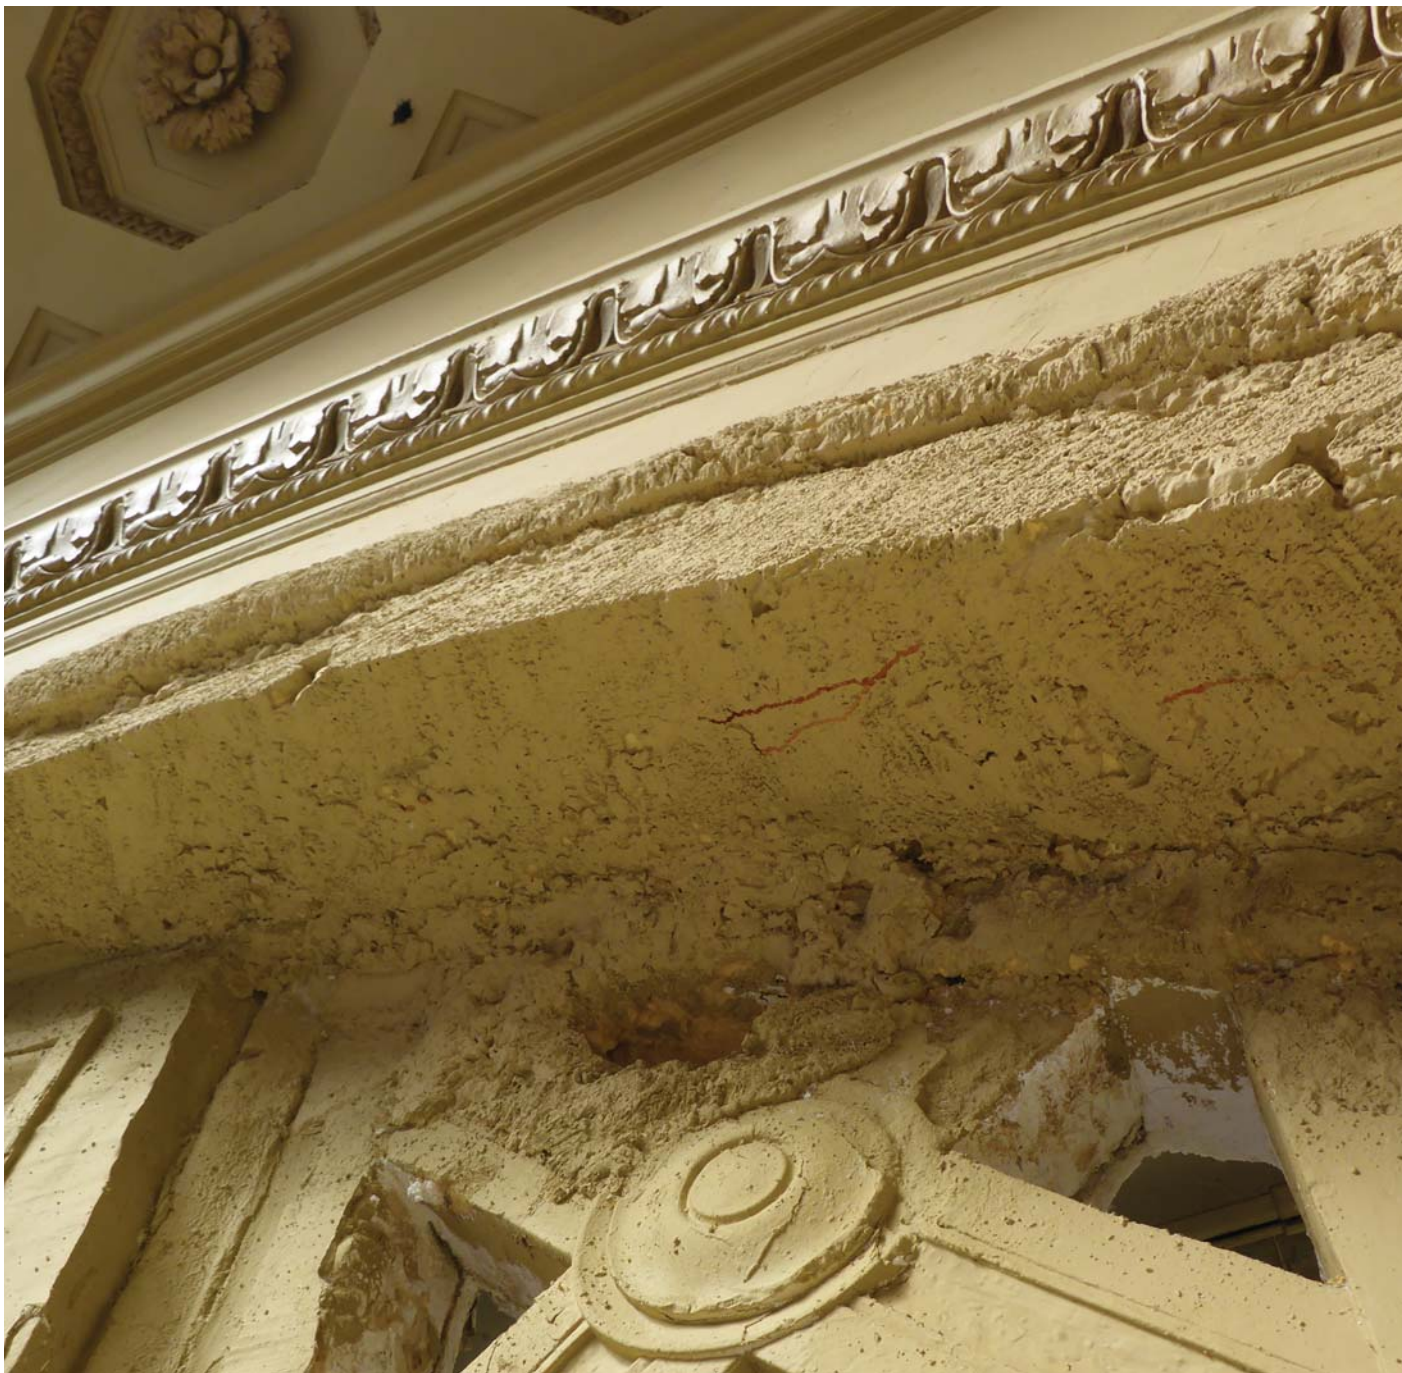
appearance of the skylight the designers intended. Further down, on the ceiling coffers and upper walls signs of deteriorated plaster are easily spotted from the floor, while staining on the travertine marble of the lower walls is also evident, both caused by the failed and leaking drains.

PLASTER DETERIORATION
DETAIL AT NORTHWEST CORNER
