Great Hall Skylight Investigation

September 2015 - June 2016

UNION STATION

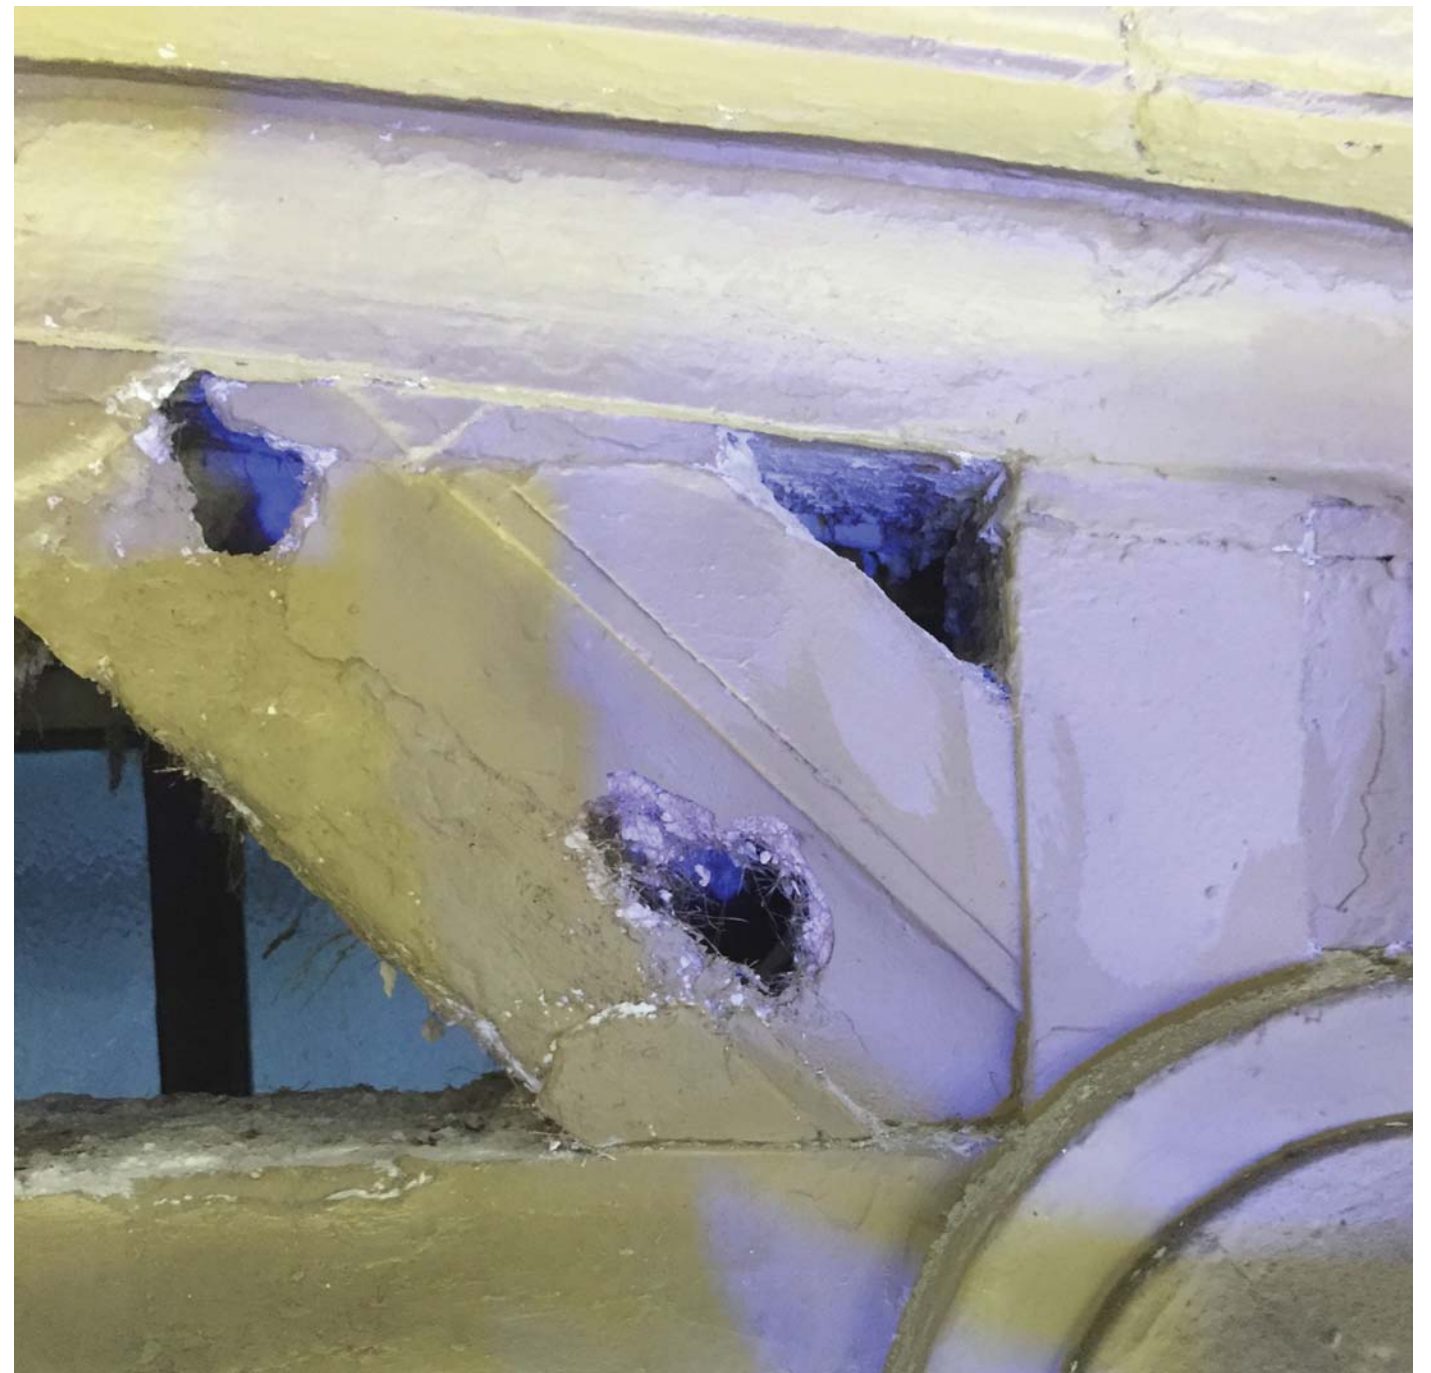
PLASTER DETERIORATION
DETAIL AT SOUTHWEST CORNER

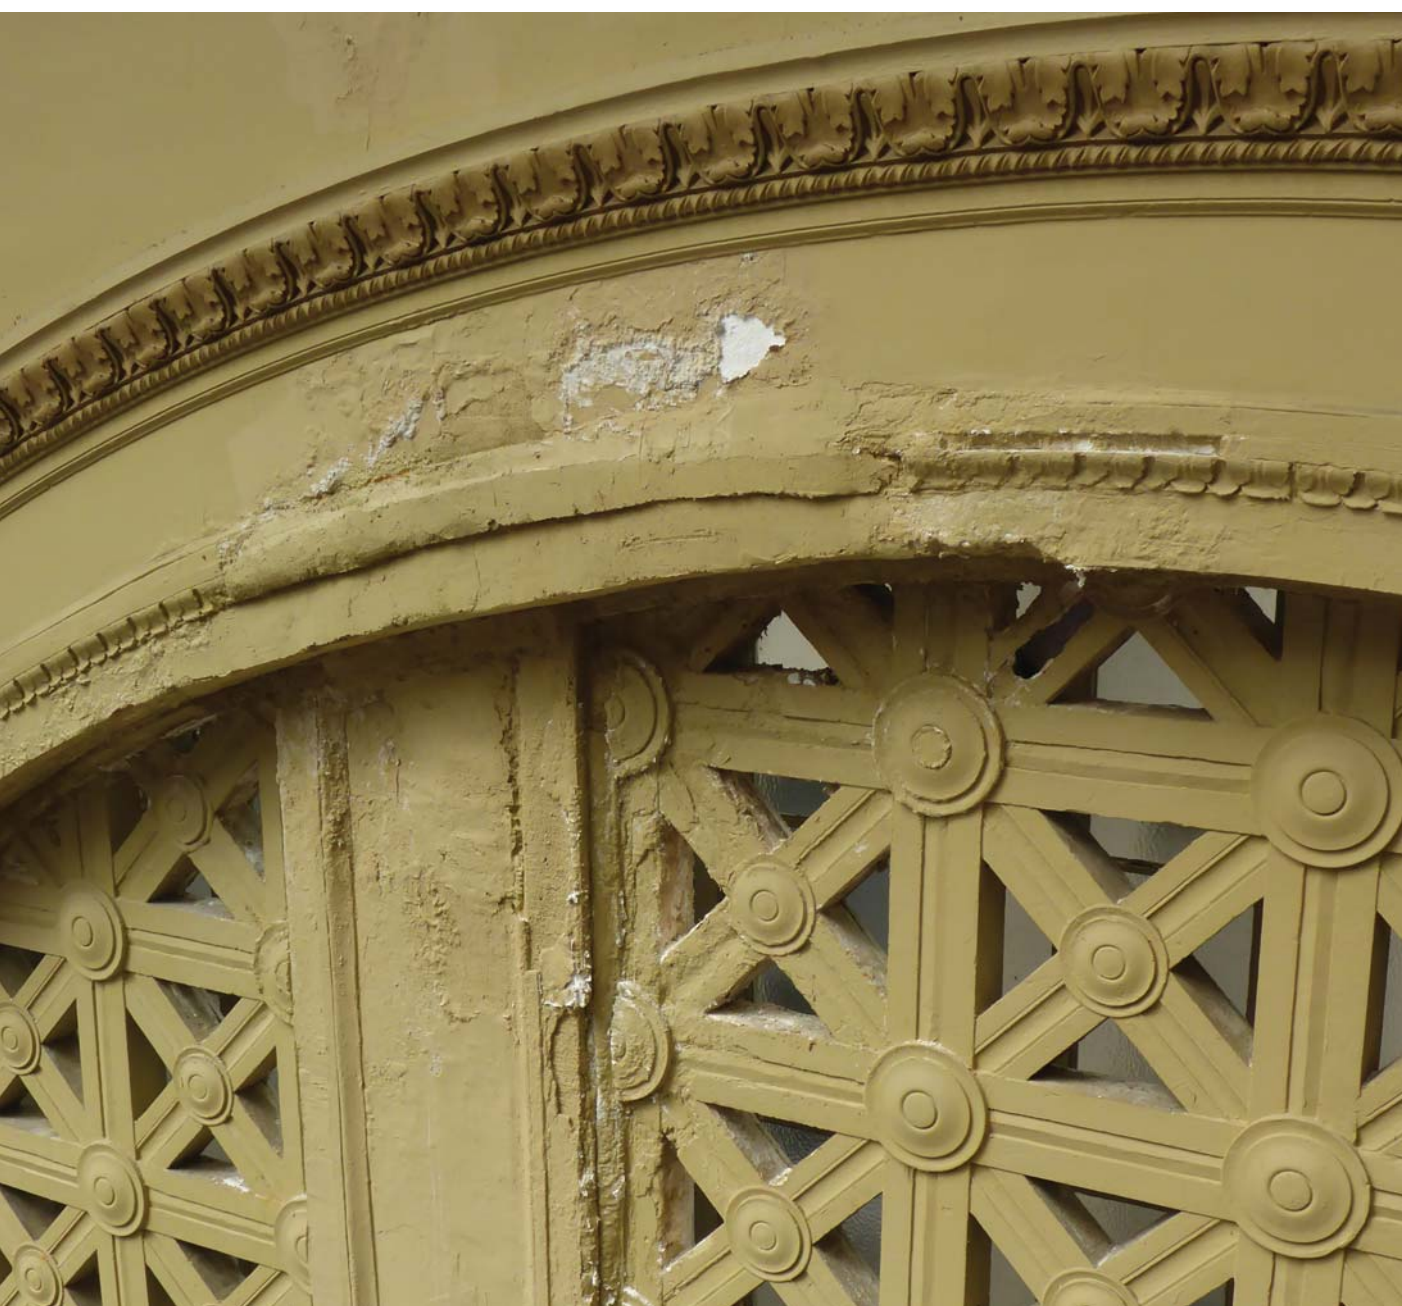
PLASTER DETERIORATION
DETAIL AT NORTHWEST CORNER

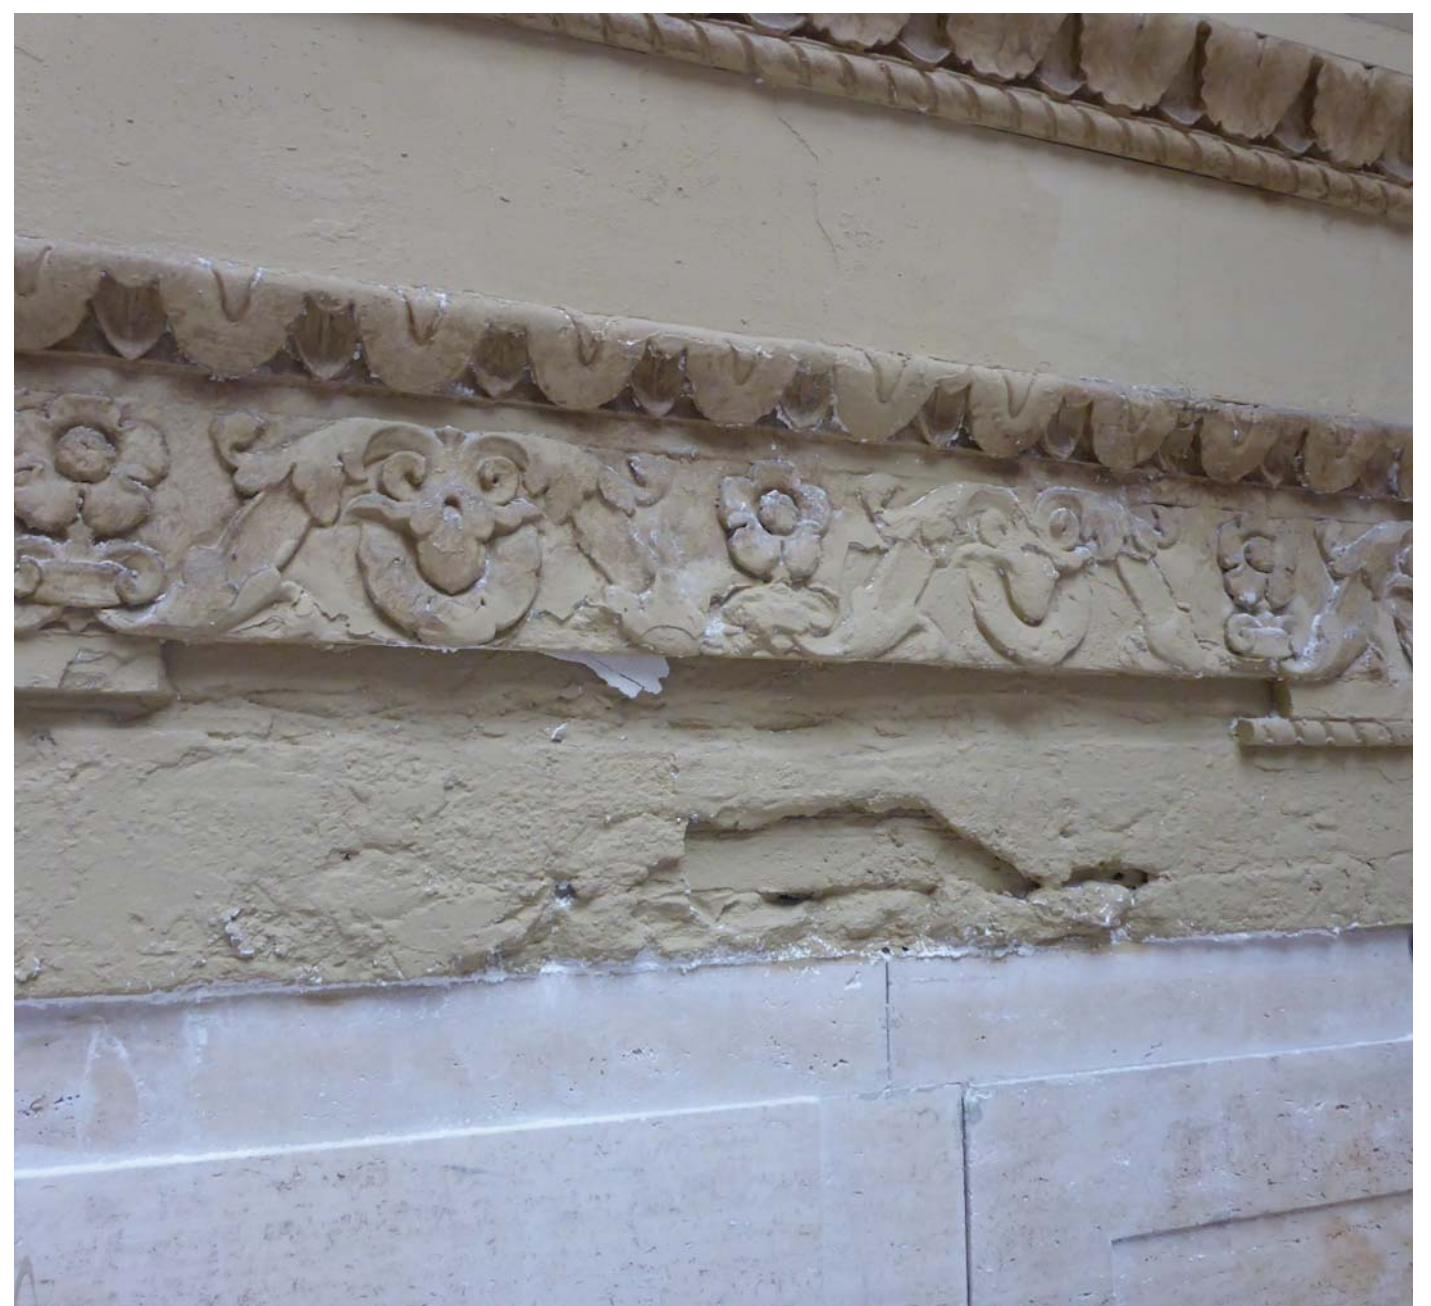
PLASTER DETERIORATION AT
EAST WALL CORNICE
