A RECREATIONAL REUSE STUDY
for the FORMER ELGIN STATE
HOSPITAL LAUNDRY BUILDING

PREPARED FOR THE CITY OF ELGIN,
THE PARKS & RECREATION DEPARTMENT AND
THE PARKS & RECREATION ADVISORY COMMISSION

ELGIN MENTAL HEALTH CENTER Condition Assessment - Laundry Building

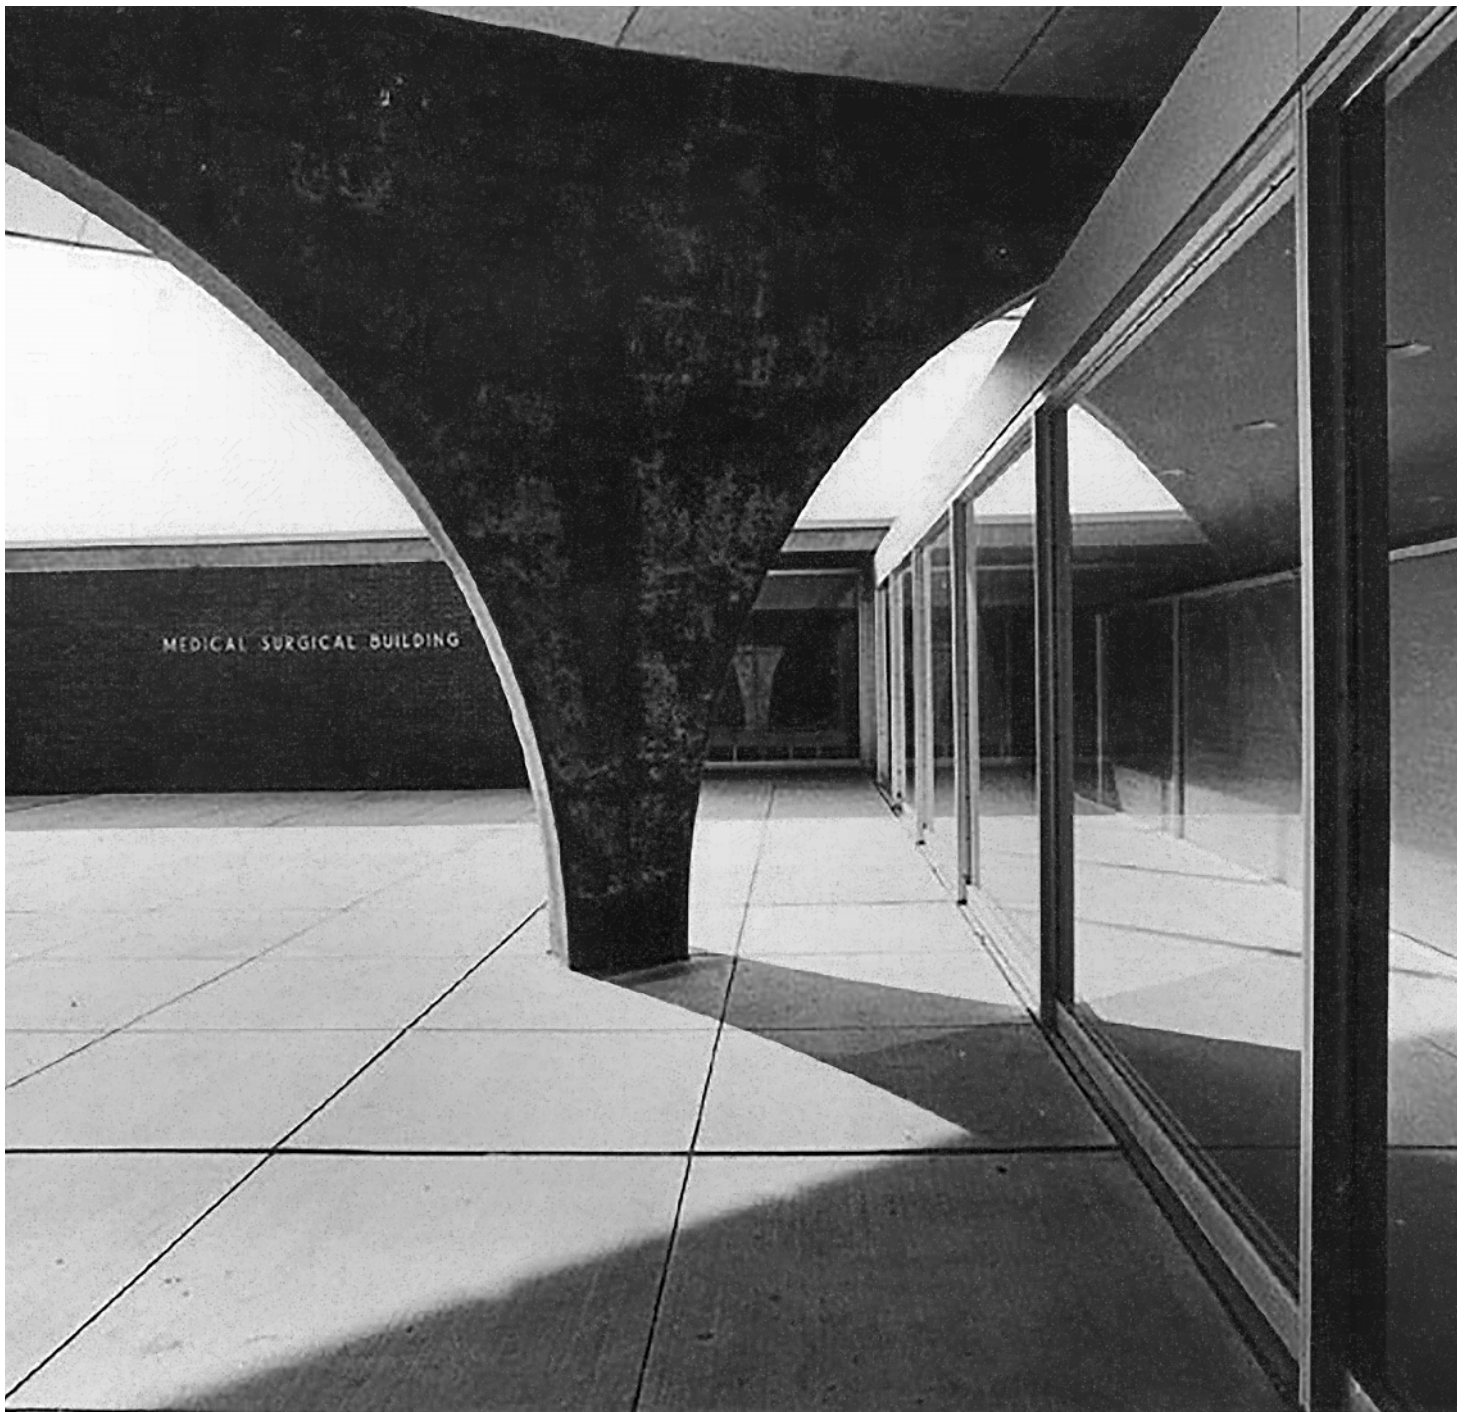
Right: Structural Detail of the Medical Surgical Building

View of column detail, Elgin State Hospital. (Larry Gordon photo, n.d.)

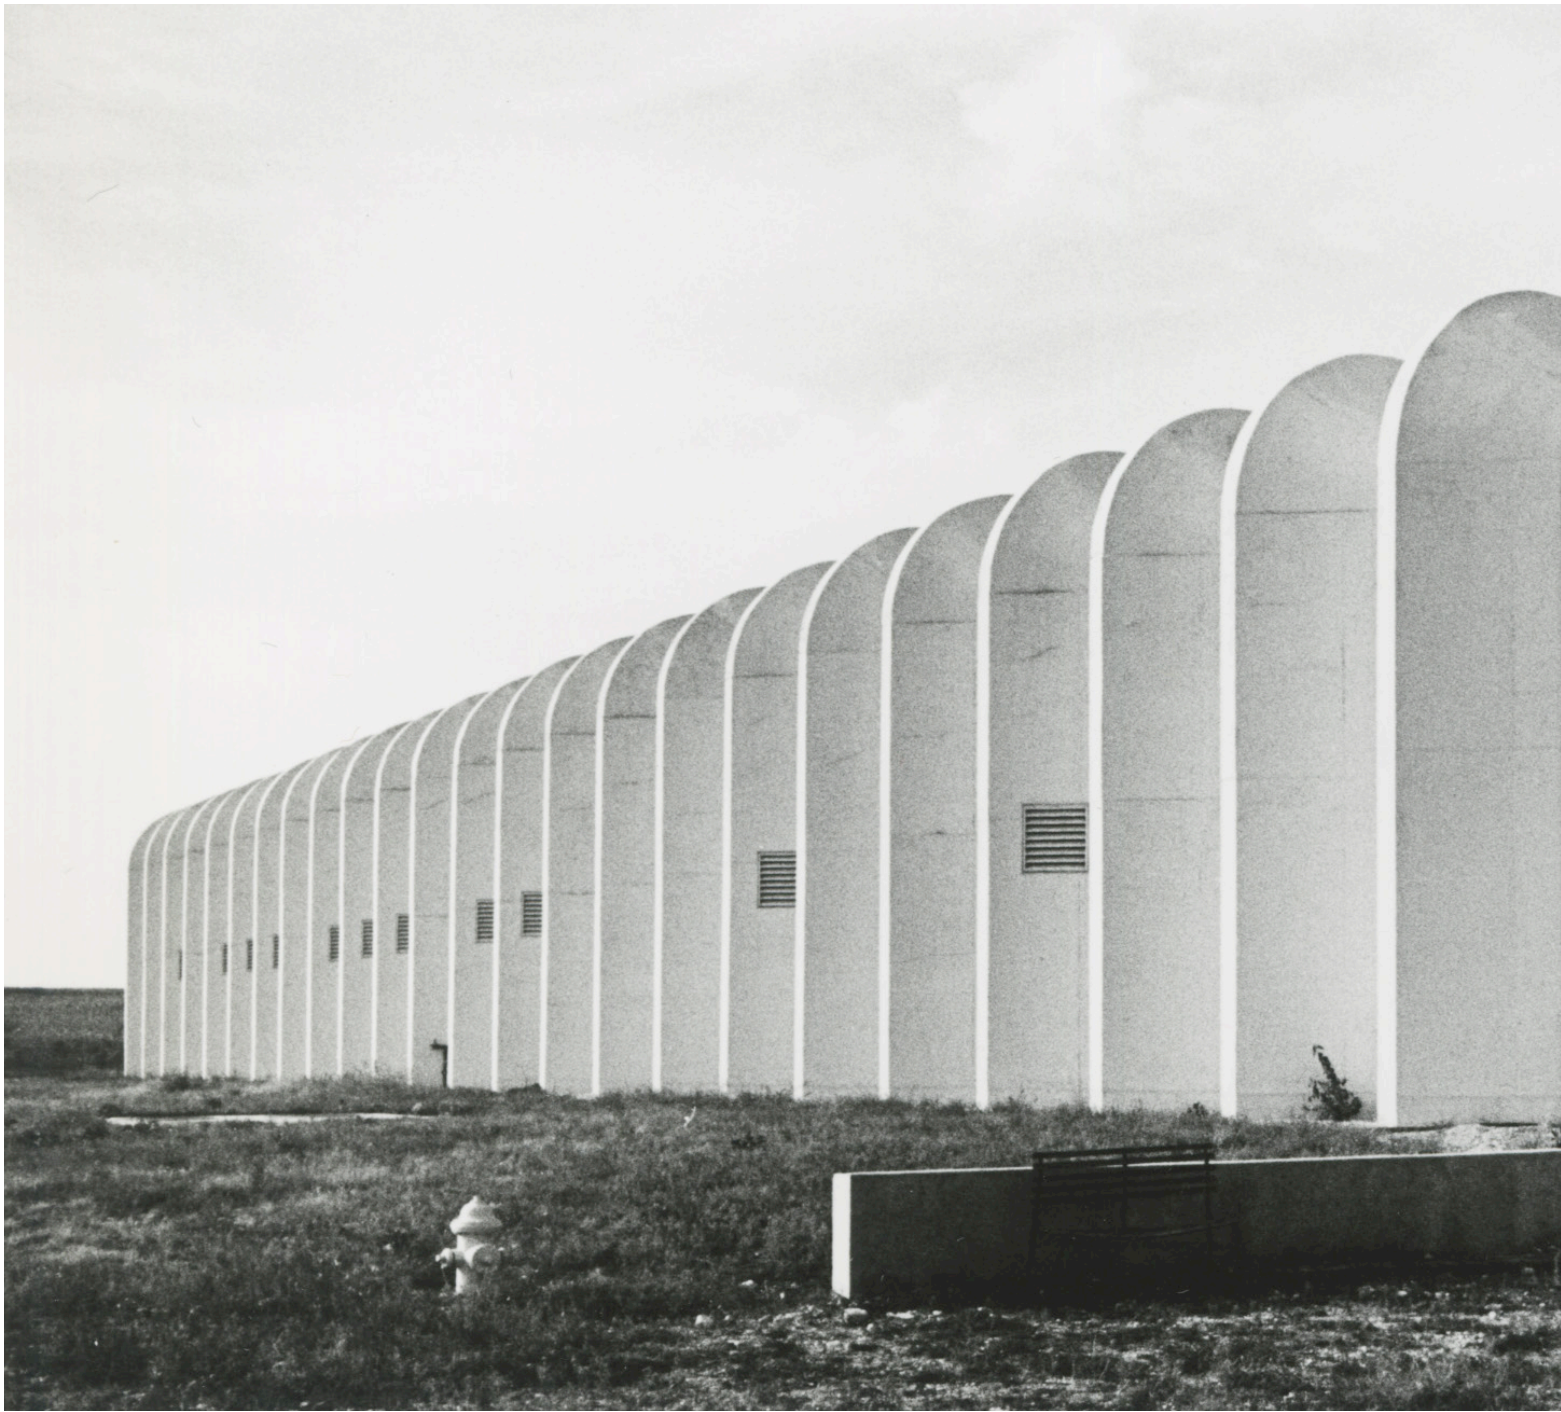
Goldberg's design relies upon the repetitive use of continuous large scaled, "V" shaped structural members as both vertical columns and walls, utilizing their depth to achieve the more than 100 ft. long span condition of the roof. The troughs between the concrete "V"'s are sloped to function as roof drains, sloping approximately 50 ft. in each direction. The elemental, straightforward expression of the building as a hangar-like shed, open on two ends, lends itself towards reuse.

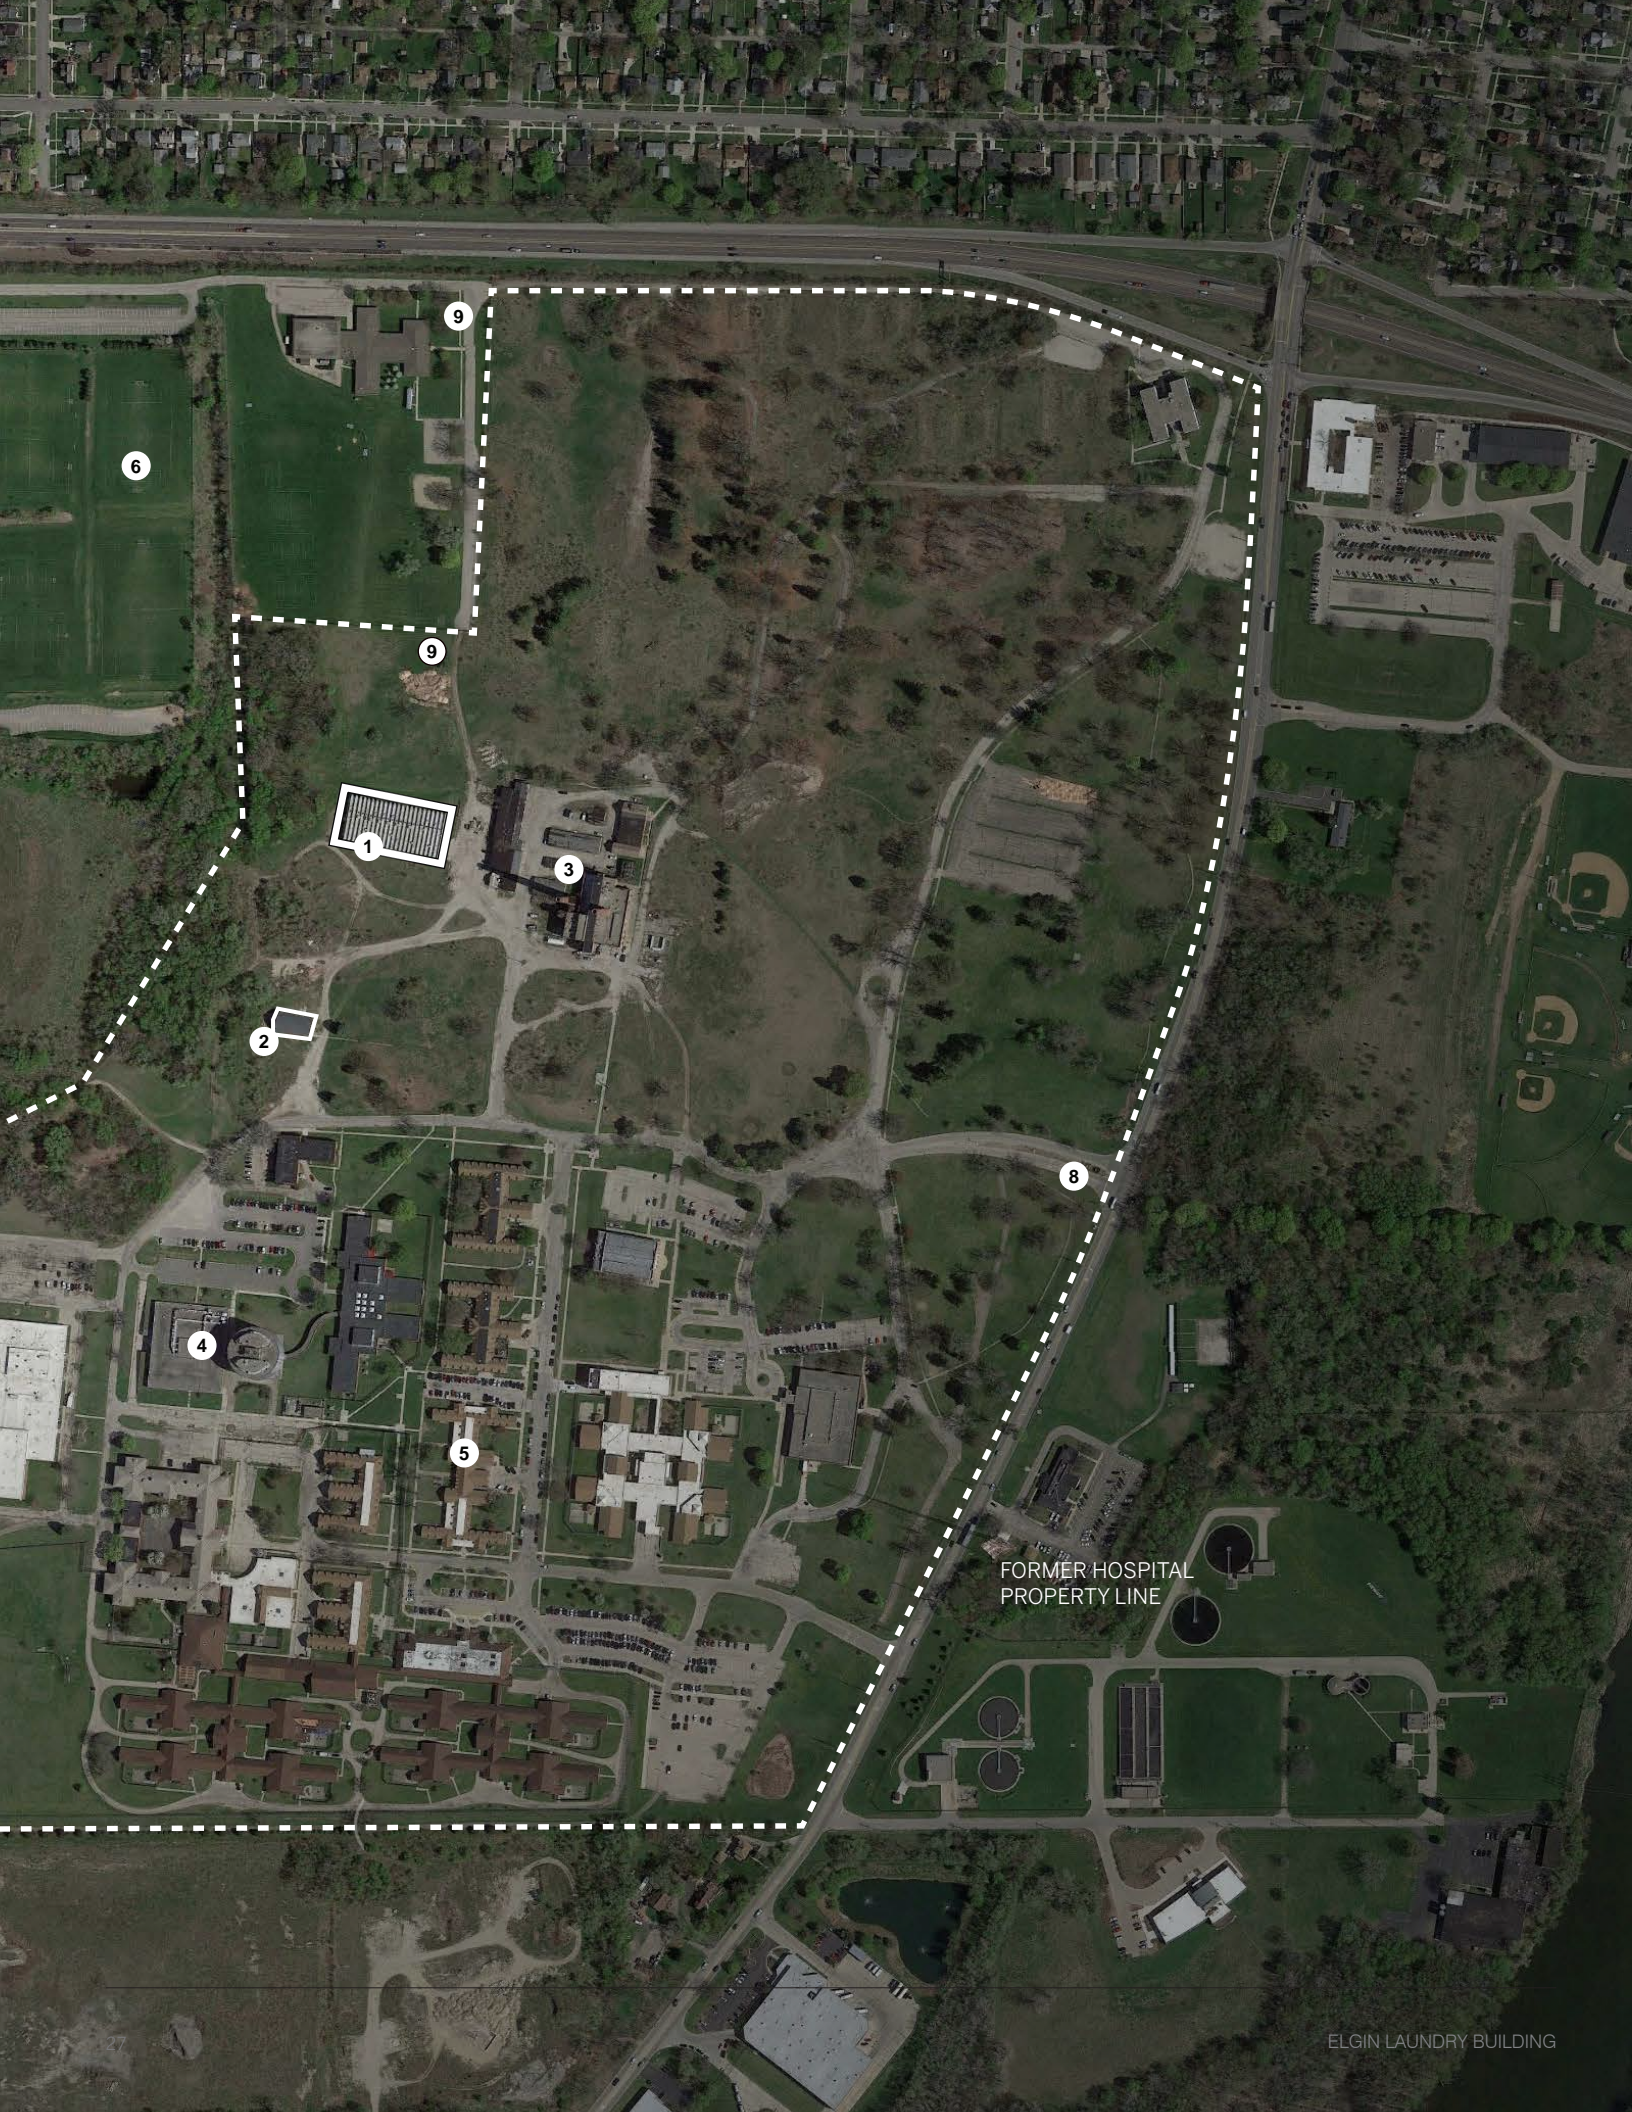
The hospital site plan reveals the growth and change of the site over time from its historic, pastoral core, to a series of peripheral, newer additions - including both of the Goldberg buildings. The Central Plant building (3) is excluded from the transfer of the northern portion of the Mental Health Center land from the State of Illinois to the City of Elgin.

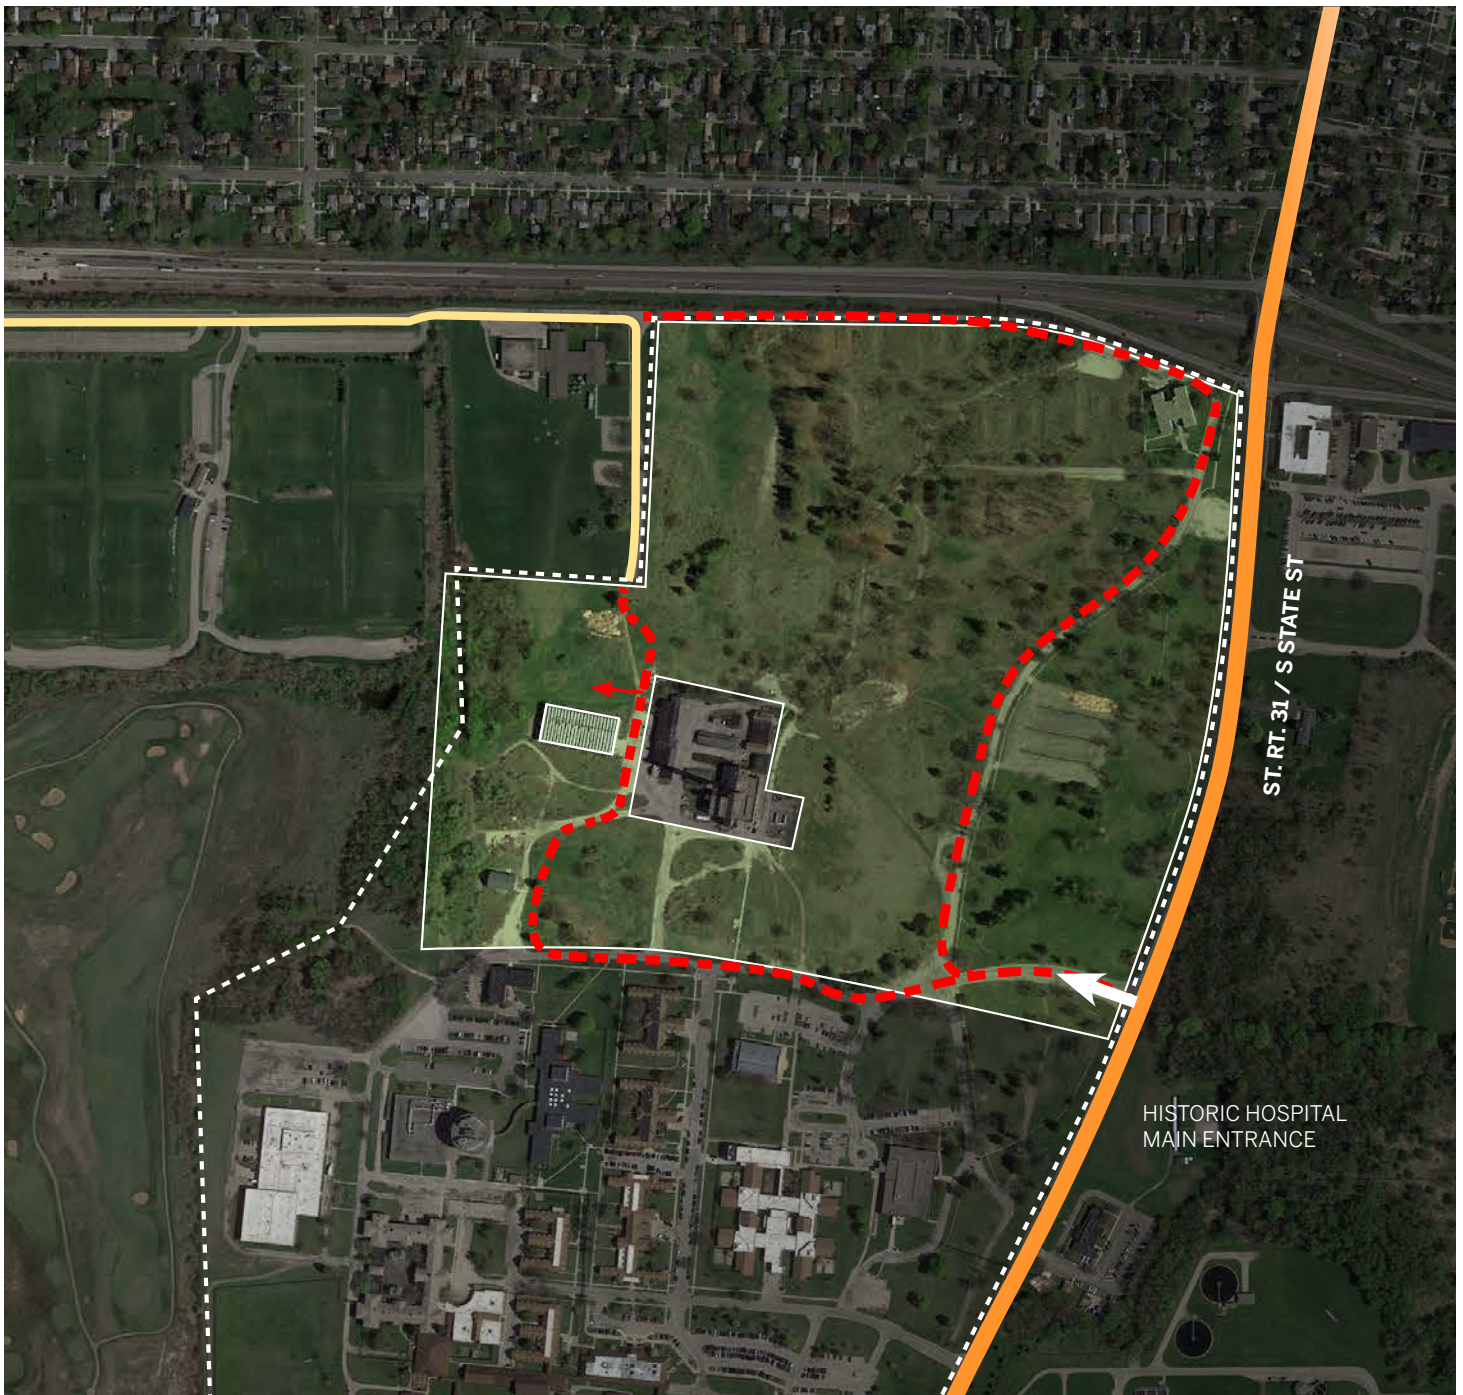
Connectivity to St. Rt. 31 - Re-use infrastructure

One of the primary goals of the City is to establish a second main entrance to the existing sports complex within the site area of the land transfer. The site could utilize the existing historic hospital entrance just south of the transfer boundary. The site will also incorporate new bike trail links which connect to existing City of Elgin bikeways.

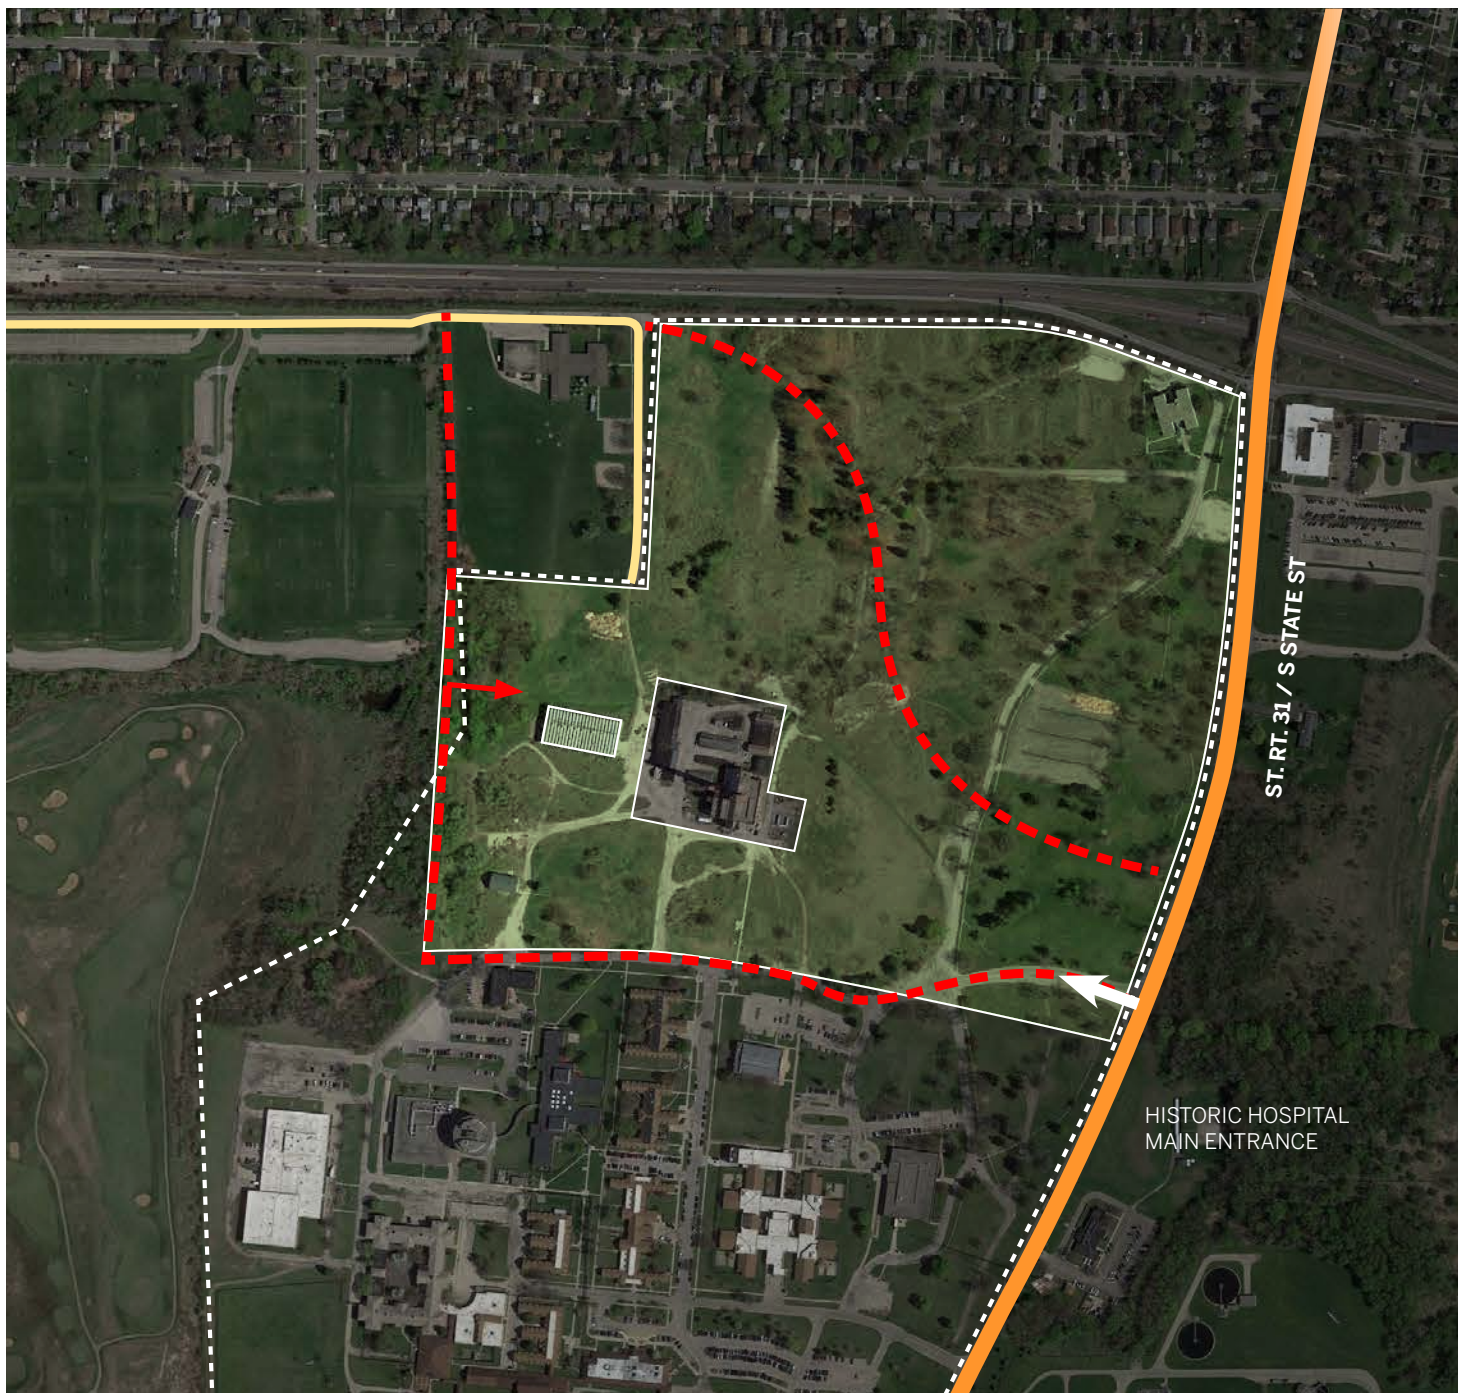
Connectivity to St. Rt. 31 - Create new infrastructure

Alternatively, a new "Main Parks Entrance" could be established north of the historic hospital entrance. The configuration and location of this entrance could take advantage of/rebuild atop the historic road locations which once traversed this portion of the site but have since fallen into disrepair.

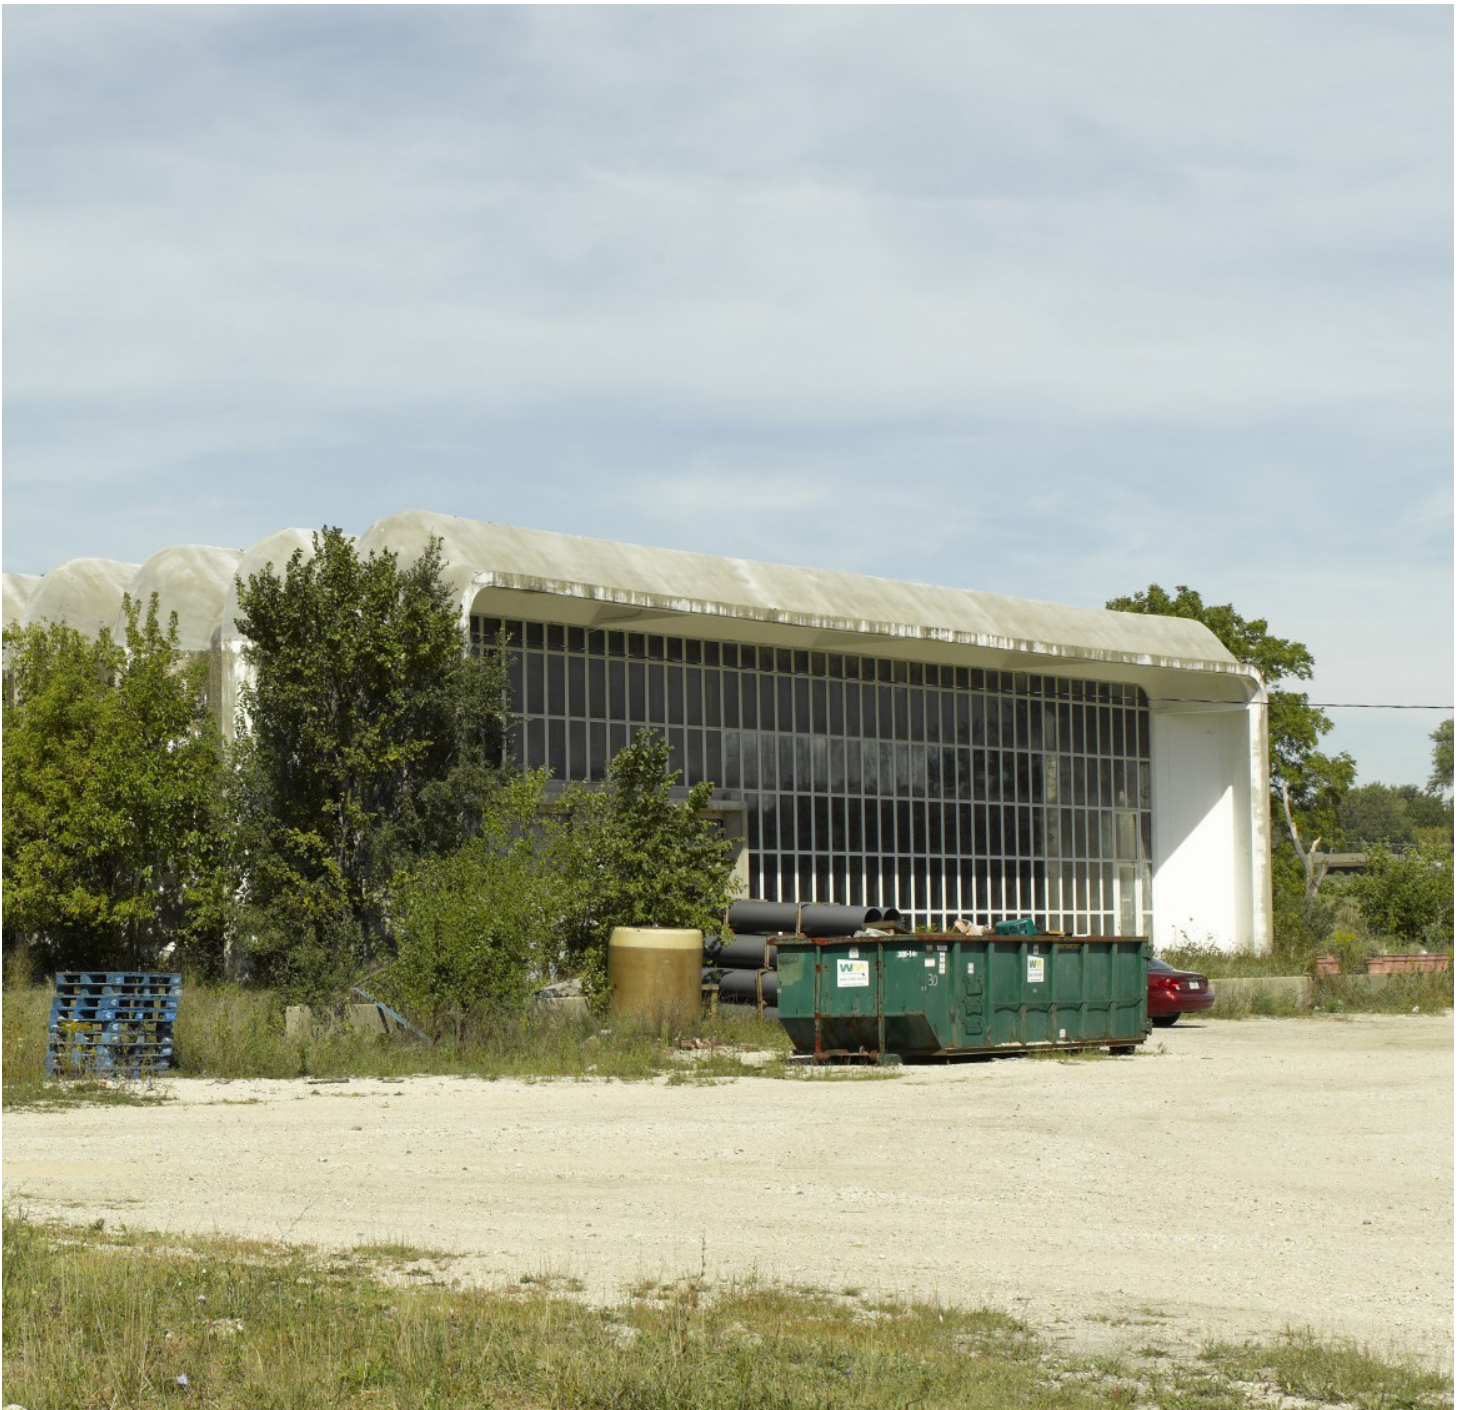
The current state of the building is cosmetically dated, but appears to be structurally sound. The paint finish on the concrete needs to be reapplied and waterproofing on the roof reassessed. The curtain walls on both ends of the building require maintenance or should be removed and replaced with a higher performing thermal envelope utilizing contemporary glazing and thermal assemblies.

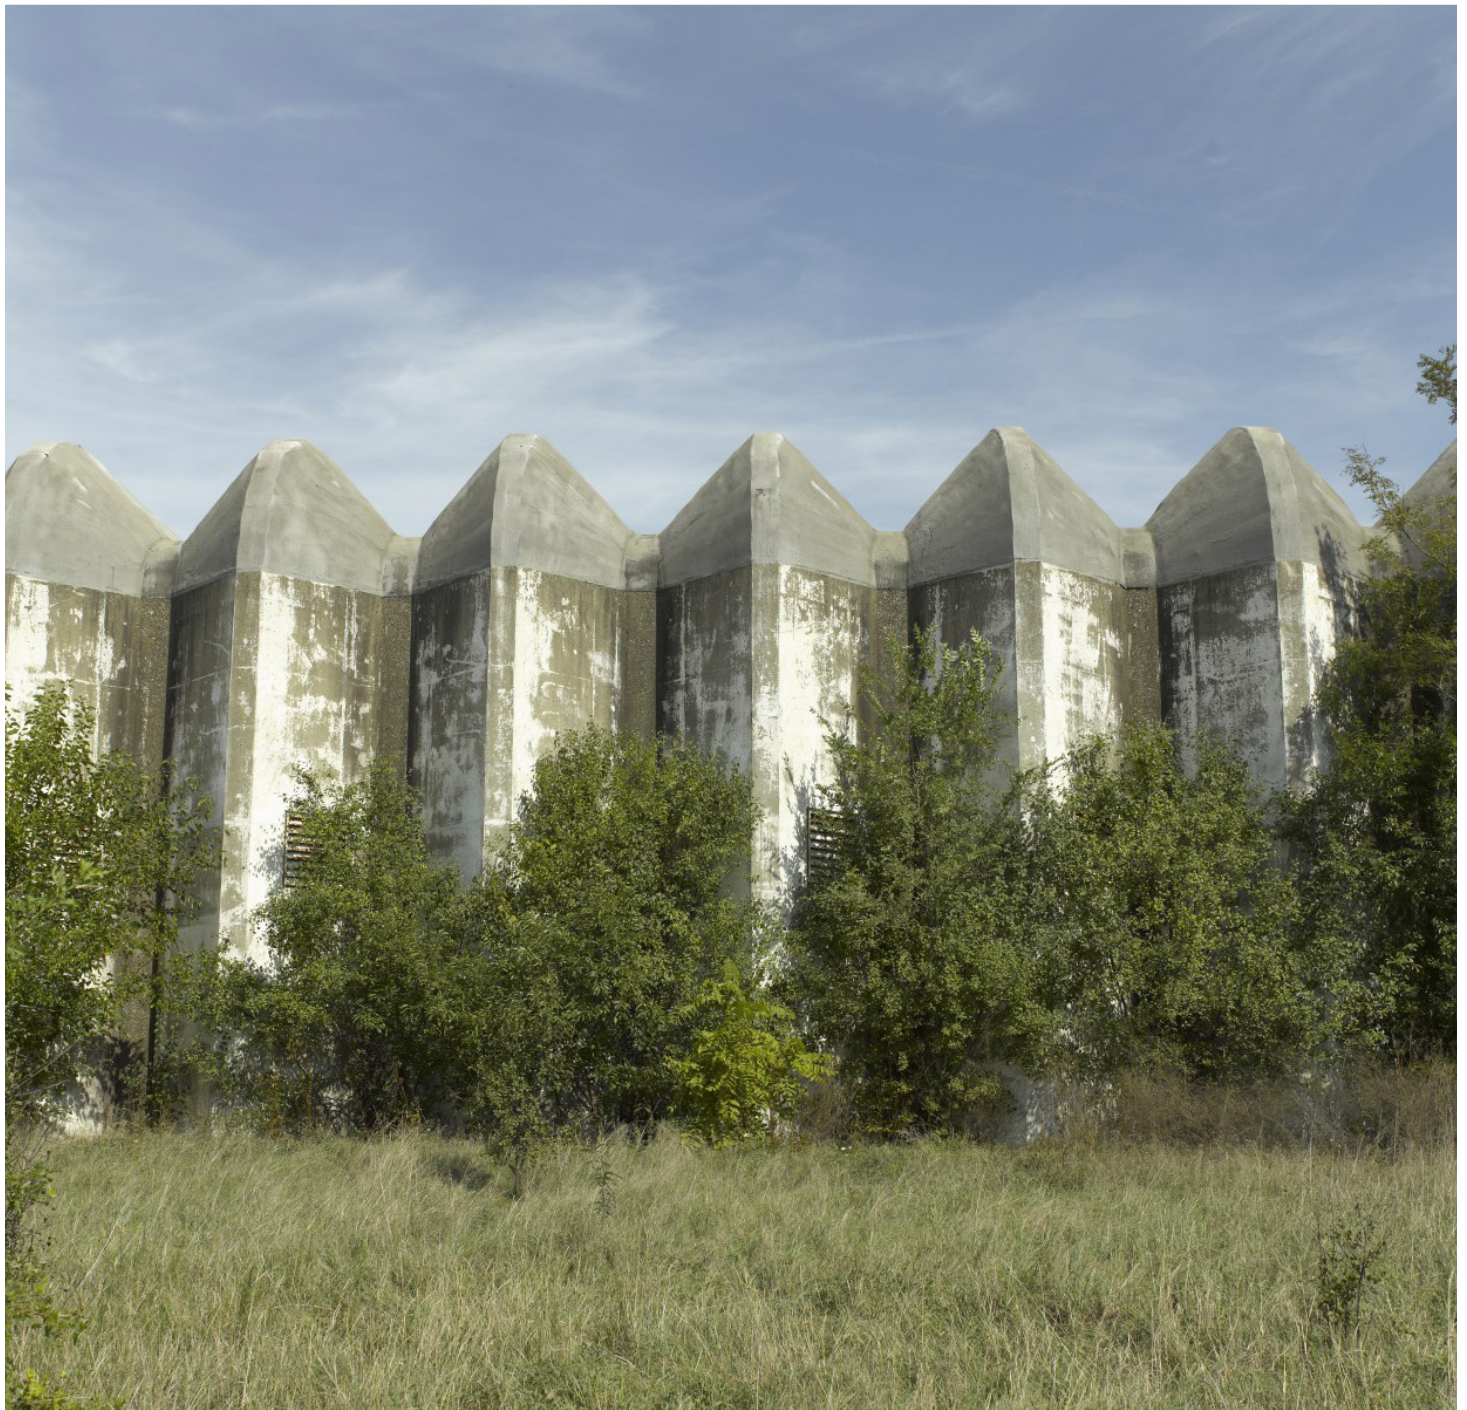
A series of precast planks are set within the sloping planes of the concrete structure. These removable panels allow exhaust hoods and MEP equipment in the roof plane to be relocated as layouts on the ground level would change over time.

Note that the roof was not accessed at the time of WJE's Condition Assessment and would require further evaluation.

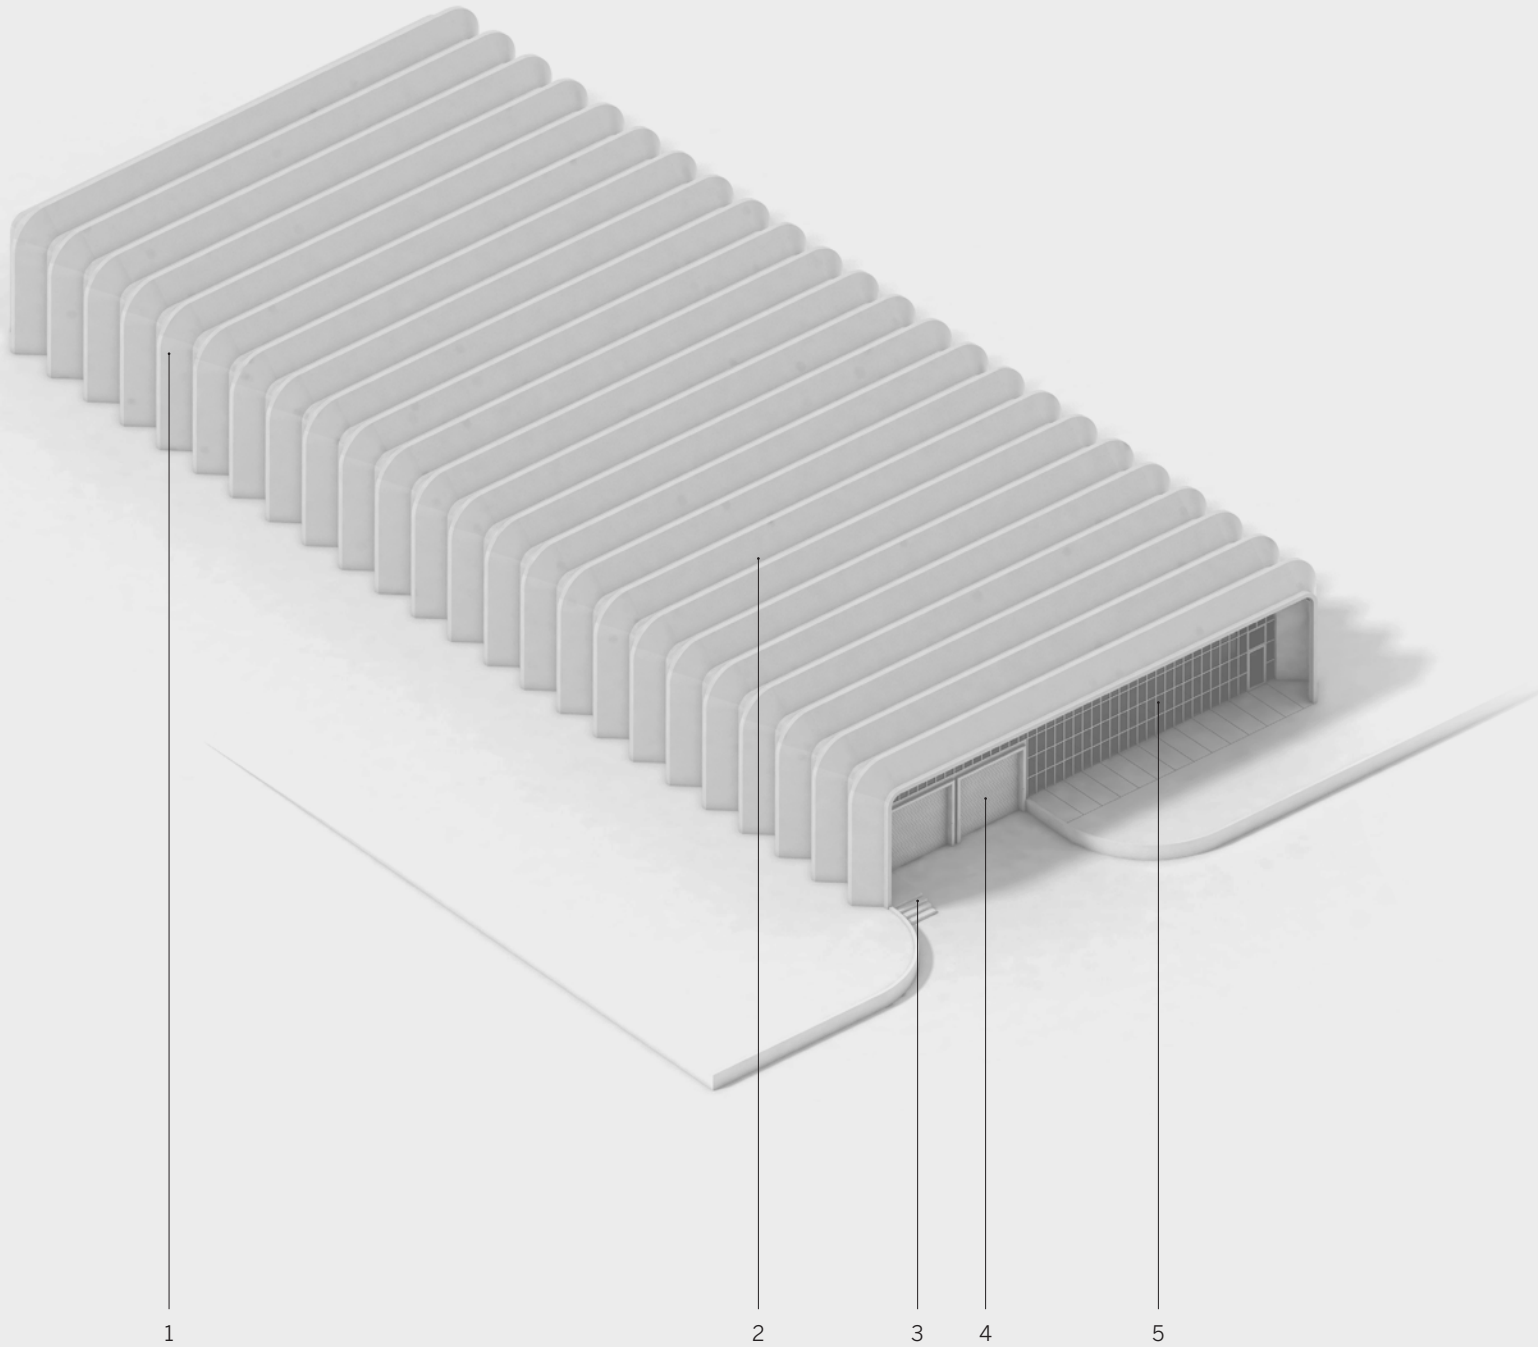
Exterior Enclosure Existing Conditions

- 1 24 FREESTANDING FOLDED CONCRETE PORTALS
- 2 VENTILATION OPENINGS (TO BE LOCATED PENDING ROOF SURVEY)
- 3 PEDESTRIAN ACCESS
- 4 LOADING DOCKS / OVERHEAD DOORS
- 5 RECESSED CURTAIN WALLS ON EAST AND WEST ELEVATIONS

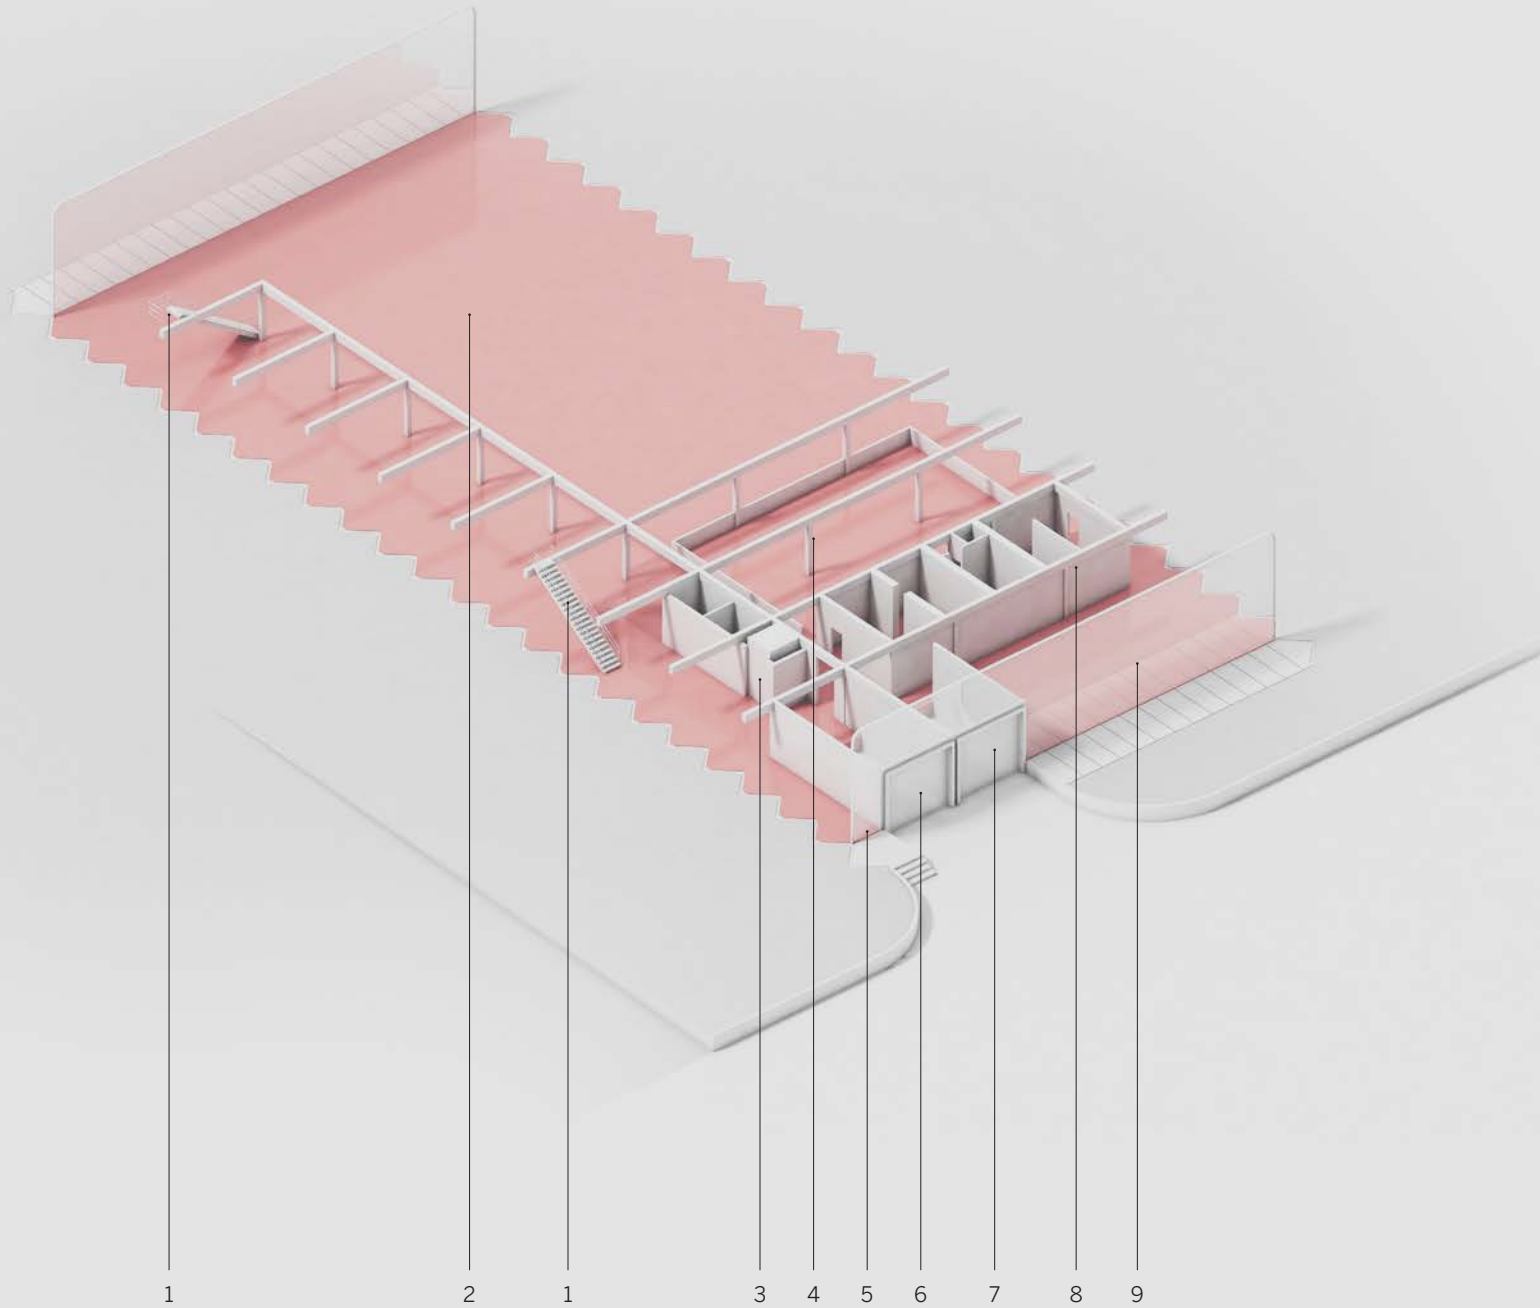
Ground Level Existing Conditions

- 1 STAIRS TO LEVEL 2
- 2 MAIN LAUNDRY AREA (EQUIPMENT)
- 3 TWO-SIDED ELEVATOR
- 4 MENDING AREA
- 5 ENTRY VESTIBULE
- 6 CLEAN DOCK
- 7 SOILED DOCK
- 8 LOCKER ROOMS + RESTROOMS
- 9 CLEAN LINEN STORAGE

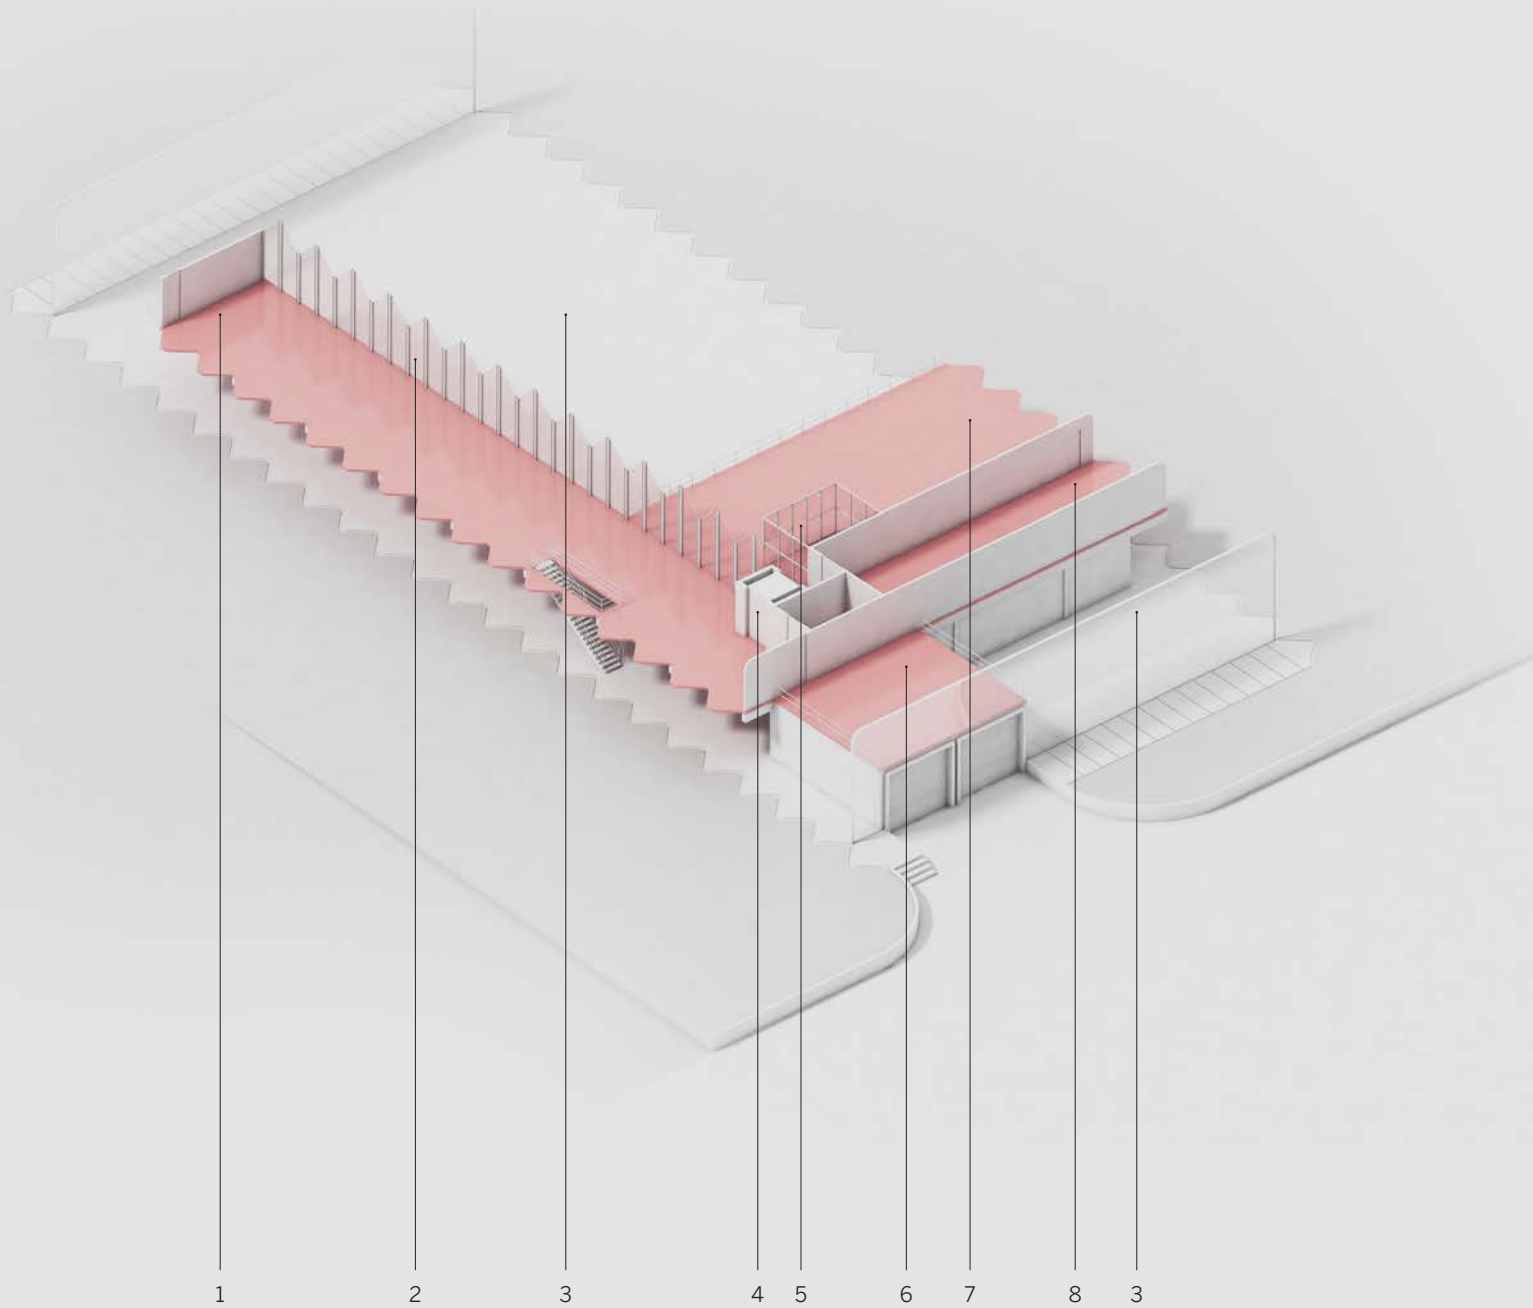
Mezzanine Level Existing Conditions

- 1 SORTING ROOM
- 2 CURTAINWALL
- 3 DOUBLE-HEIGHT SPACE
- 4 TWO-SIDED ELEVATOR
- 5 GLASS ENCLOSURE
- 6 LUNCH ROOM
- 7 UTILITY ROOM
- 8 STORAGE ROOM
