A RECREATIONAL REUSE STUDY
for the FORMER ELGIN STATE
HOSPITAL LAUNDRY BUILDING

PREPARED FOR THE CITY OF ELGIN,
THE PARKS & RECREATION DEPARTMENT AND
THE PARKS & RECREATION ADVISORY COMMISSION

ELGIN MENTAL HEALTH CENTER Condition Assessment - Laundry Building

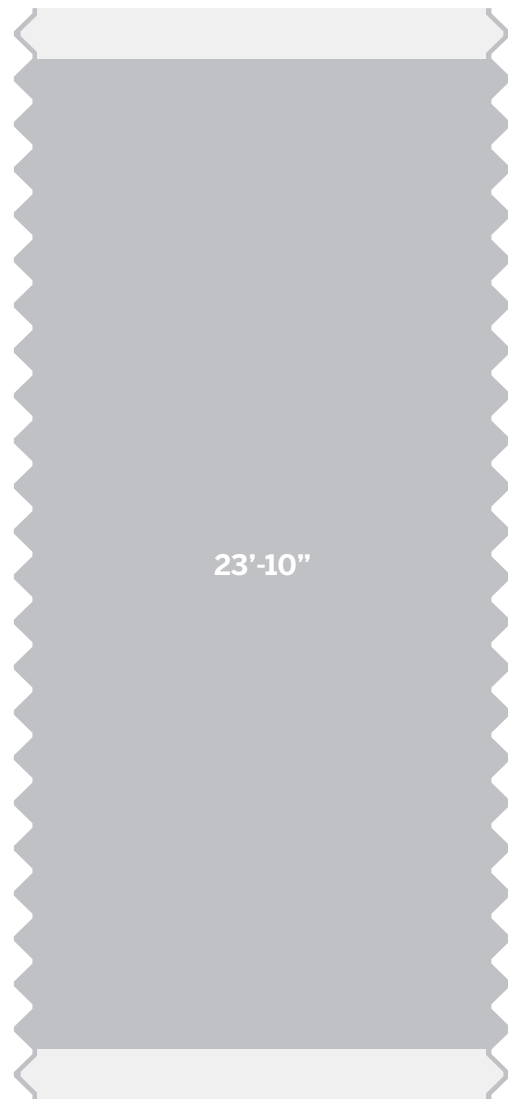
Gymnastics Halls consist of a series of apparatus that require very different surface areas and height clearances. The above matrix provides an idea of the available surface and clear heights depending on the location within the space. Conceptually, the existing building can accommodate such program.

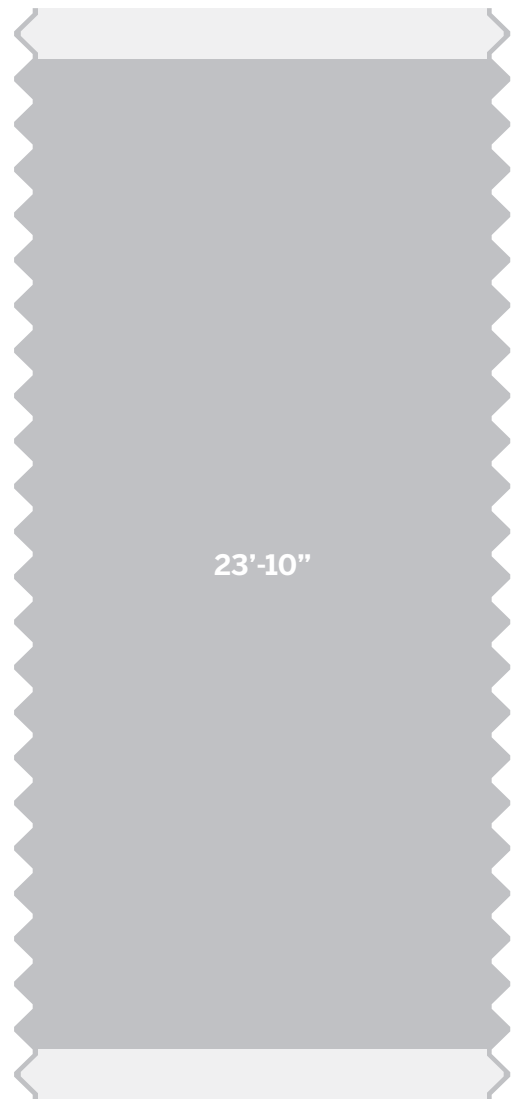
Workout rooms consist of a series of equipment that have height and surface restrictions. Depending on the foreseen capacity, the surface requirements can vary. Considering the layout of the existing space, the upper level (either the existing mezzanine or a new-built) would provide a sufficient surface area for a comfortable workout room.

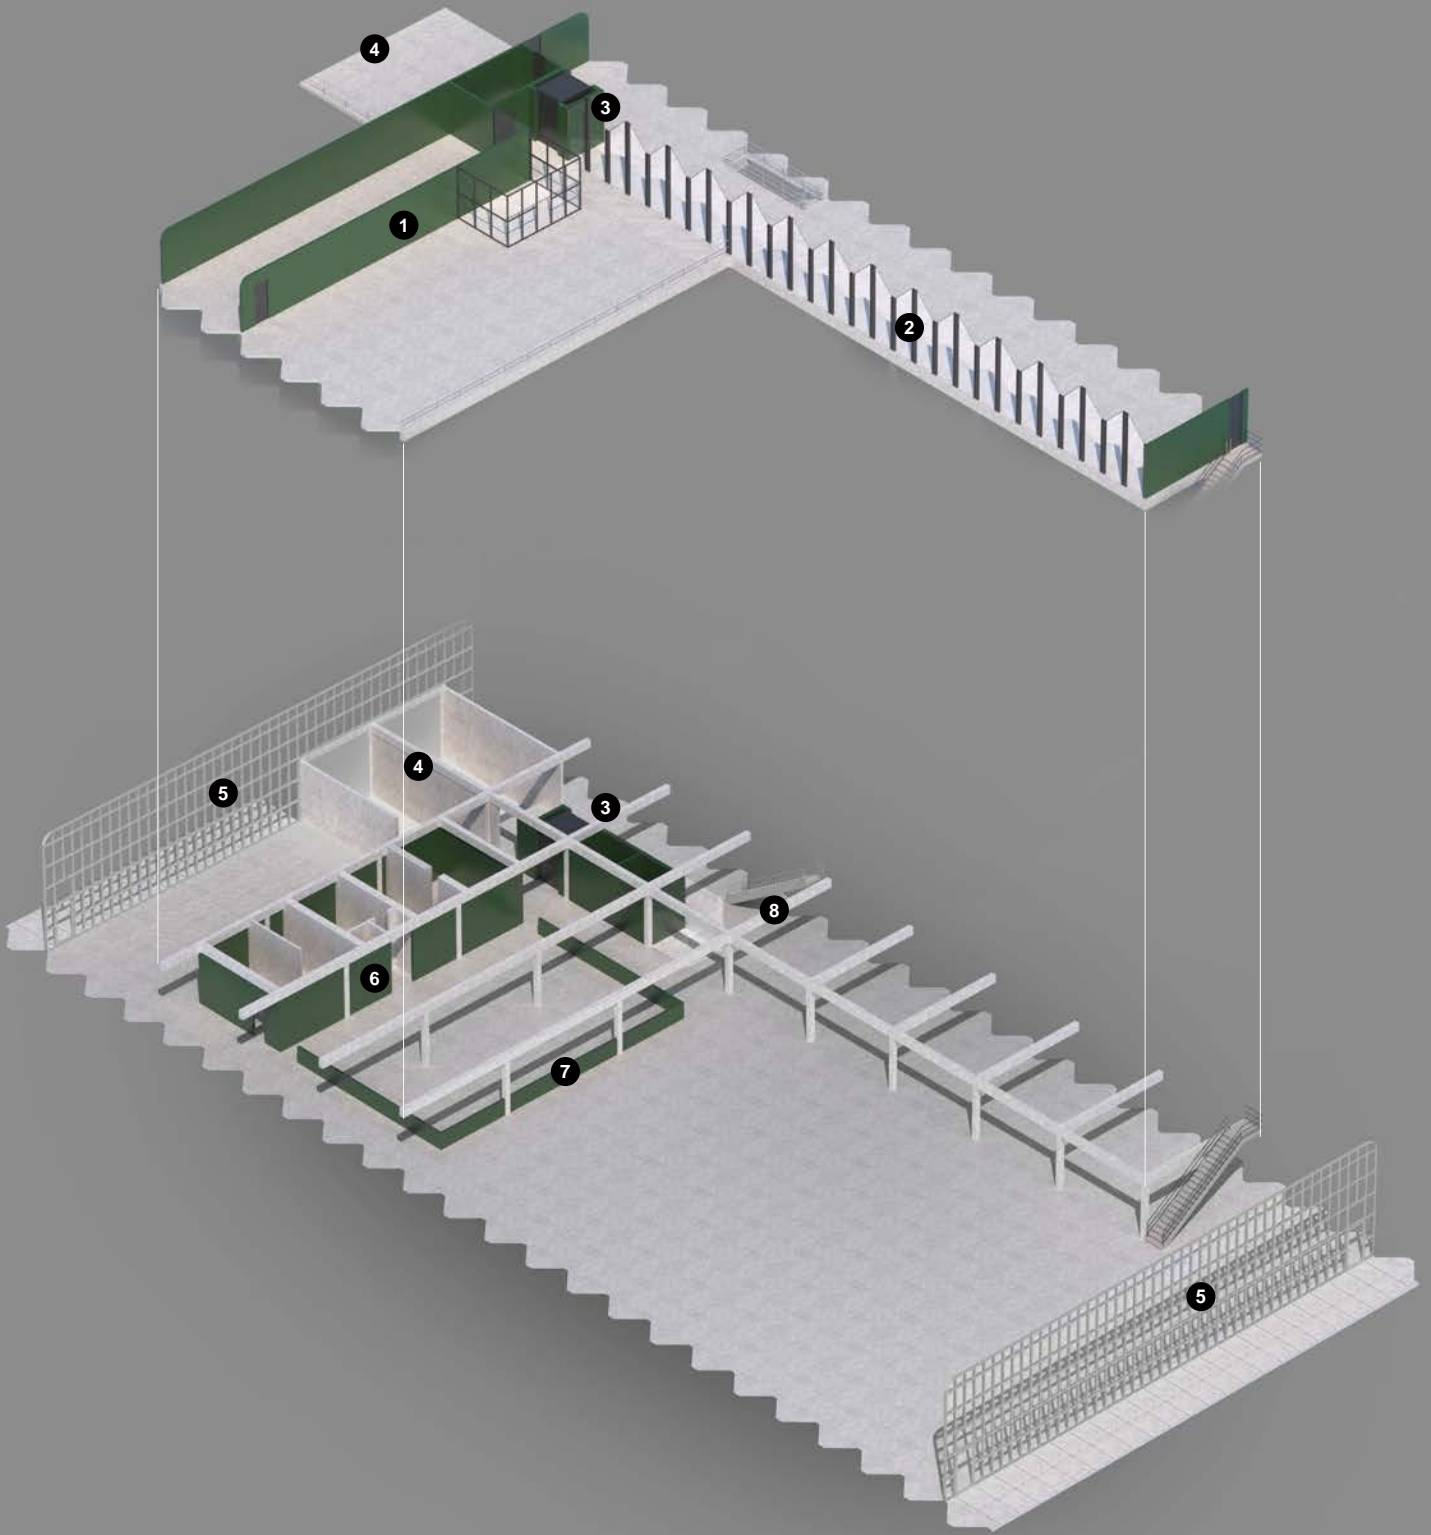
Existing Conditions / Updates

- 1 REMOVE EXISTING PARTITIONS AT UPPER LEVEL
- 2 RETAIN CURTAINWALL
- 3 RETAIN ELEVATOR
- 4 REMOVE EXISTING DOCK ENCLOSURES AND ASSOCIATED FLOORPLATE
- 5 REPLACE AND UPDATE CURTAIN WALLS
- 6 RECONFIGURE LOCKER ROOMS / MAINTAIN MEP CONNECTIONS
- 7 REMOVE PARTITION
- 8 REMOVE EXISTING STAIRCASE

The Scenario 1 programmatic reconfiguration of the Laundry Building retains the mezzanine and removes some existing infrastructure that has no potential fit in the design. However, an effort to minimize drastic changes has been made: with the exception of the floorplate located above the former dock, the entire footprint of the mezzanine is maintained. The extensive glass enclosure of the upper floor is kept in place to allow users to enjoy views to the spaces below. The existing curtain walls on each end are to be replaced with higher performing glass enclosures.

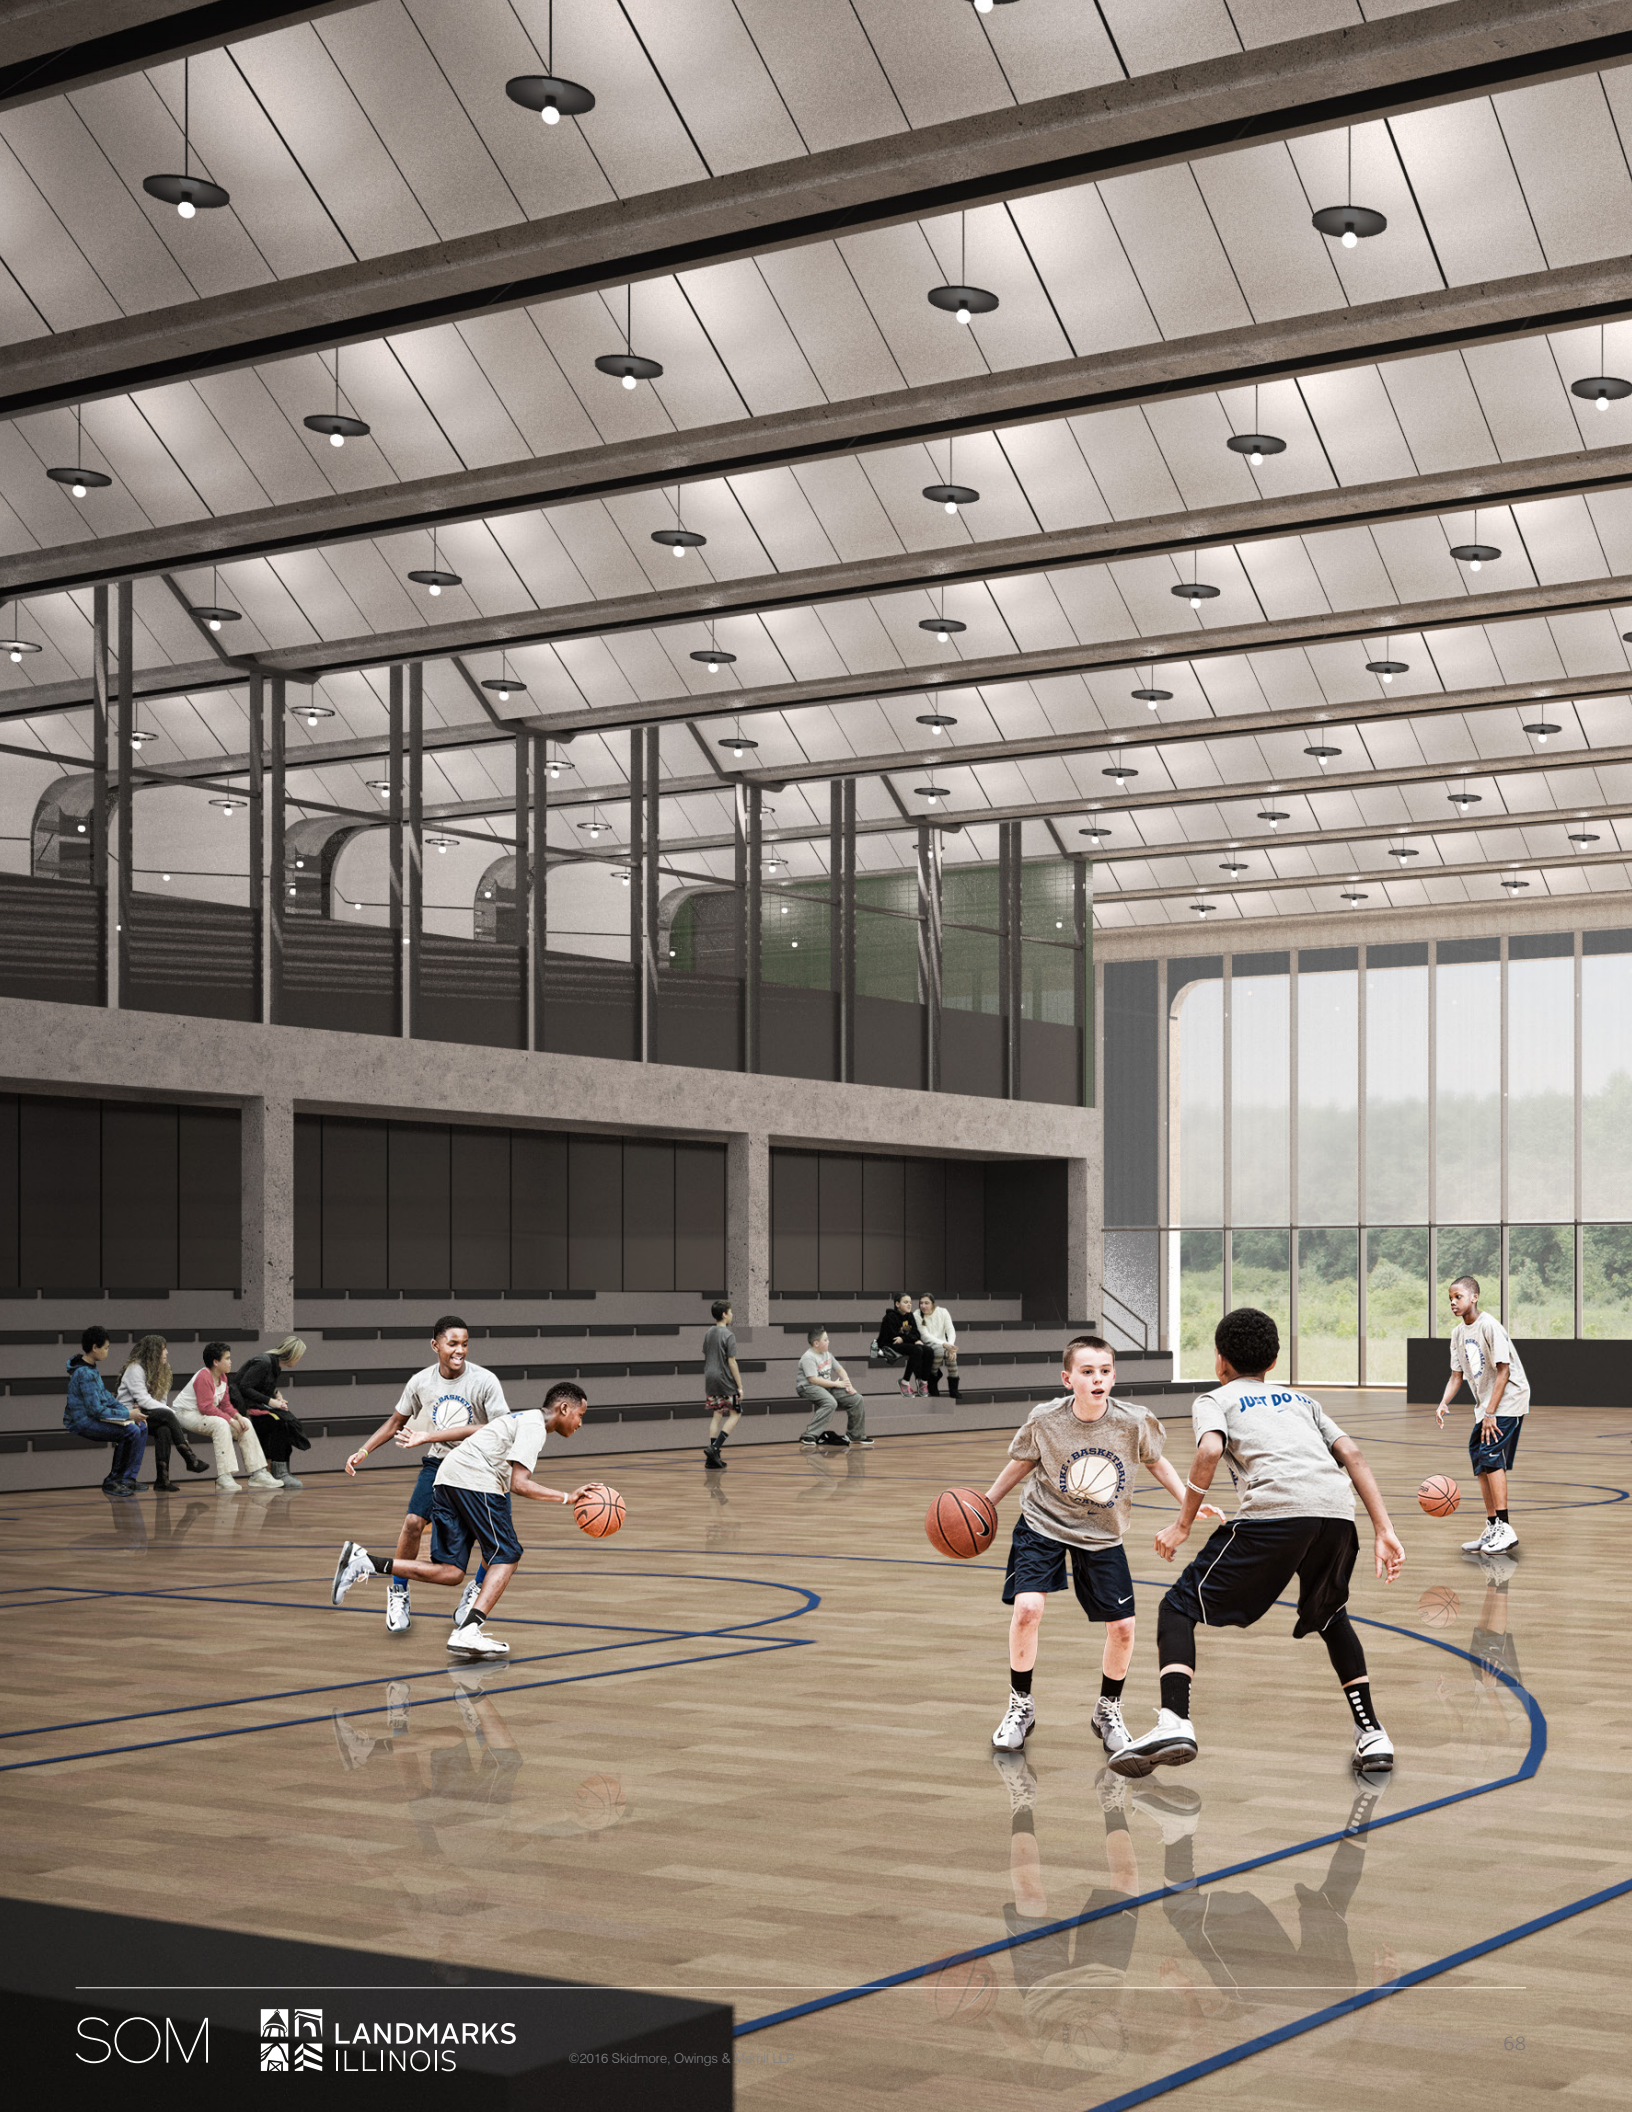
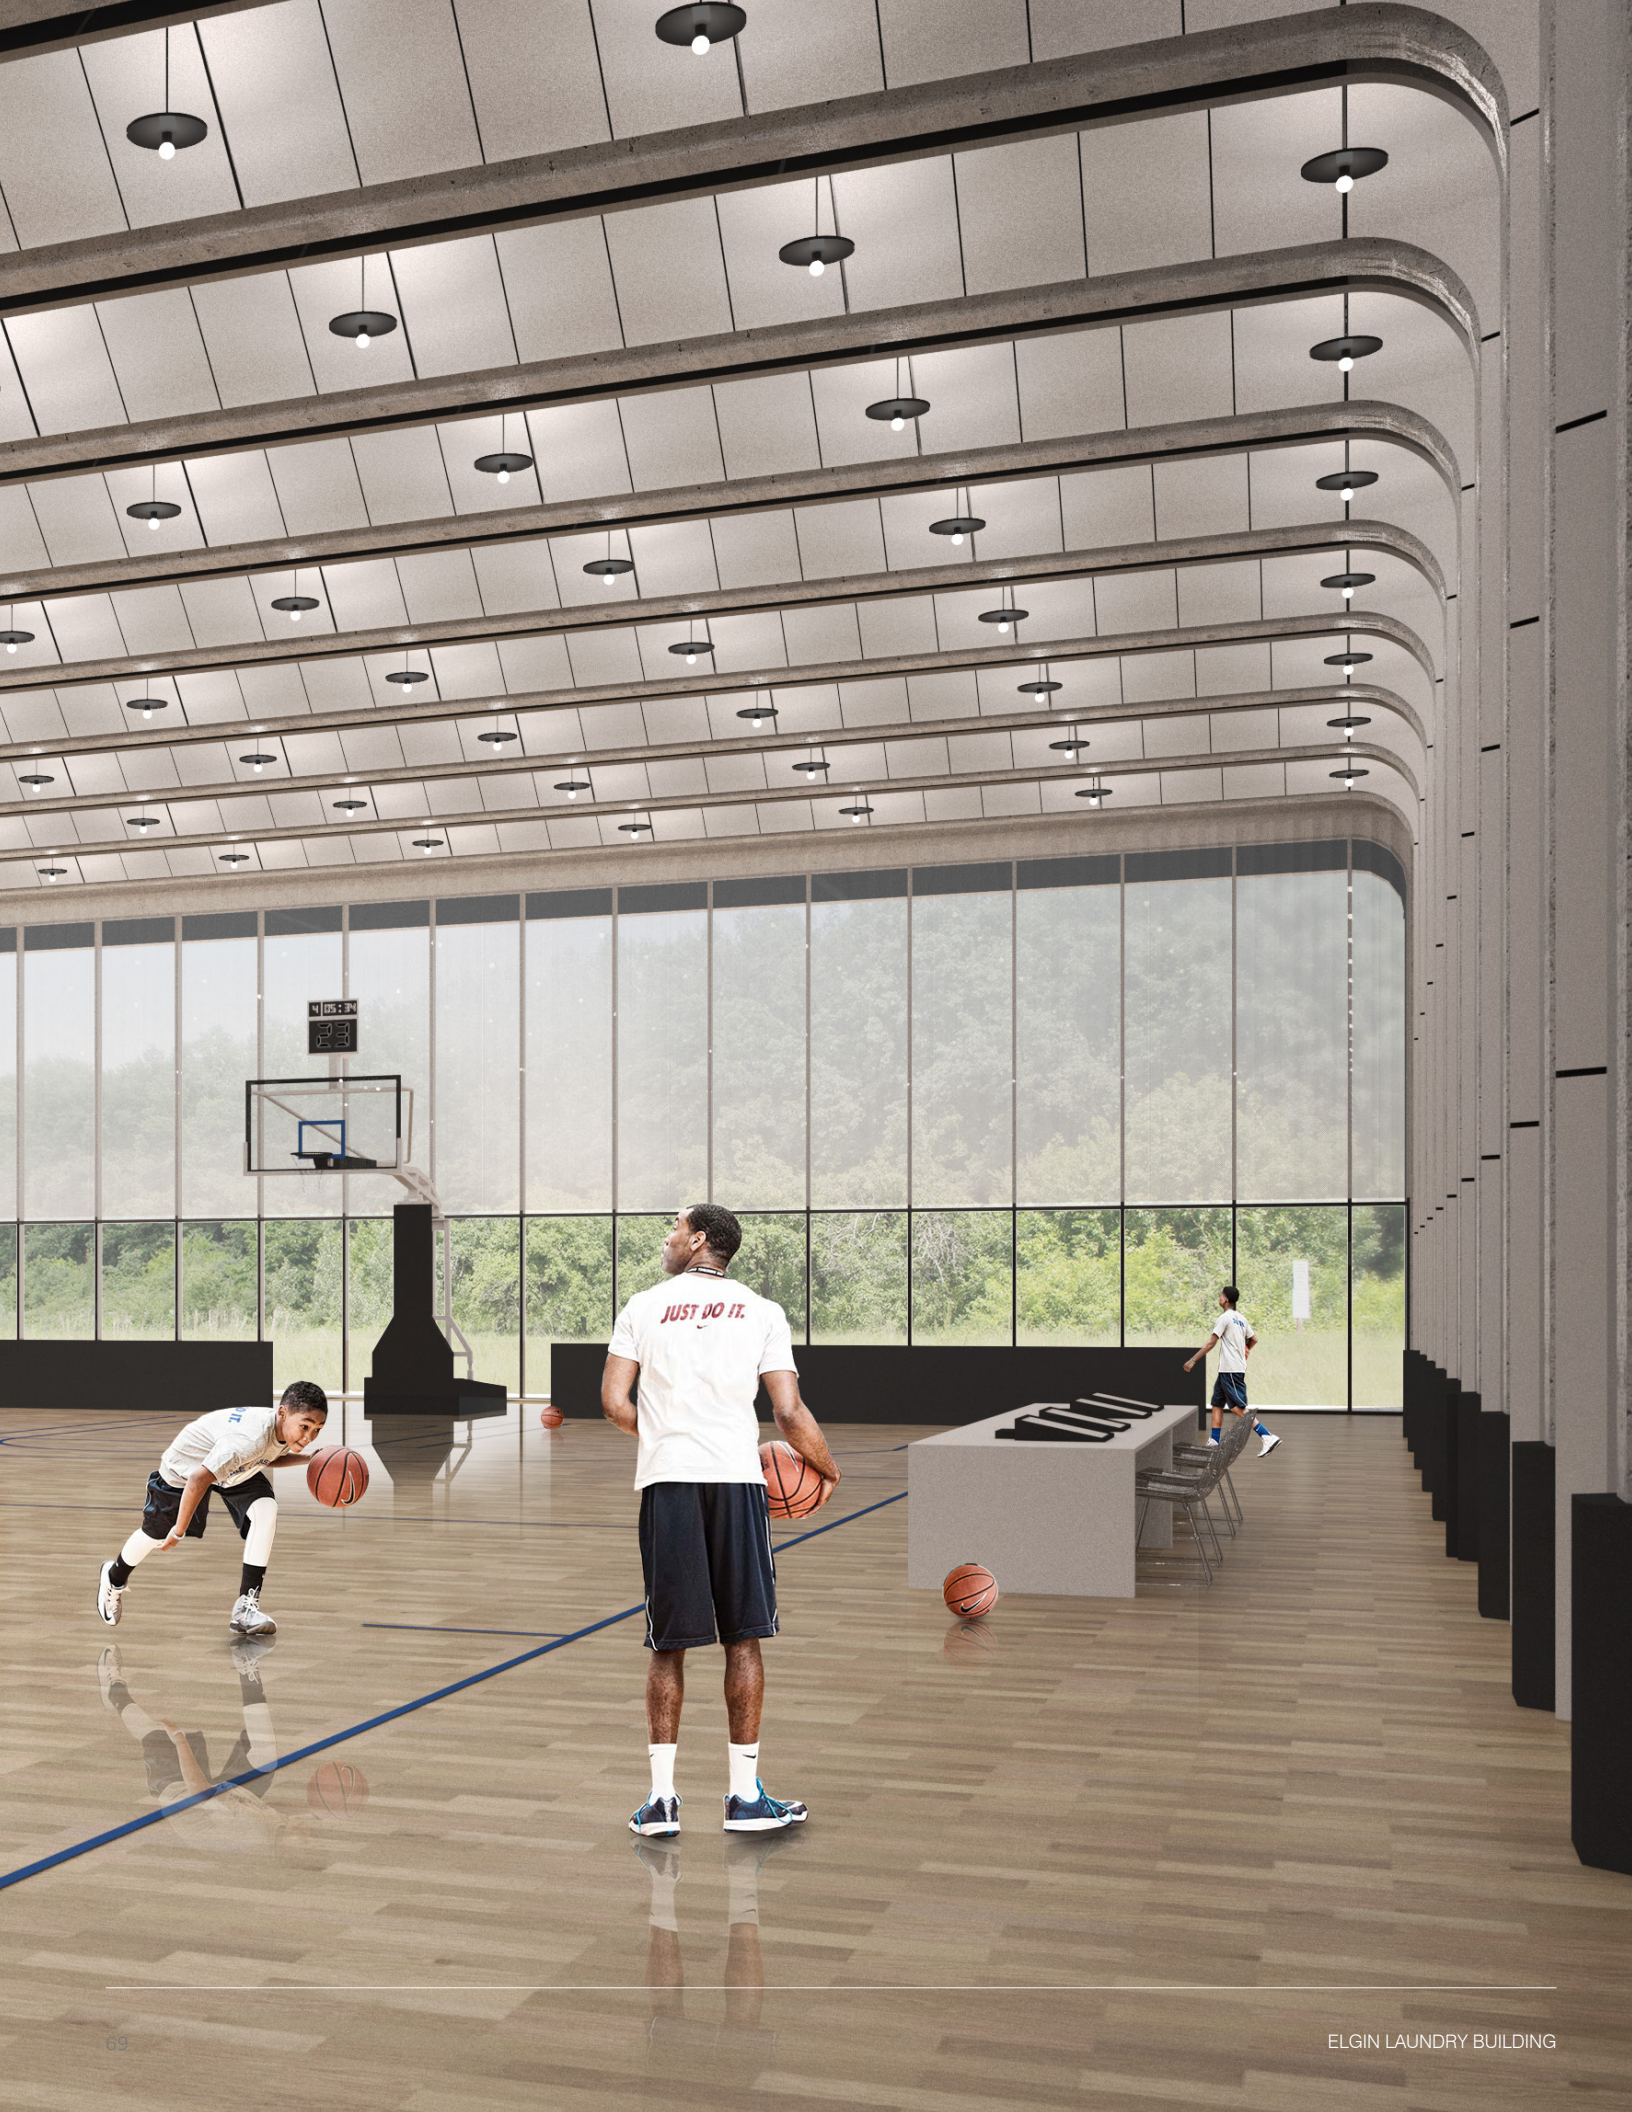
- Main play area fits:
 - (1) full-size basketball court
 - (1) youth-sized basketball court
 - (2) Volleyball
 - (3) Pickleball
- Yoga / Dance studio 2510 sq. ft. (61' by 41')
- Spin Room 1715 sq. Ft. (34' by 50')
- Strength enhancement area 3515 sq. Ft. (25' by 138')

- Reception desk
- Administration Space 750 sq. ft. (30' by 25')
- Locker Rooms + Restrooms
- Bleachers - Capacity 130

At the lower level, the large open space can house a configuration of different sports activities: Basketball, Volleyball, Pickleball and more as needed. The existing locker rooms can be extended and reconfigured to increase the capacity. The space adjacent to the glass wall houses vertical circulation to the upper floor along with a reception area. Athletes and visitors can enter the facility from different sides. Conveniently located under the mezzanine, the seating area is concealable.

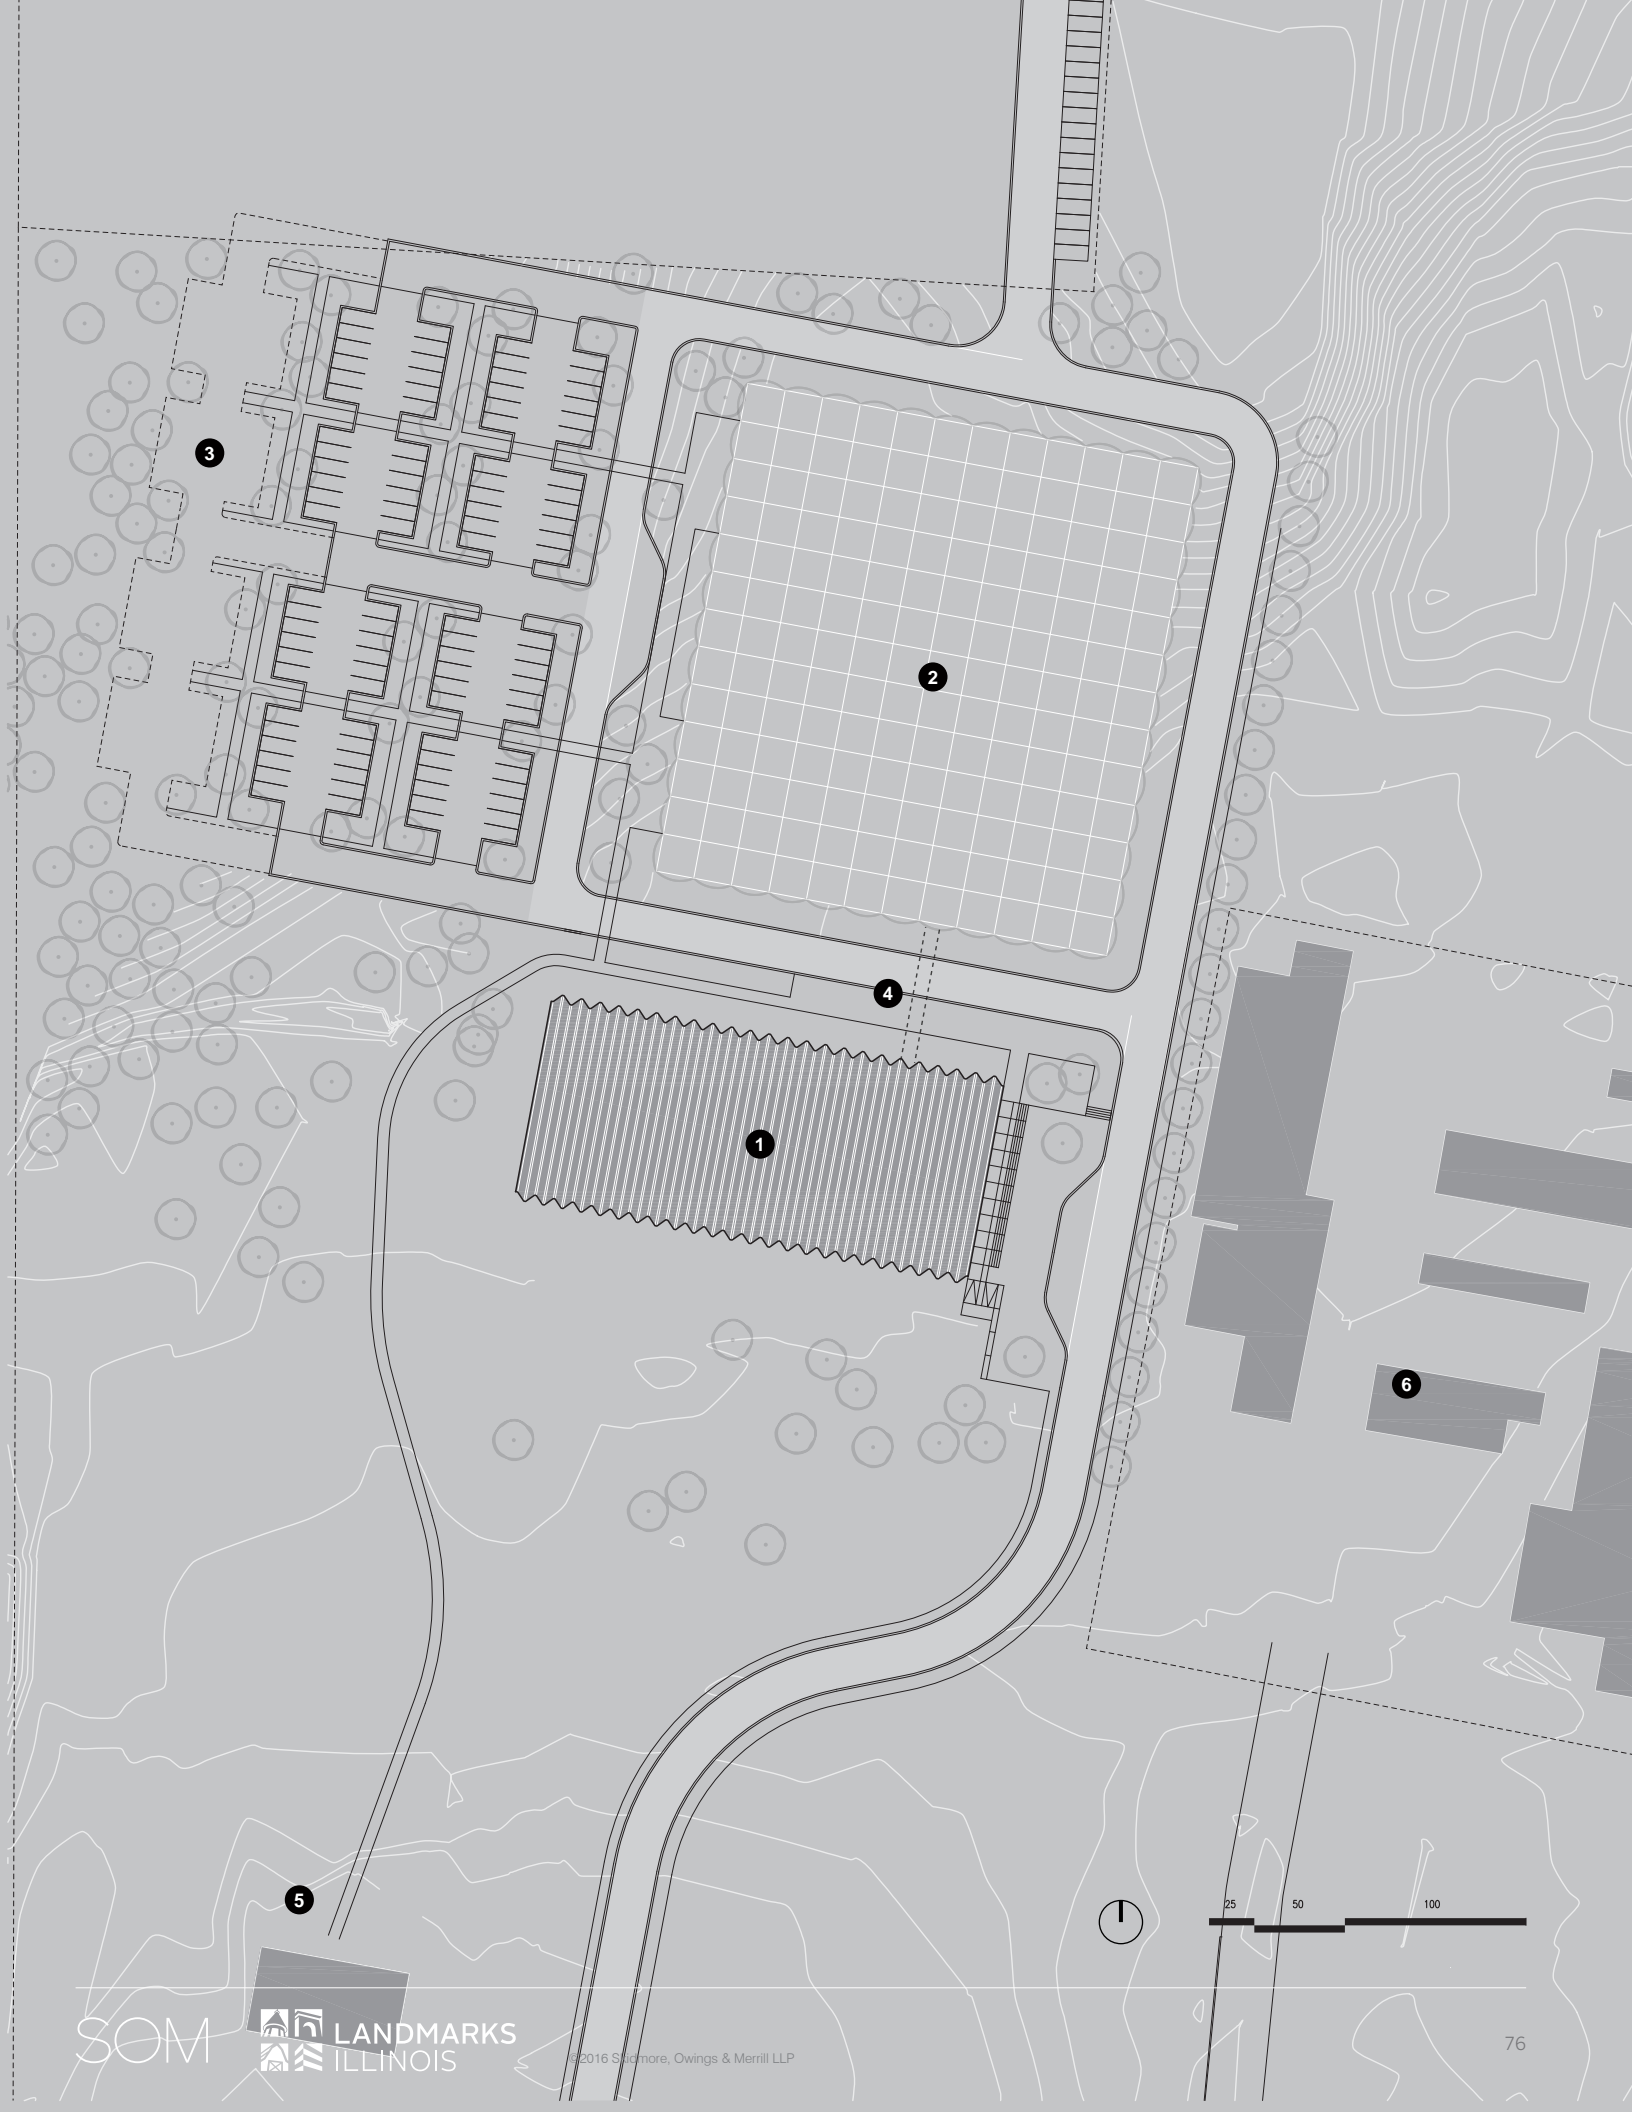
Scenario 1 - Site Plan

- 1 PHASE I - RENOVATED LAUNDRY
- 2 PHASE II - NOTIONAL 125-150K SQ. FT. FIELD HOUSE
- 3 PHASE II - SITE PARKING
- 4 FUTURE CONNECTION BETWEEN LAUNDRY BUILDING AND FIELD HOUSE
- 5 BARN WITH PEDESTRIAN ACCESS
- 6 EXISTING MENTAL HEALTH CENTER POWERPLANT WITH PRIVATE ACCESS

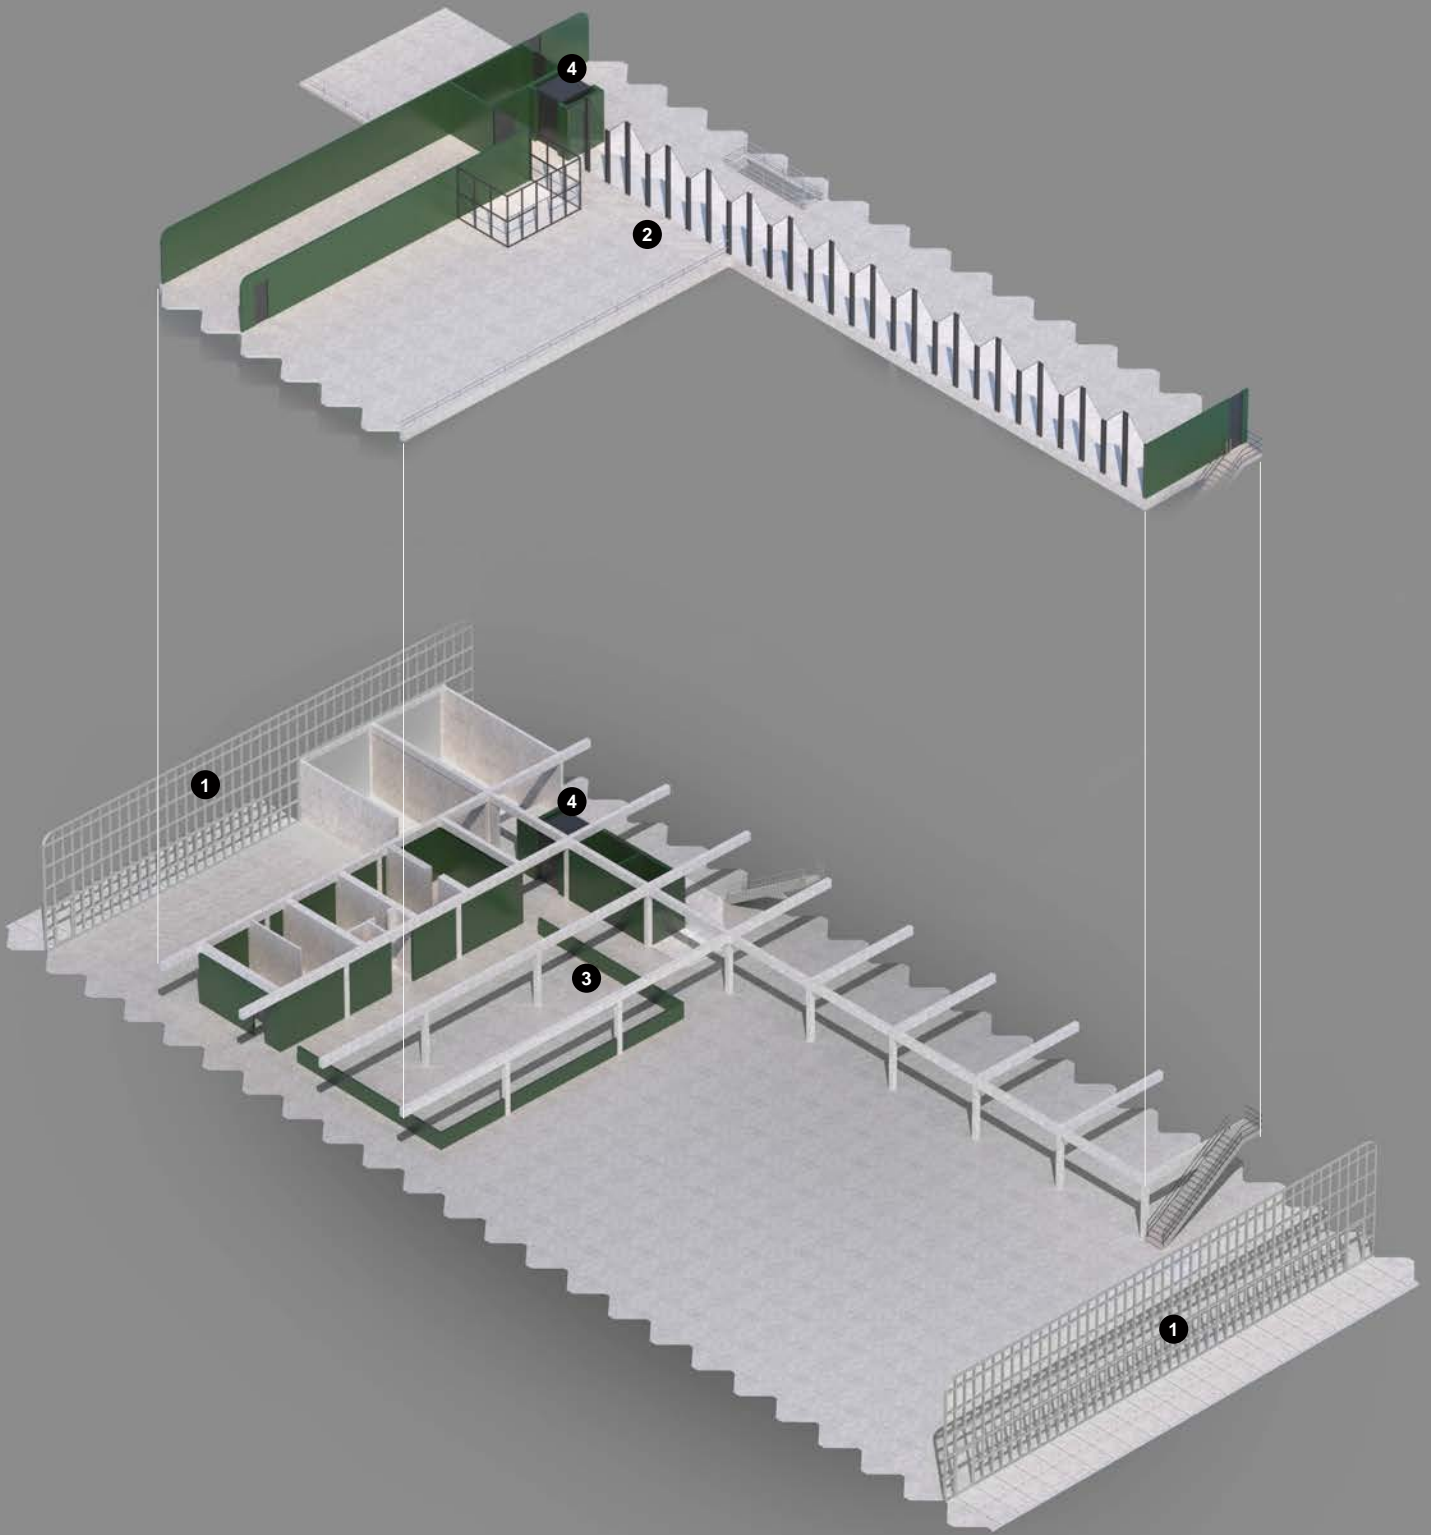
Existing Conditions / Updates

Currently, none of the interior buildout is structurally bound to the exterior envelope, hence the interior space can be opened in its entirety to accommodate a complete remodel. Removing the interior infrastructure, including partitions and mezzanine, allows us to explore the full potential of the space and make the best use of the existing envelope in relation to its new programs and functions.

- 1 REPLACE AND UPDATE CURTAIN WALLS
- 2 REMOVE MEZZANINE LEVEL AND PARTITIONS
- 3 REMOVE LOWER LEVEL PARTITIONS
- 4 REMOVE ELEVATOR
