A RECREATIONAL REUSE STUDY
for the FORMER ELGIN STATE
HOSPITAL LAUNDRY BUILDING

PREPARED FOR THE CITY OF ELGIN,
THE PARKS & RECREATION DEPARTMENT AND
THE PARKS & RECREATION ADVISORY COMMISSION

ELGIN MENTAL HEALTH CENTER Condition Assessment - Laundry Building

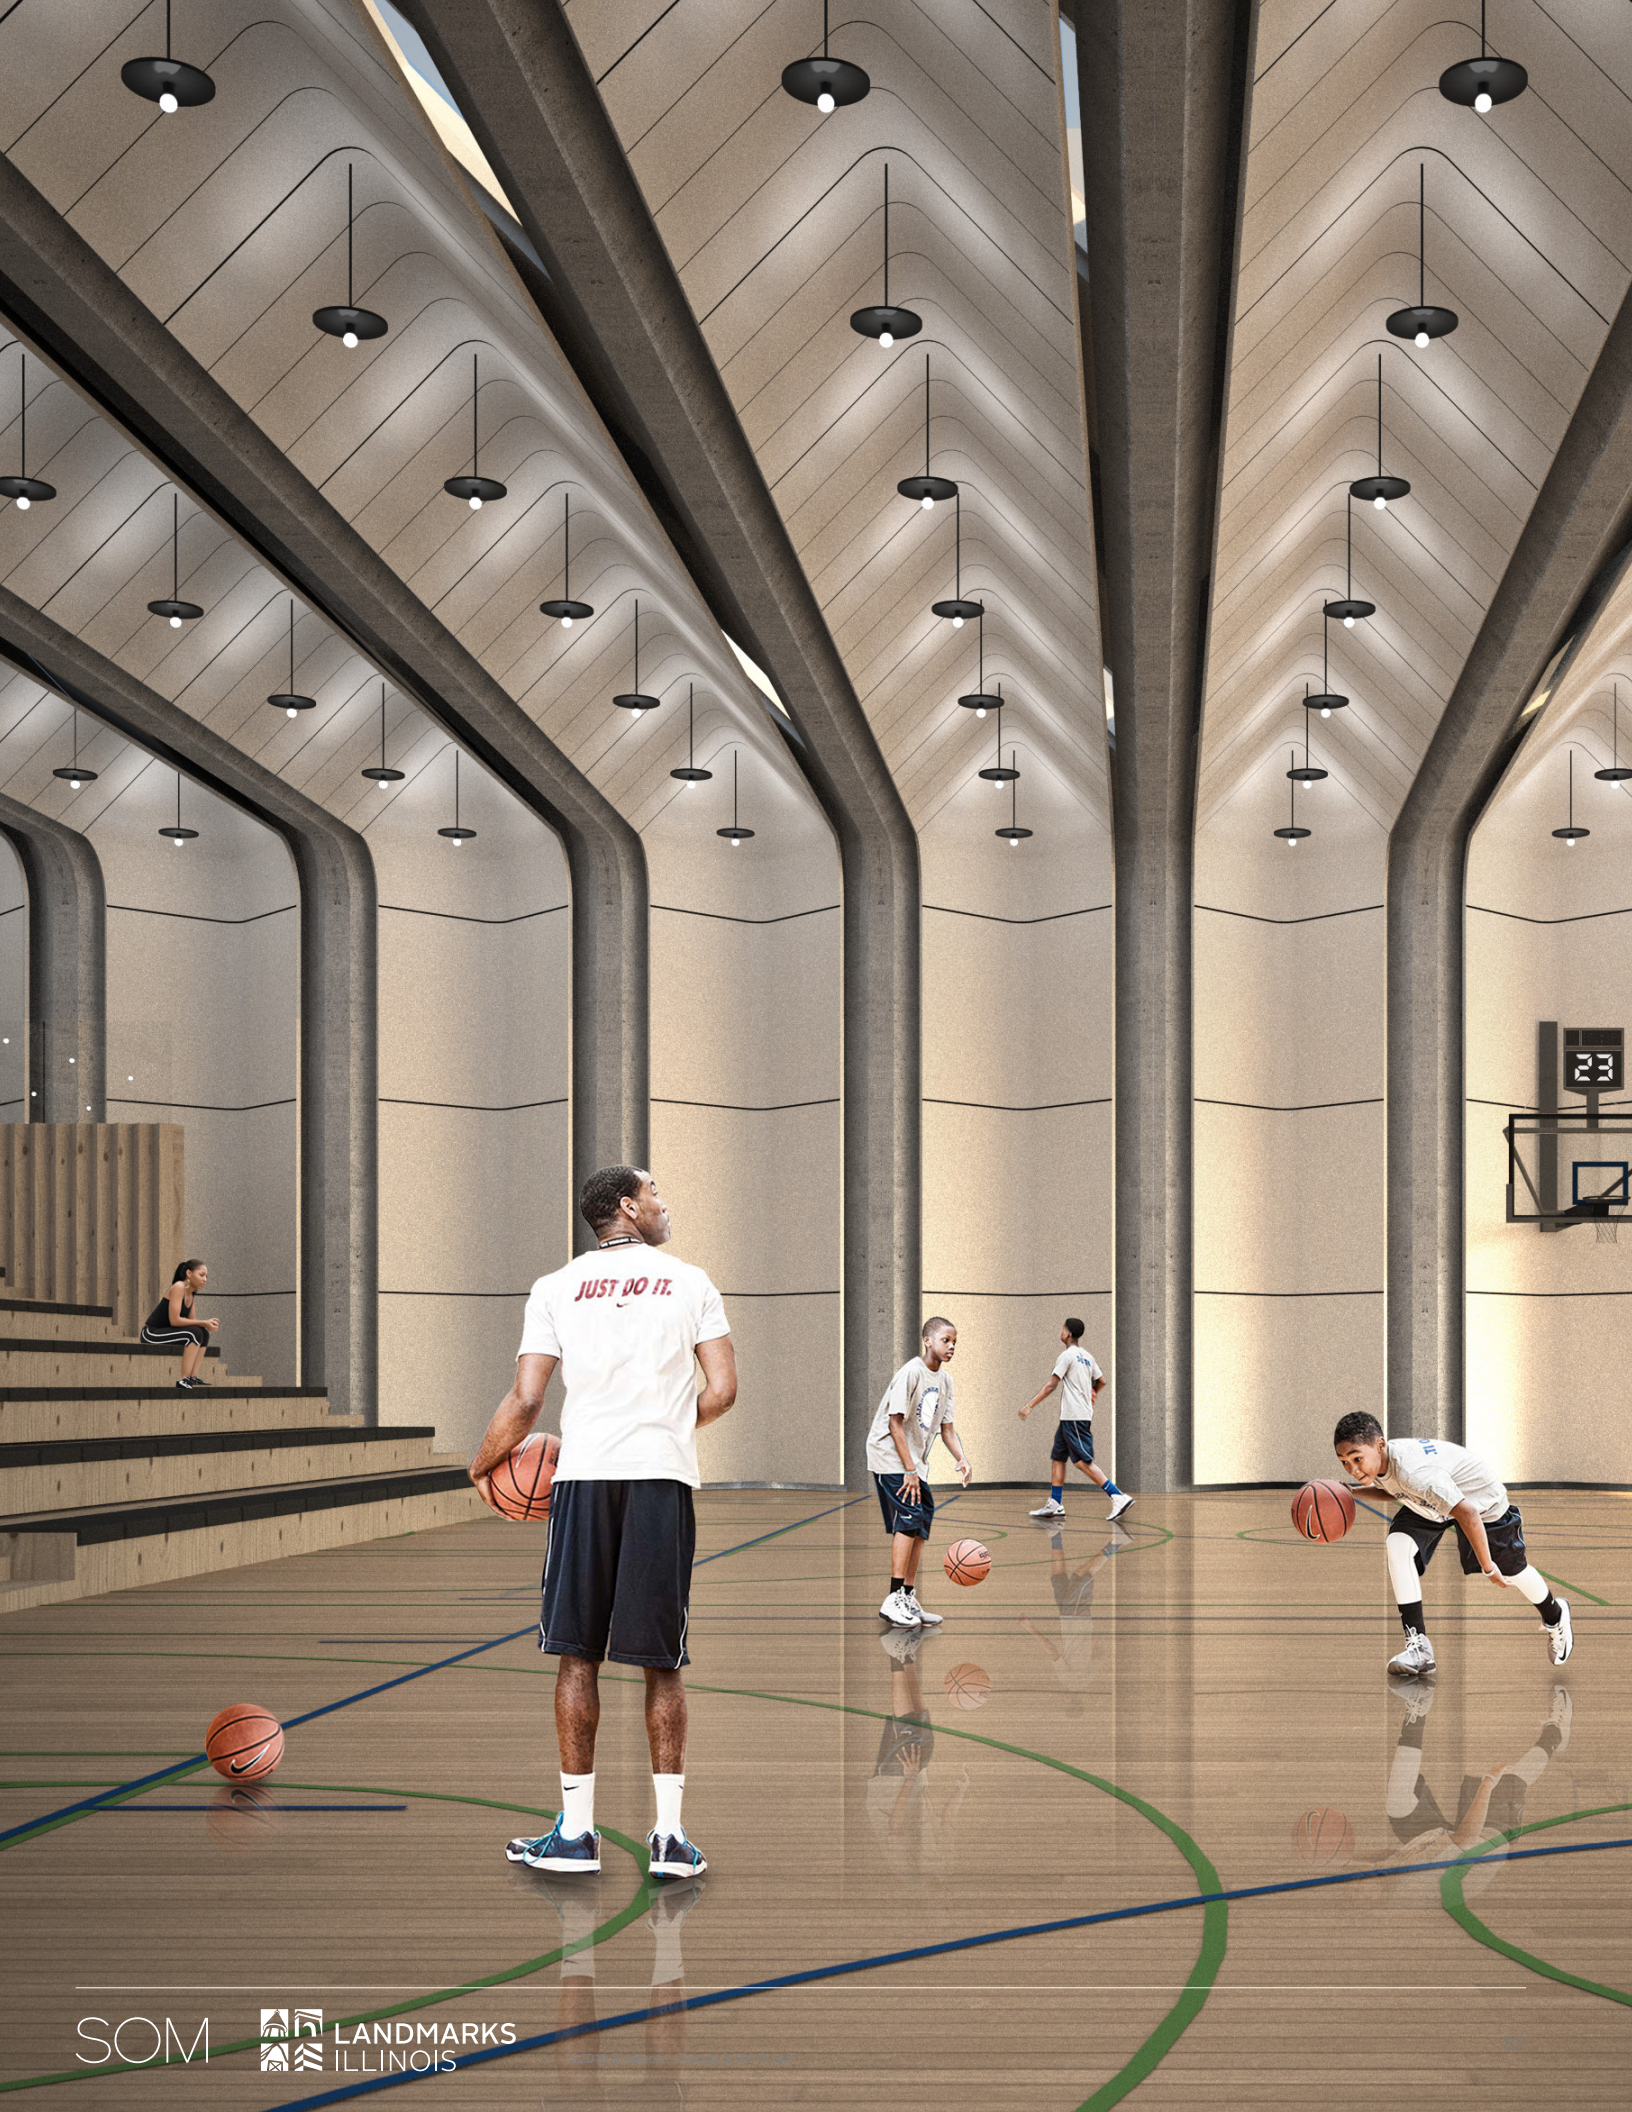
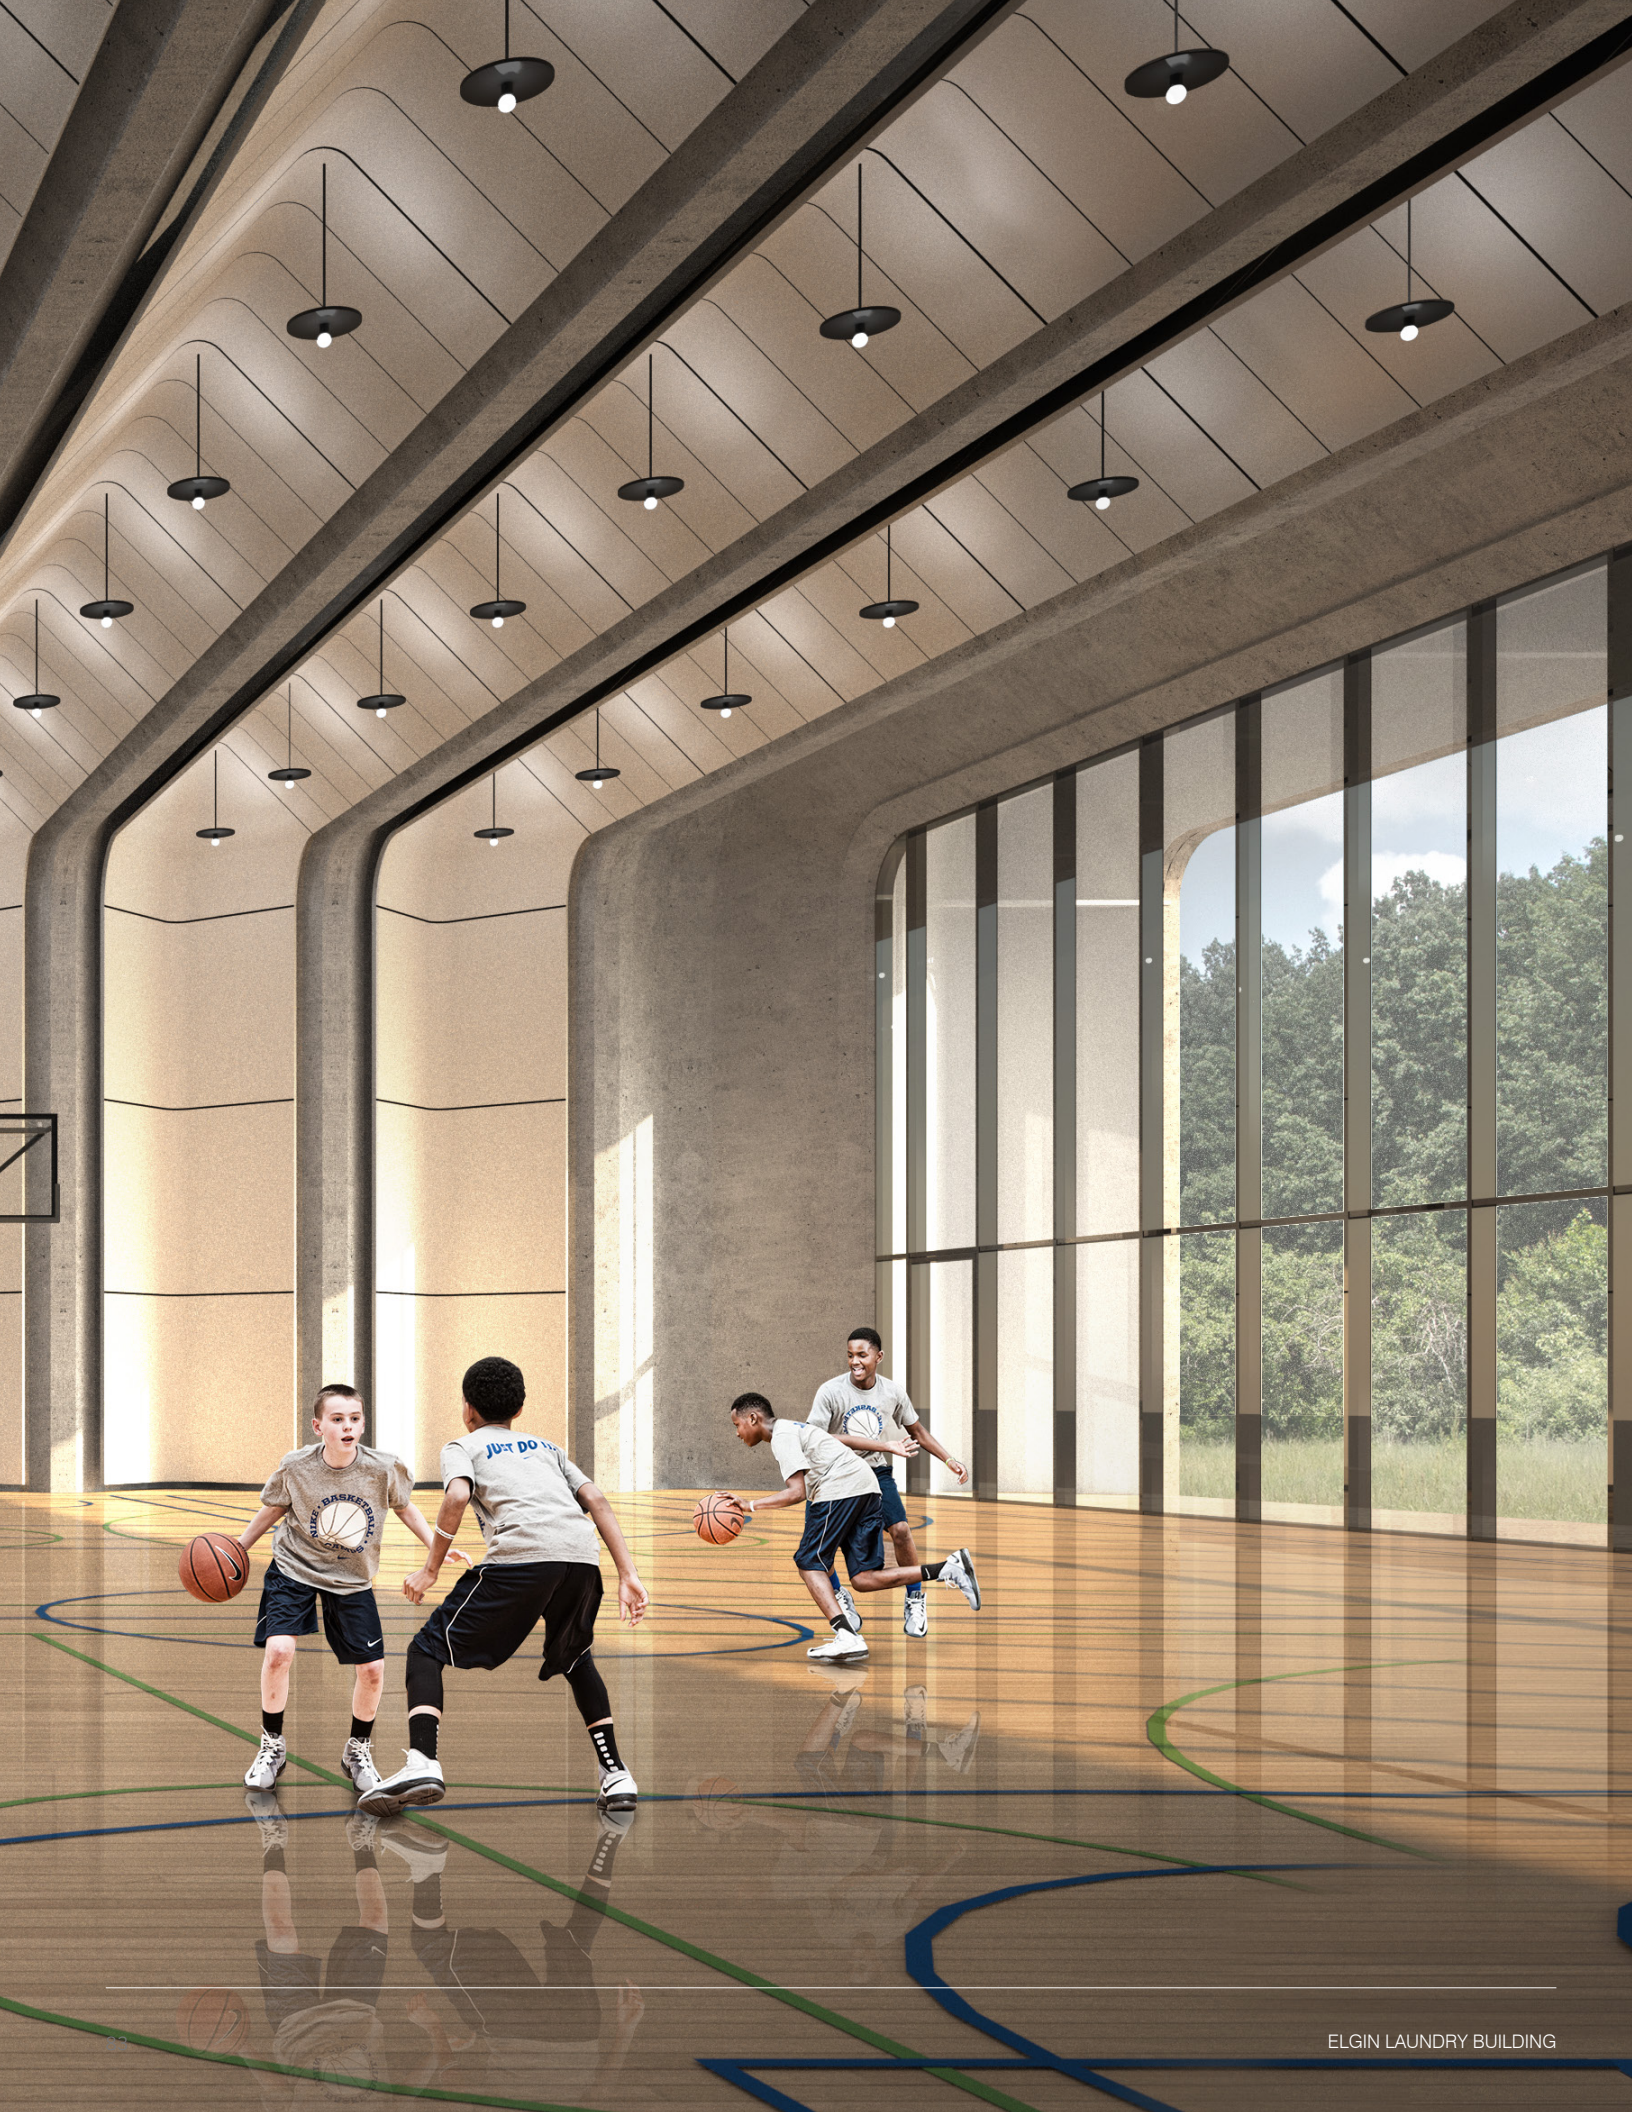
- 1 REPLACE AND UPDATE CURTAIN WALLS
- 2 REMOVE MEZZANINE LEVEL AND PARTITIONS
- 3 REMOVE LOWER LEVEL PARTITIONS
- 4 REMOVE ELEVATOR

- Main play area: fits
 - (1) full-size basketball court
 - (2) youth-sized basketball courts
 - (2) Volleyball
 - (3) Pickleball
- Martial arts / wrestling / dance studio 5500 sq. ft. (50' by 110')
- Strength enhancement area 3300 sq. Ft. (30' by 110')

- Reception desk
- Administration space 750 sq. ft. (30' by 25')
- Locker Rooms + Restrooms
- Bleachers - Capacity 340
- New access and circulation spine 2000 sq. ft. (52' by 100')

The main programs are pushed to each end of the building closer to the exterior views and natural light. While the services such as lockers, bathrooms and storage are organized towards the center of the building. A double height circulation spine allows athletes and visitors to navigate the facility easily. In this configuration, the bleachers are also operable in order to enlarge the play area capacity up to two youth-sized basketball courts.

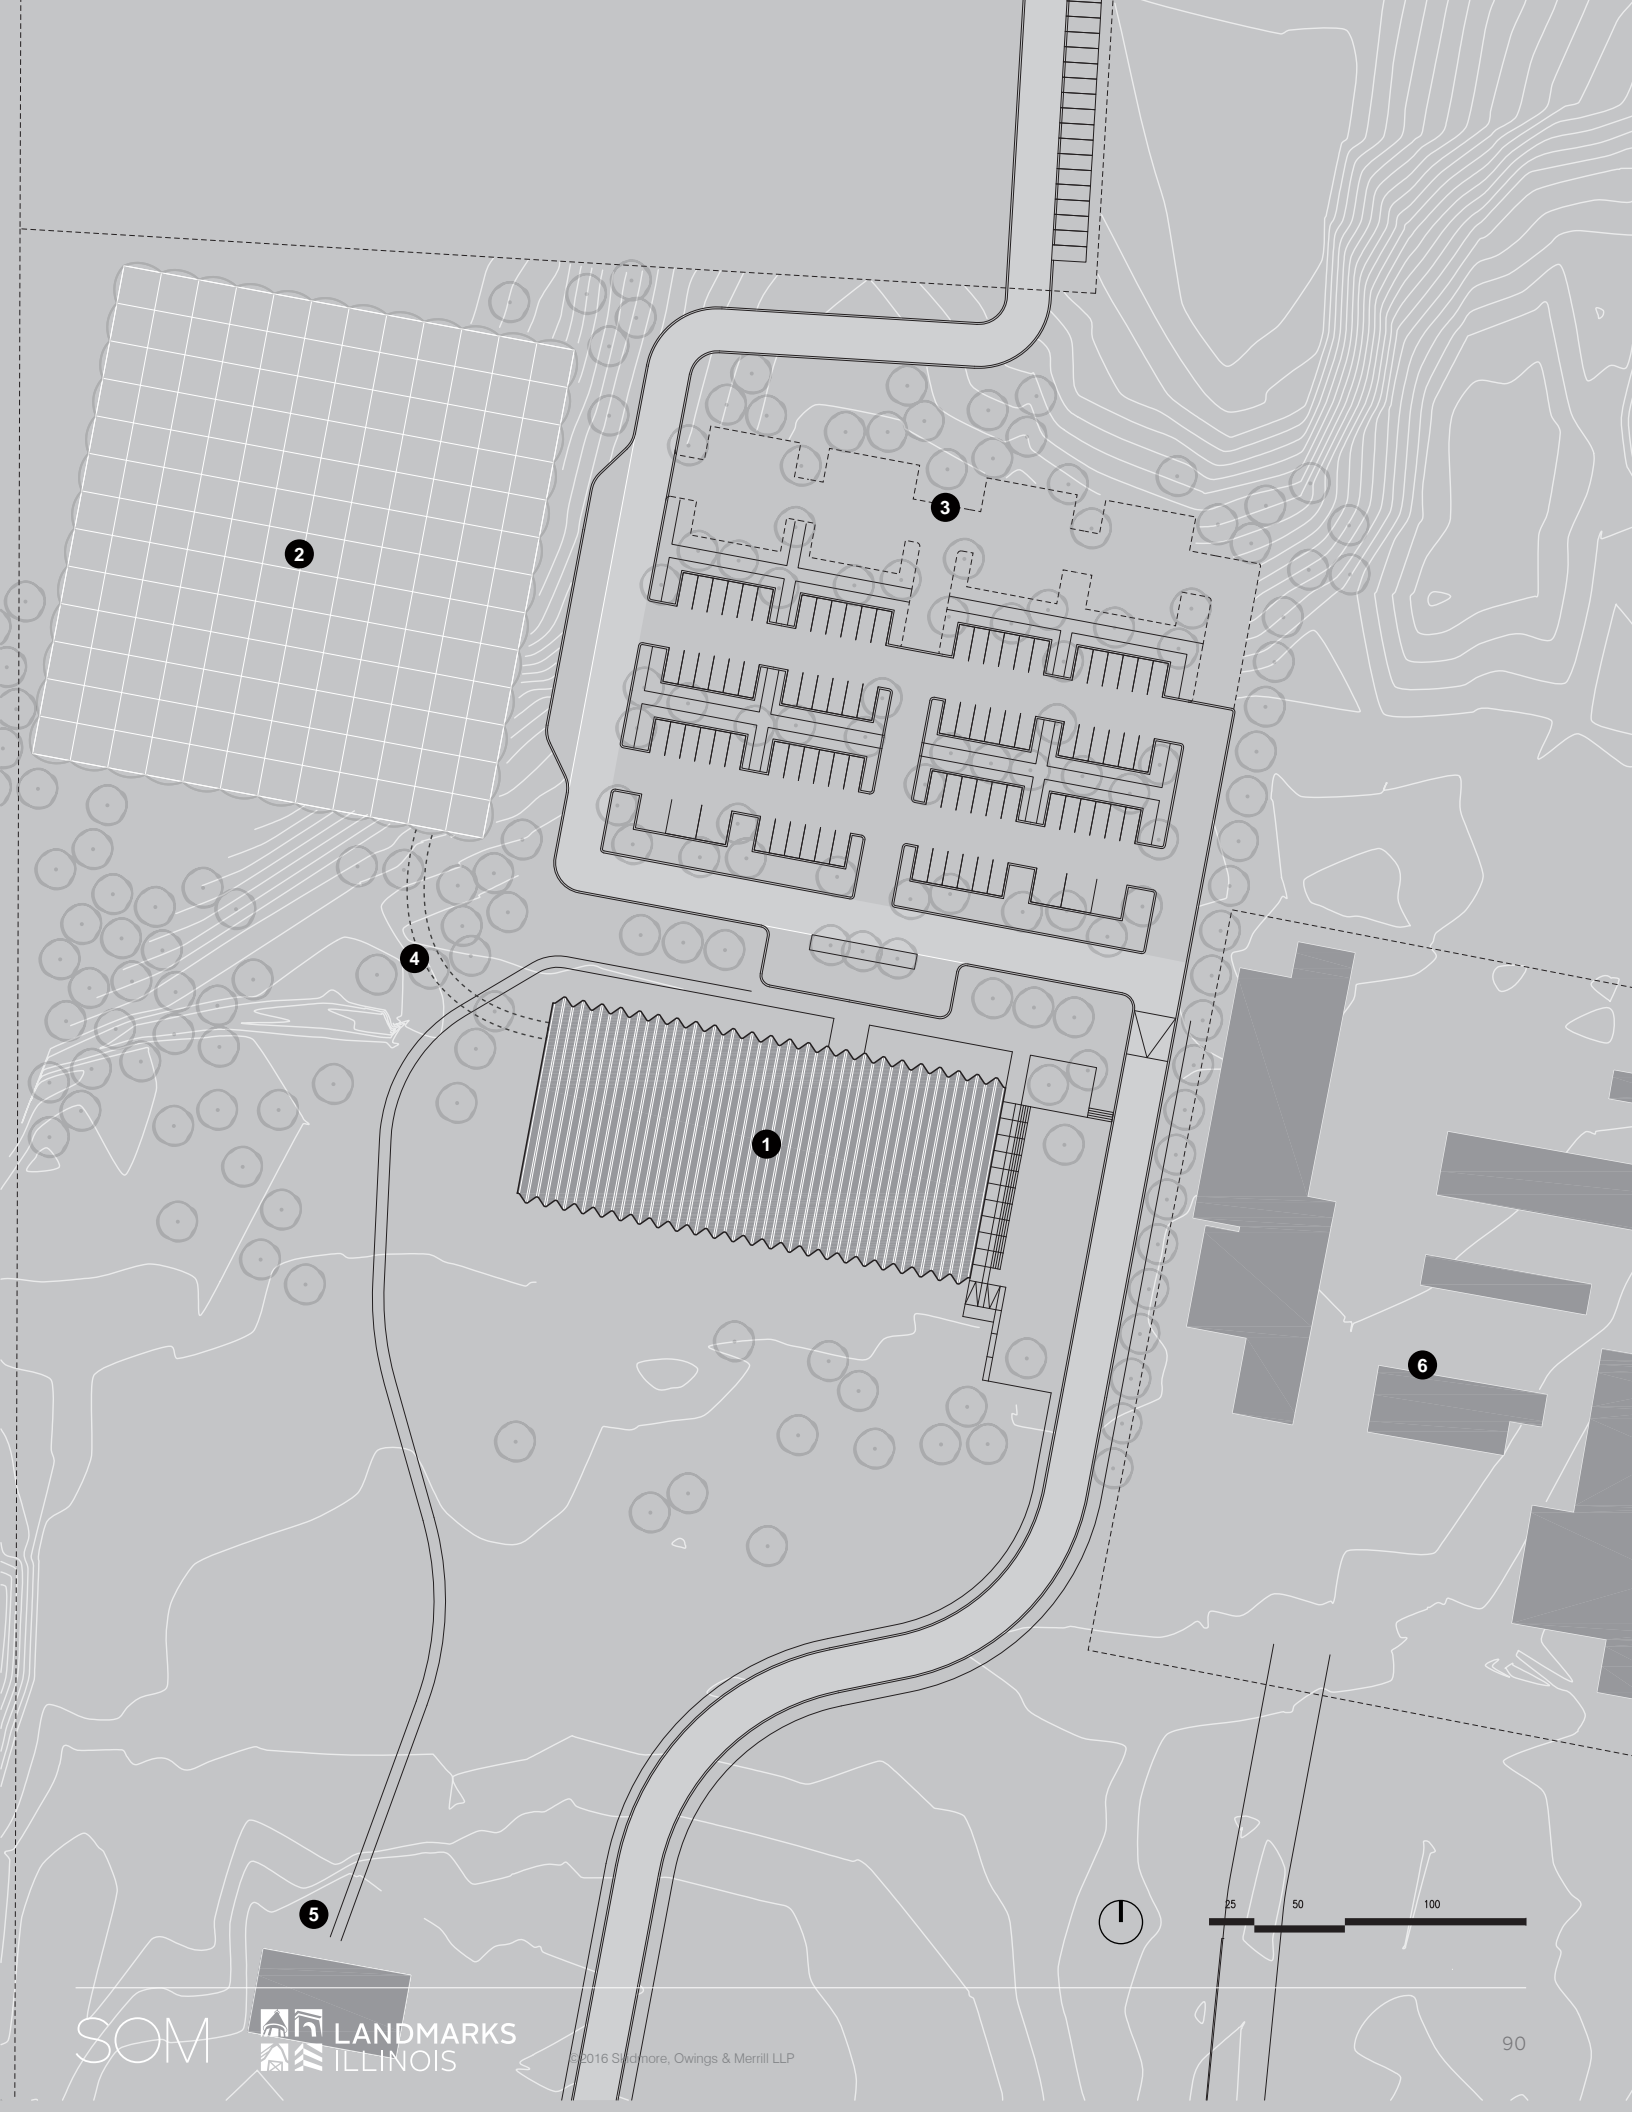
Scenario 2.A - Site Plan

- 1 PHASE I - RENOVATED LAUNDRY
- 2 PHASE II - NOTIONAL 125-150K SQ. FT. FIELD HOUSE
- 3 PHASE II - SITE PARKING
- 4 FUTURE CONNECTION BETWEEN LAUNDRY BLDG AND FIELD HOUSE
- 5 BARN WITH PEDESTRIAN ACCESS
- 6 EXISTING MENTAL HEALTH CENTER POWERPLANT WITH PRIVATE ACCESS

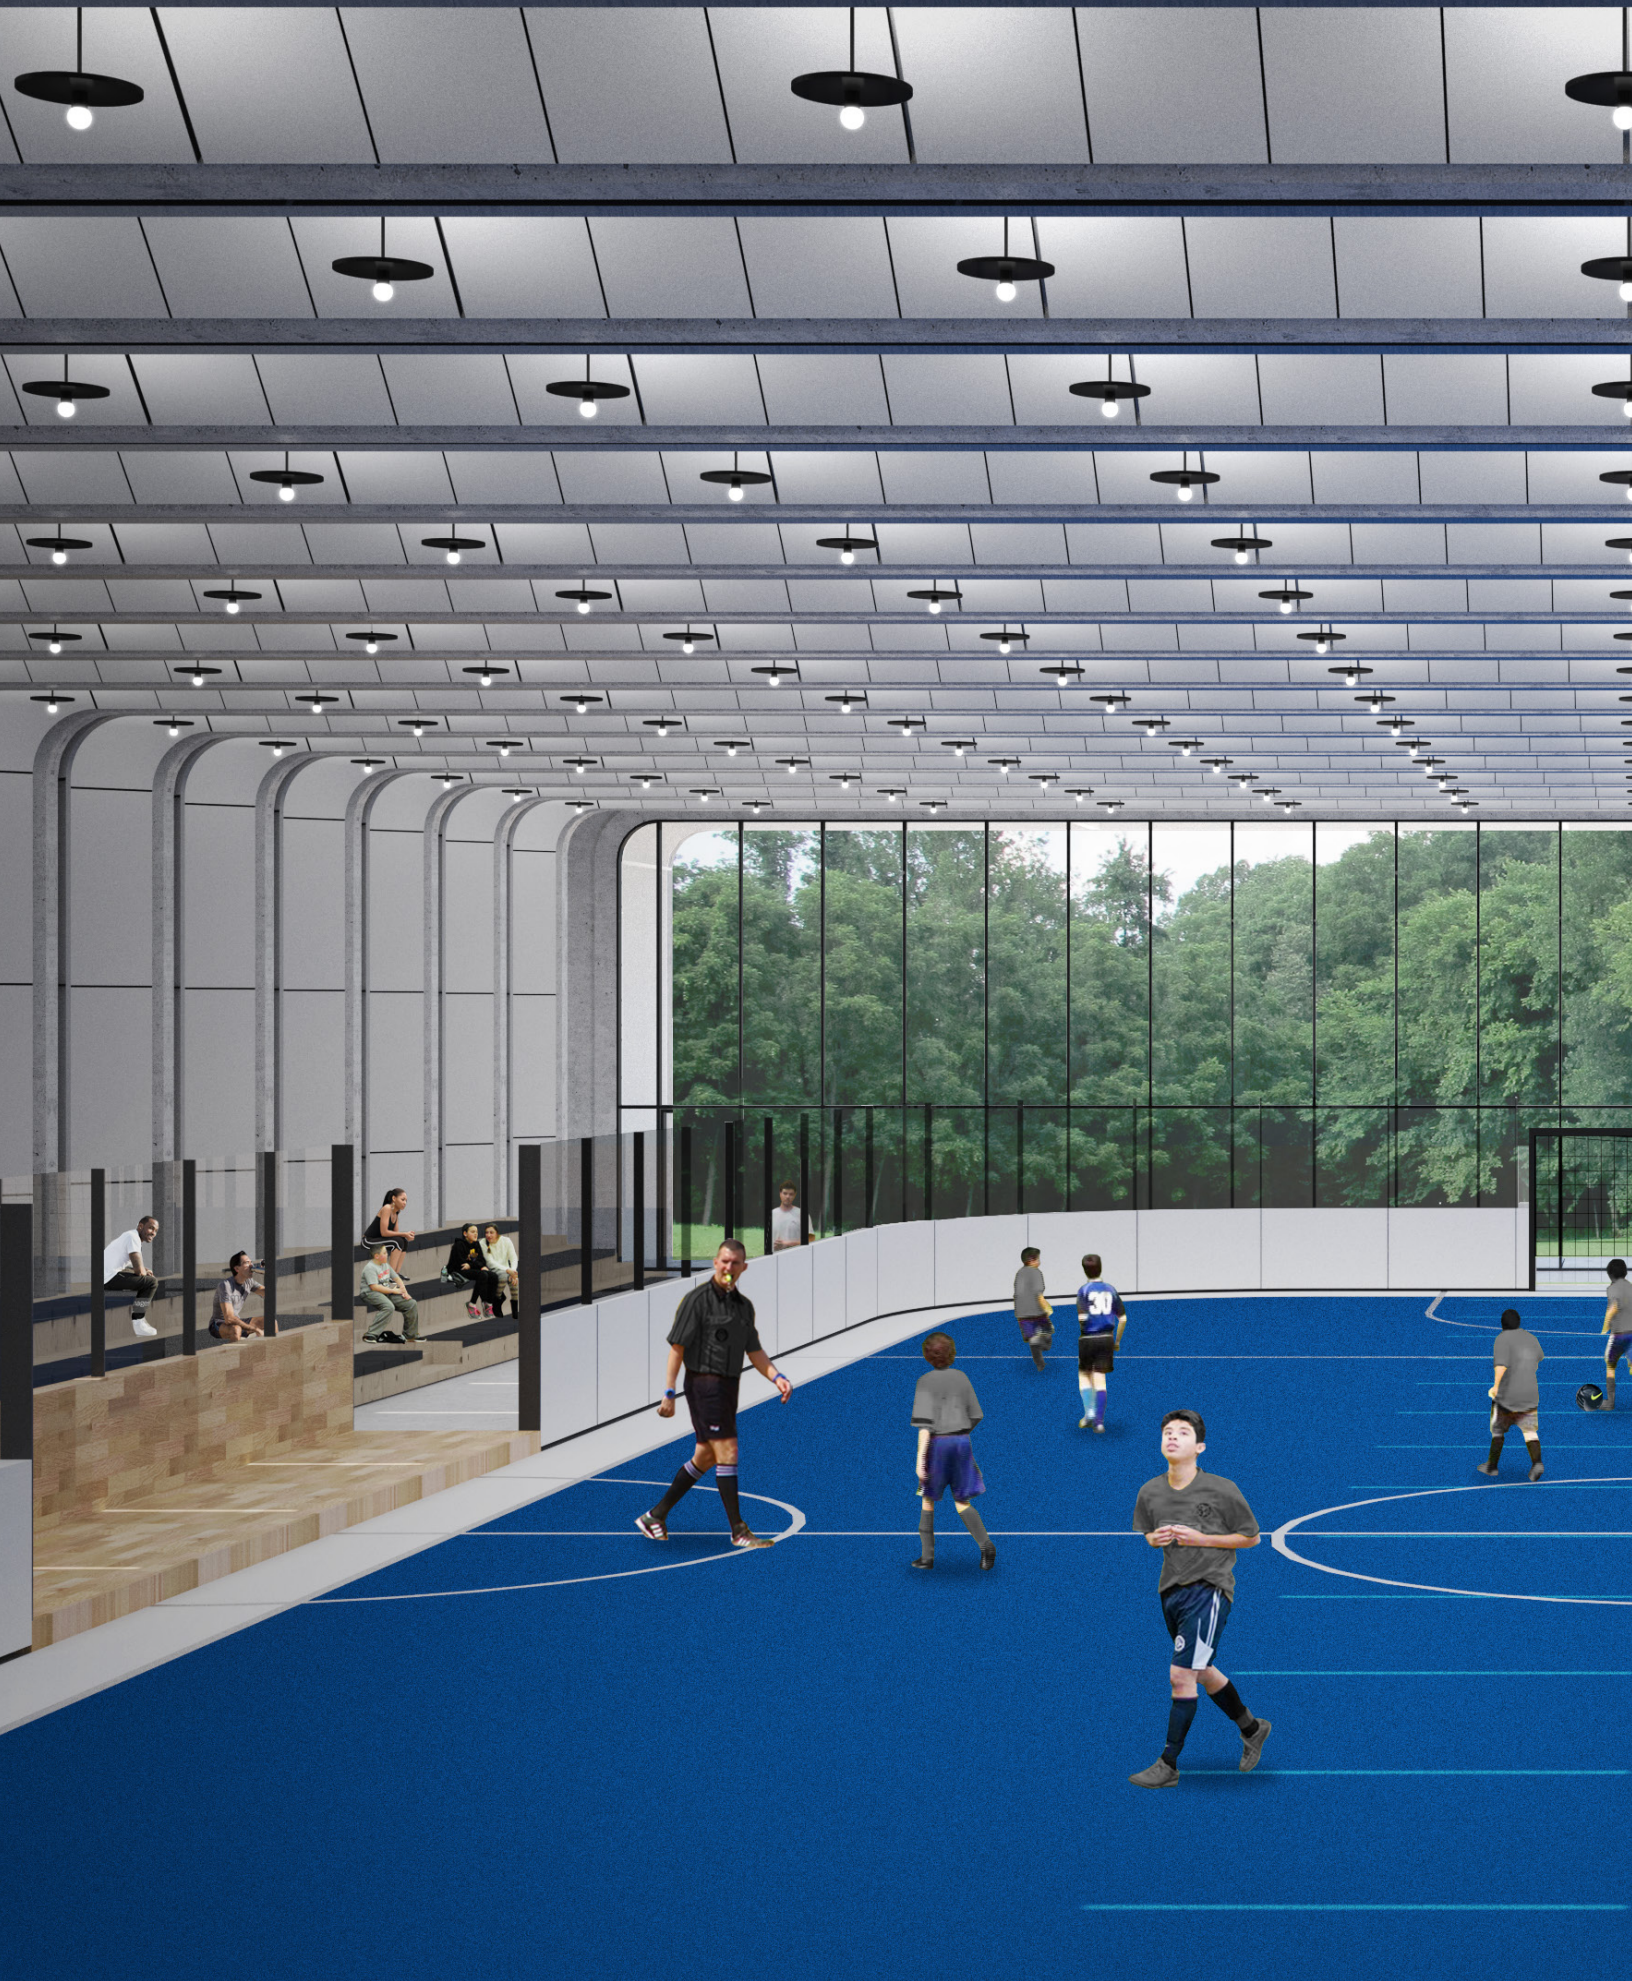
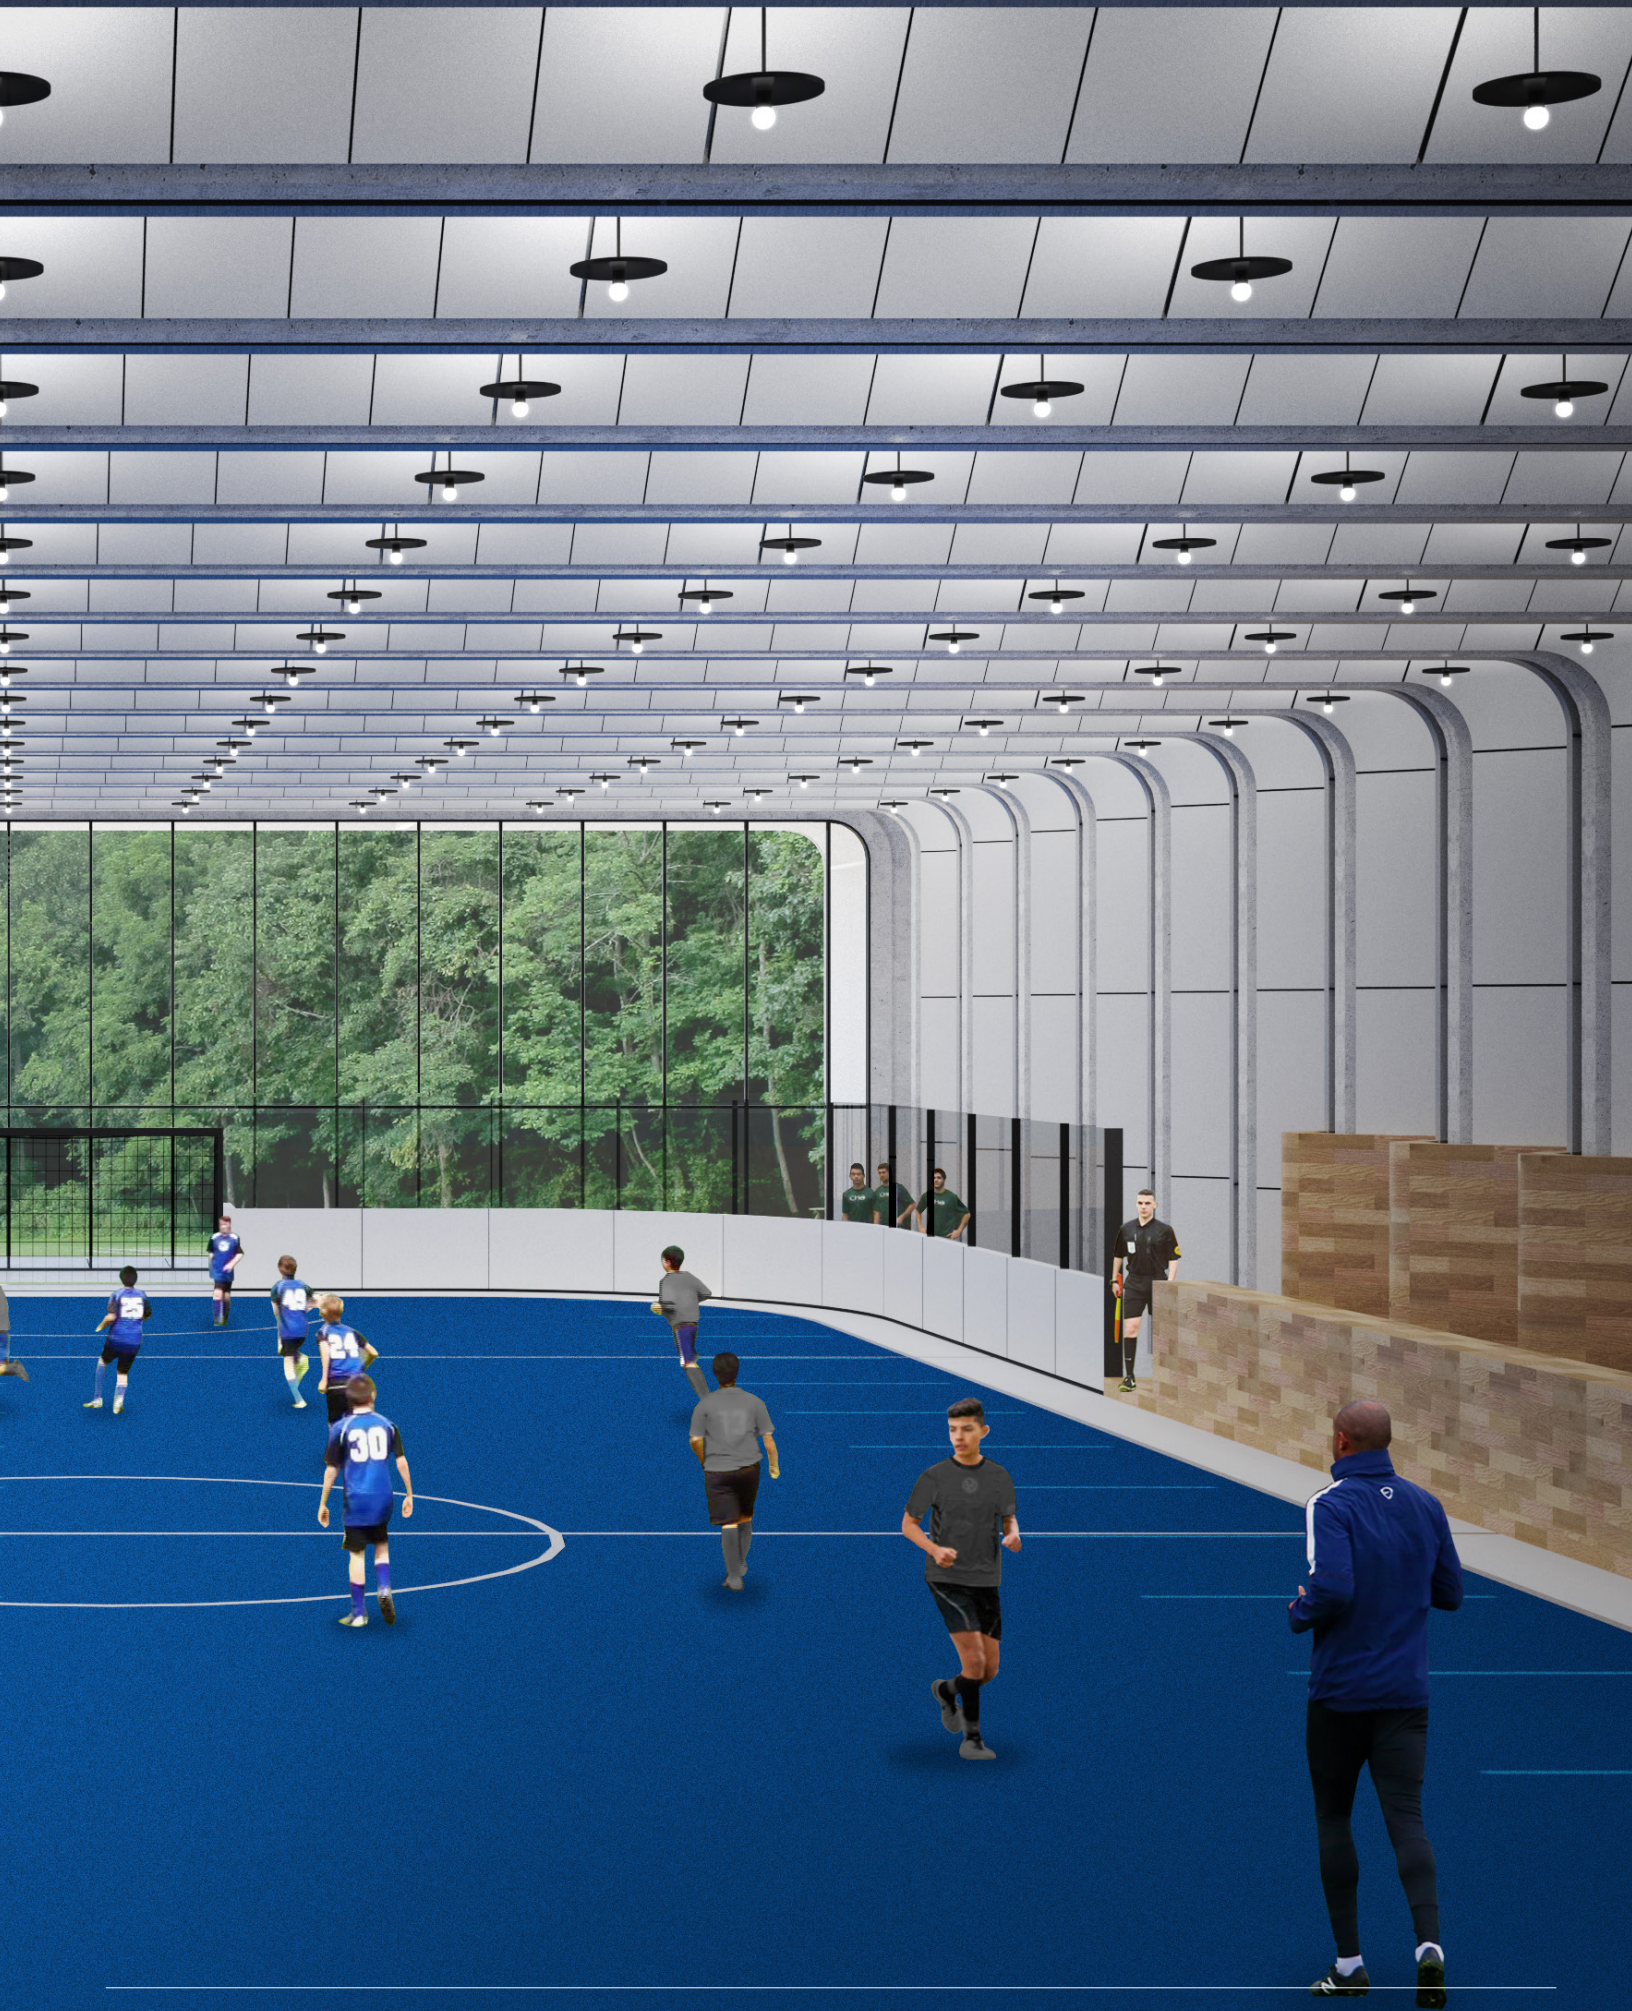
For Scenario 2.B, the removal of all interior infrastructure including partitions and the mezzanine offers an extensive open floorplate of roughly 23,300 sq. ft. (between 105' and 110' by 220'). Introducing an indoor soccer field maximizes the usable area of the existing building.

The field that is shown in this plan measures 74 ft. by 170 ft. That is the maximum size available when fitting an indoor soccer field, bleachers and a bathroom block within the existing Laundry Building. The size of this field is smaller than the indoor soccer field size recommended by the United States Soccer Federation, but is larger than the current indoor soccer field currently located at the Eastside Recreation Center of Elgin, which measures 90ft. by 35ft.

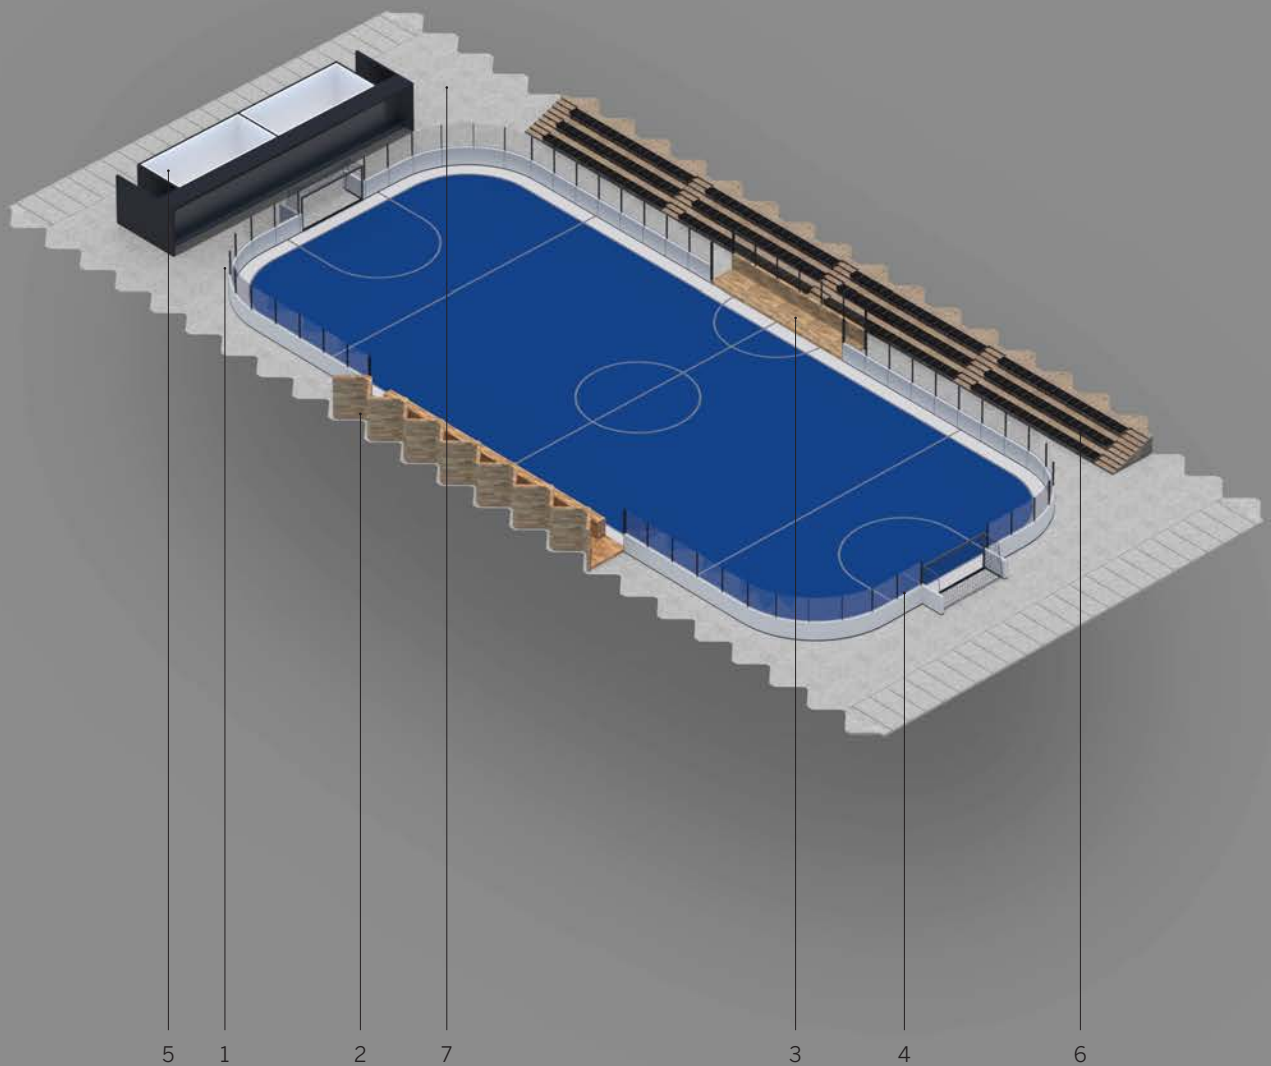
- 1 SOCCER FIELD 74' X 170'
- 2 PLAYERS' BENCHES
- 3 PENALTY BOXES
- 4 VISION GLASS
- 5 BLEACHERS - CAPACITY 192
- 6 RESTROOM BLOCK
- 7 GATHERING AREA

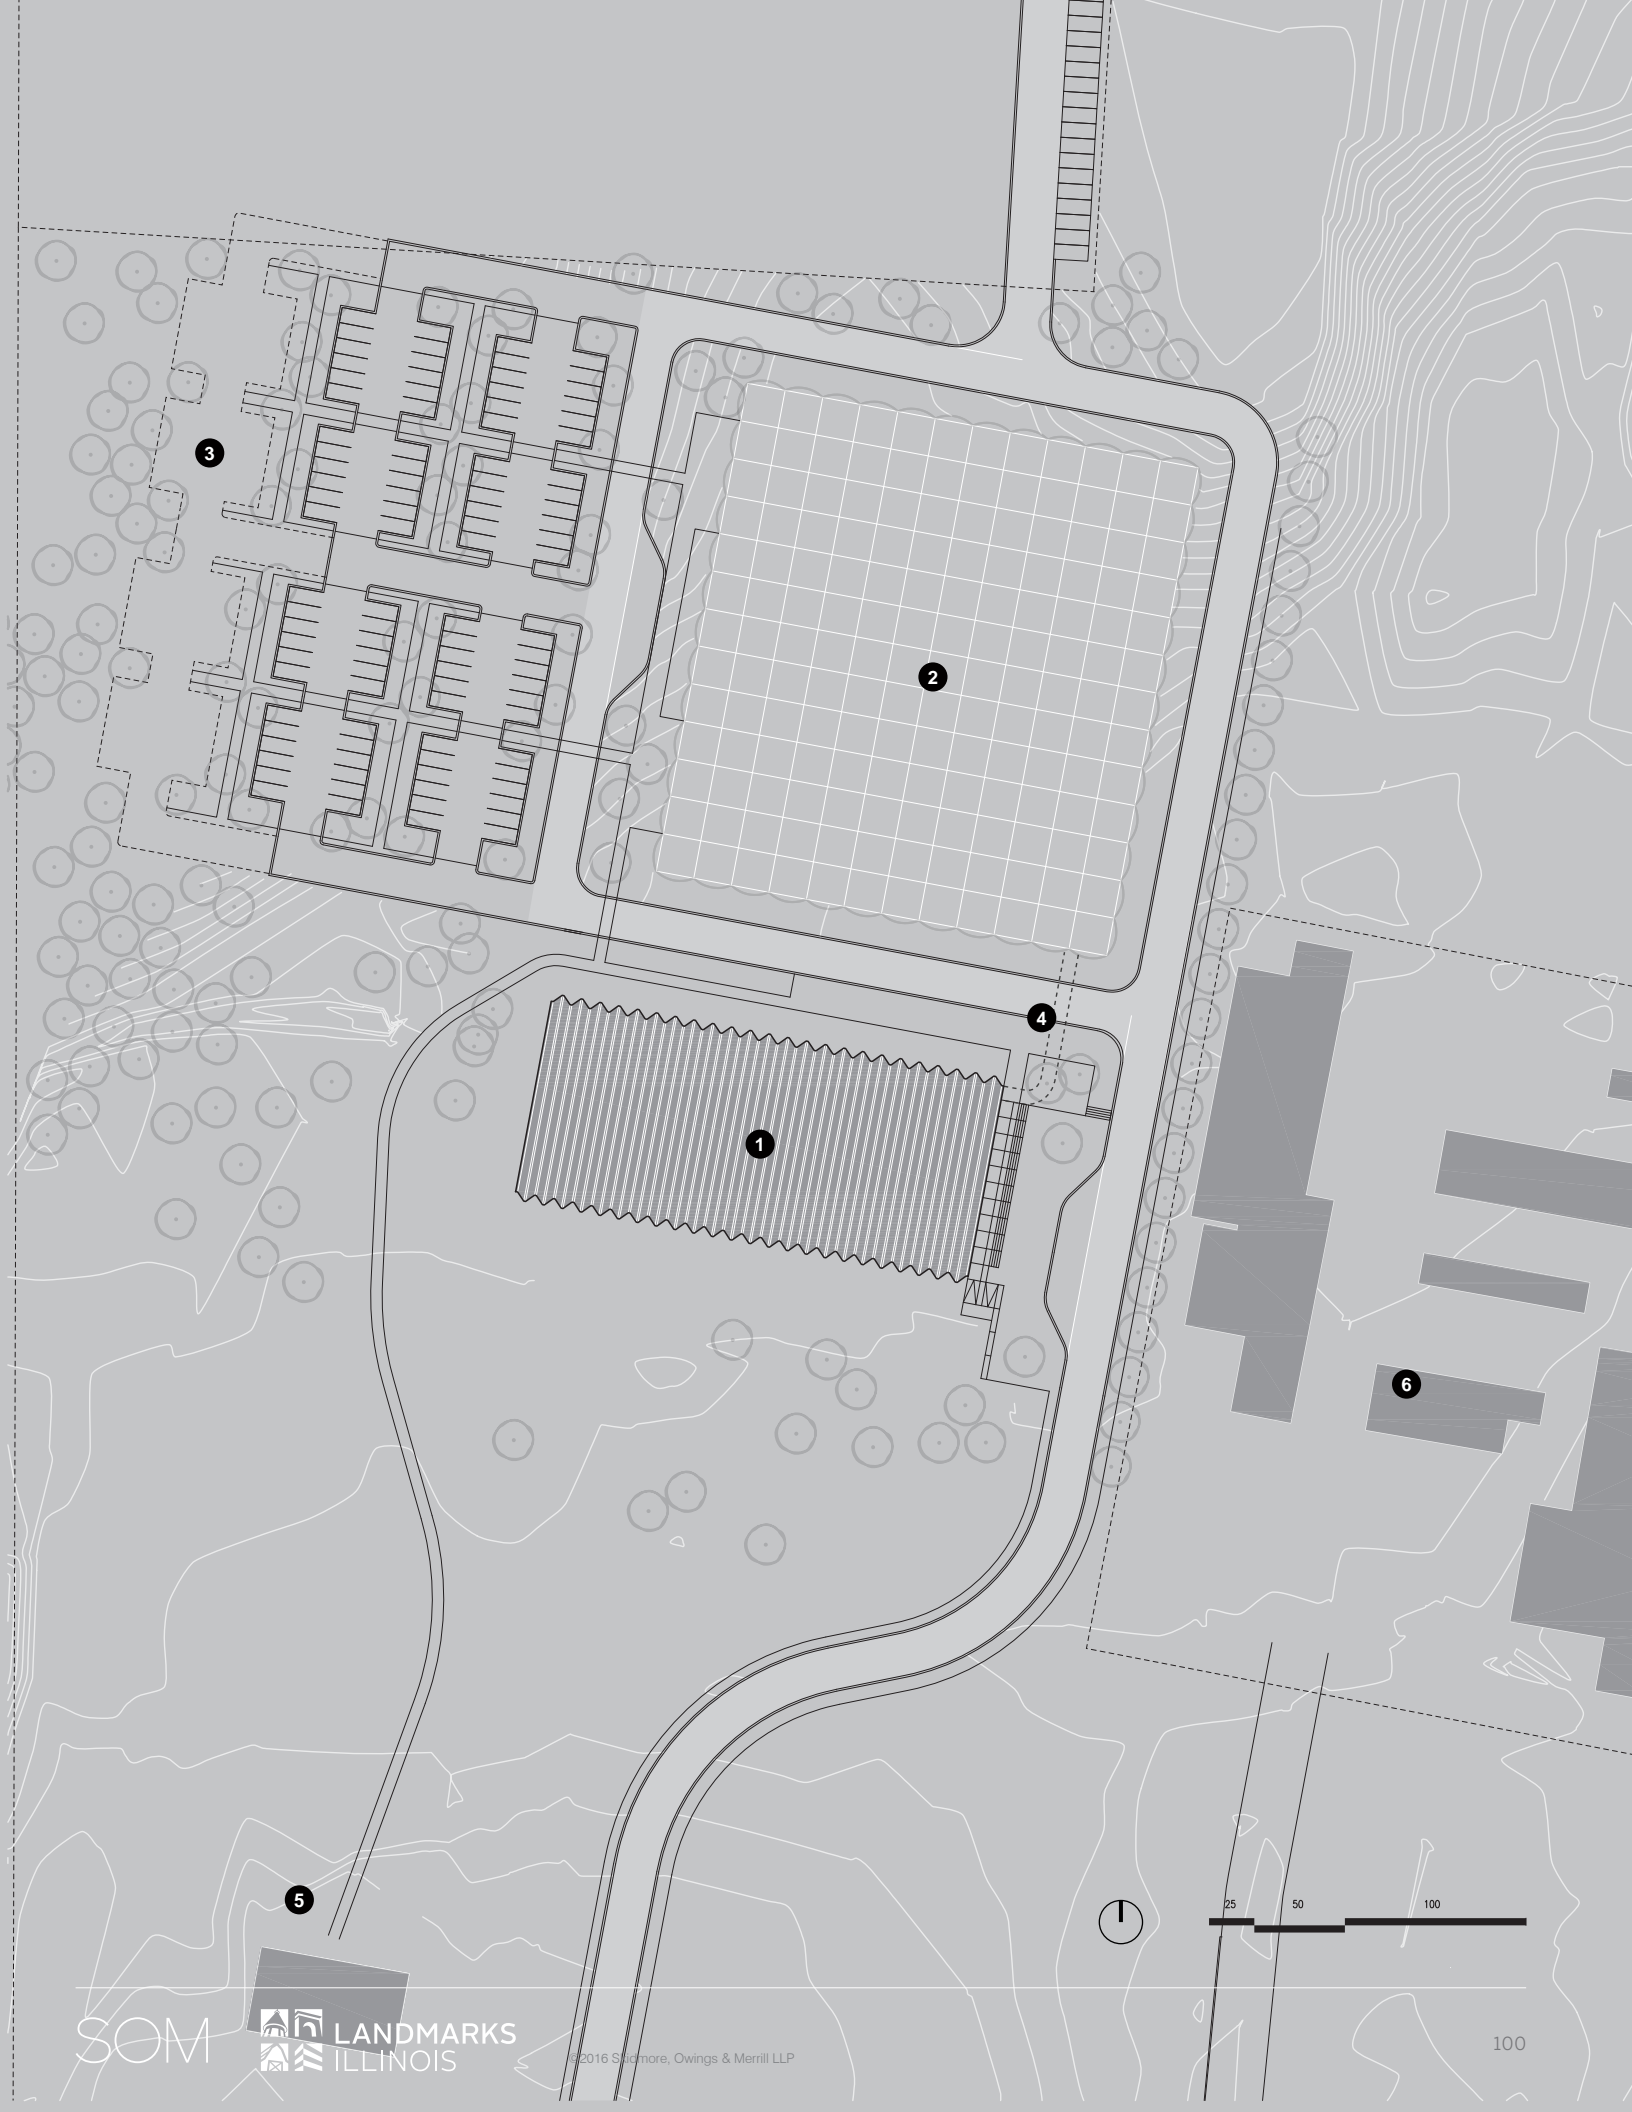
Scenario 2.B - Site Plan

- 1 PHASE I - RENOVATED LAUNDRY
- 2 PHASE II - NOTIONAL 125-150K SQ. FT. FIELD HOUSE
- 3 PHASE II - SITE PARKING
- 4 FUTURE CONNECTION BETWEEN LAUNDRY BLDG AND FIELD HOUSE
- 5 BARN WITH PEDESTRIAN ACCESS
- 6 EXISTING MENTAL HEALTH CENTER POWERPLANT WITH PRIVATE ACCESS
