A RECREATIONAL REUSE STUDY
for the FORMER ELGIN STATE
HOSPITAL LAUNDRY BUILDING

PREPARED FOR THE CITY OF ELGIN,
THE PARKS & RECREATION DEPARTMENT AND
THE PARKS & RECREATION ADVISORY COMMISSION

ELGIN MENTAL HEALTH CENTER Condition Assessment - Laundry Building

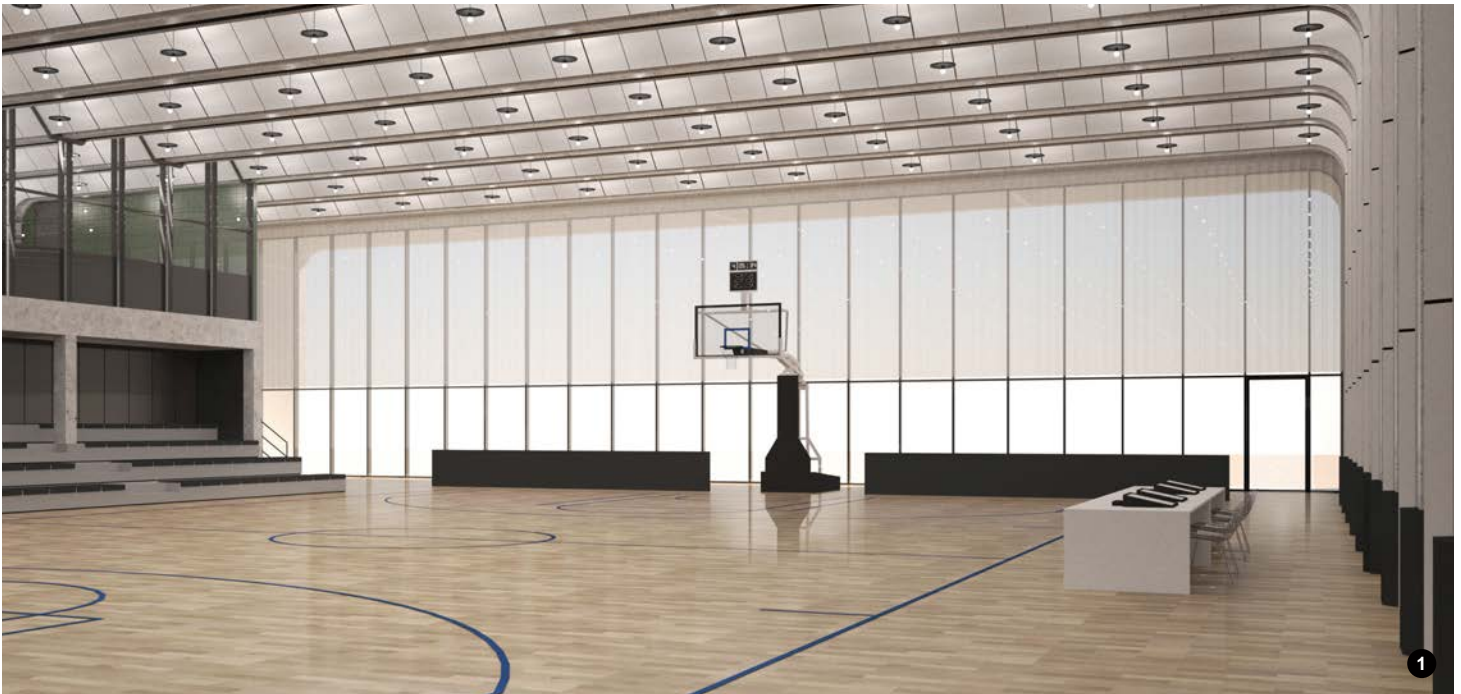
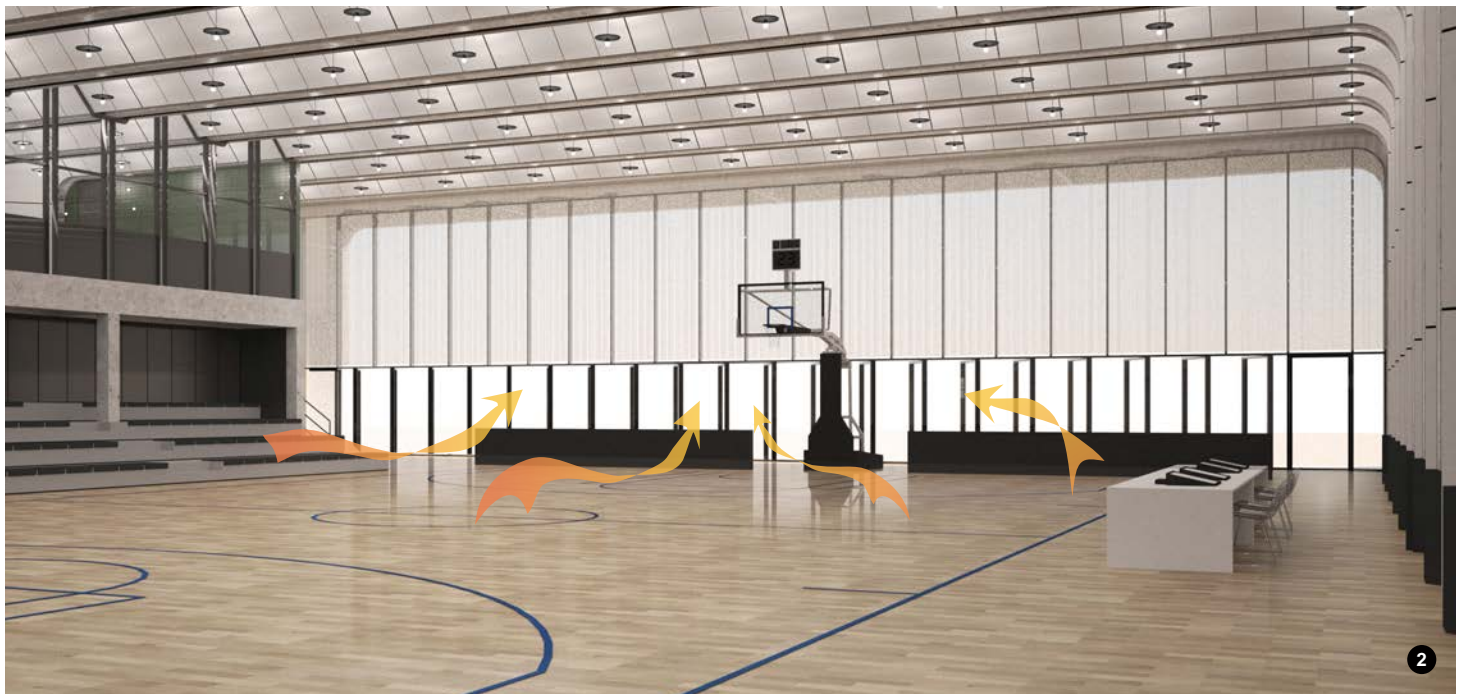
Hybrid Natural Ventilation

A hybrid natural ventilation system can be realized with a combination of air distributed through the existing louvers in the historic precast concrete enclosure system, and an operable curtain wall system. This system would allow cooling in the shoulder seasons and summer months. Hot air can be released through natural bouancy through the the curtain wall system. When combined with the thermal mass of the historic concrete structure, night ventilation can also be used to pre-condition indoor temperatures.

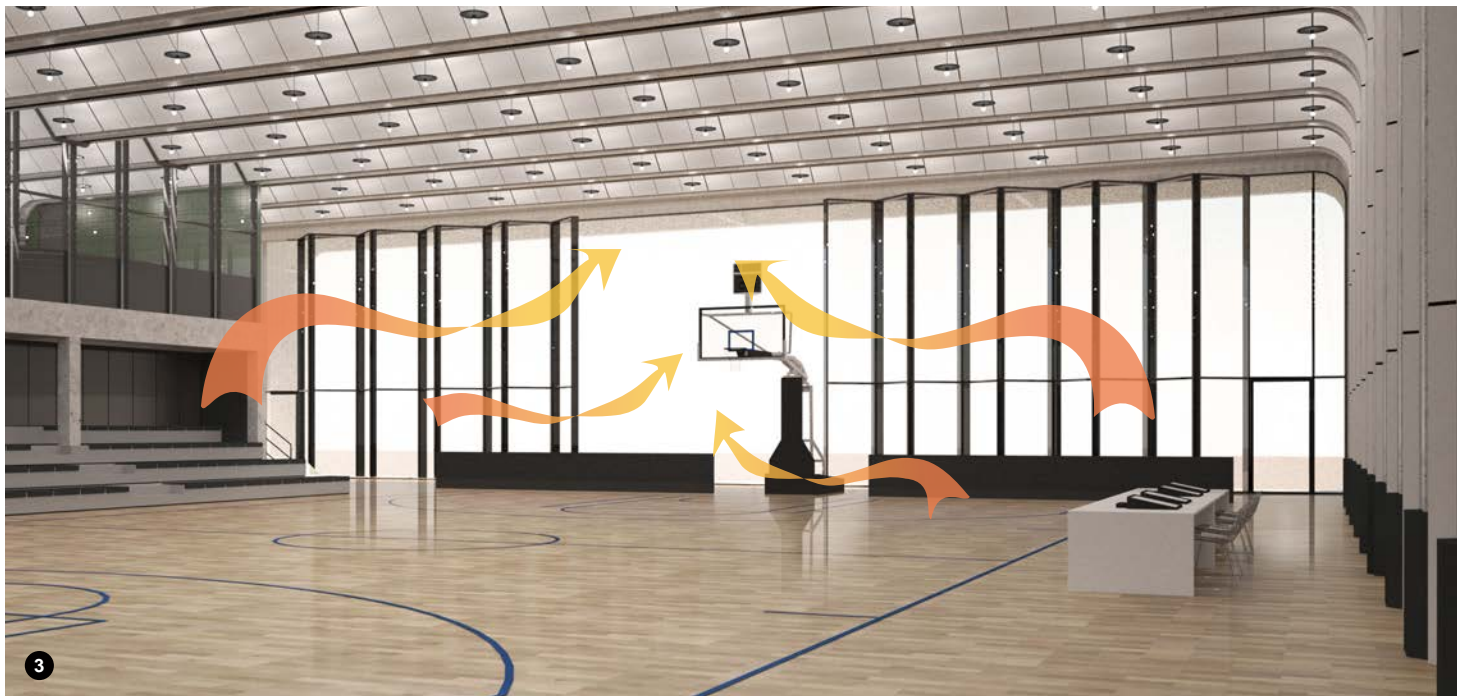
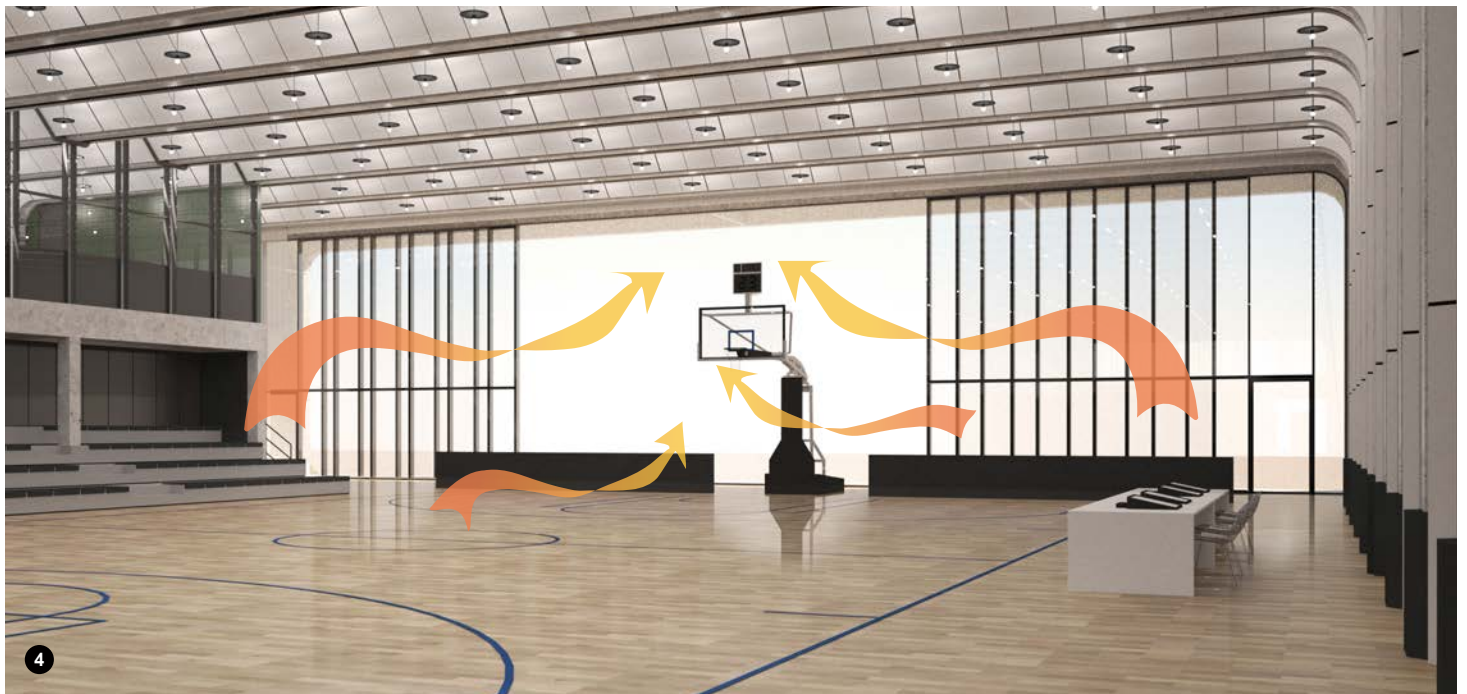
- 1 CURTAIN WALL REPLACEMENT
- 2 PIVOTING PANELS - BOTTOM 12'
- 3 UNFOLDING FULL-HEIGHT PANELS
- 4 SLIDING FULL-HEIGHT PANELS

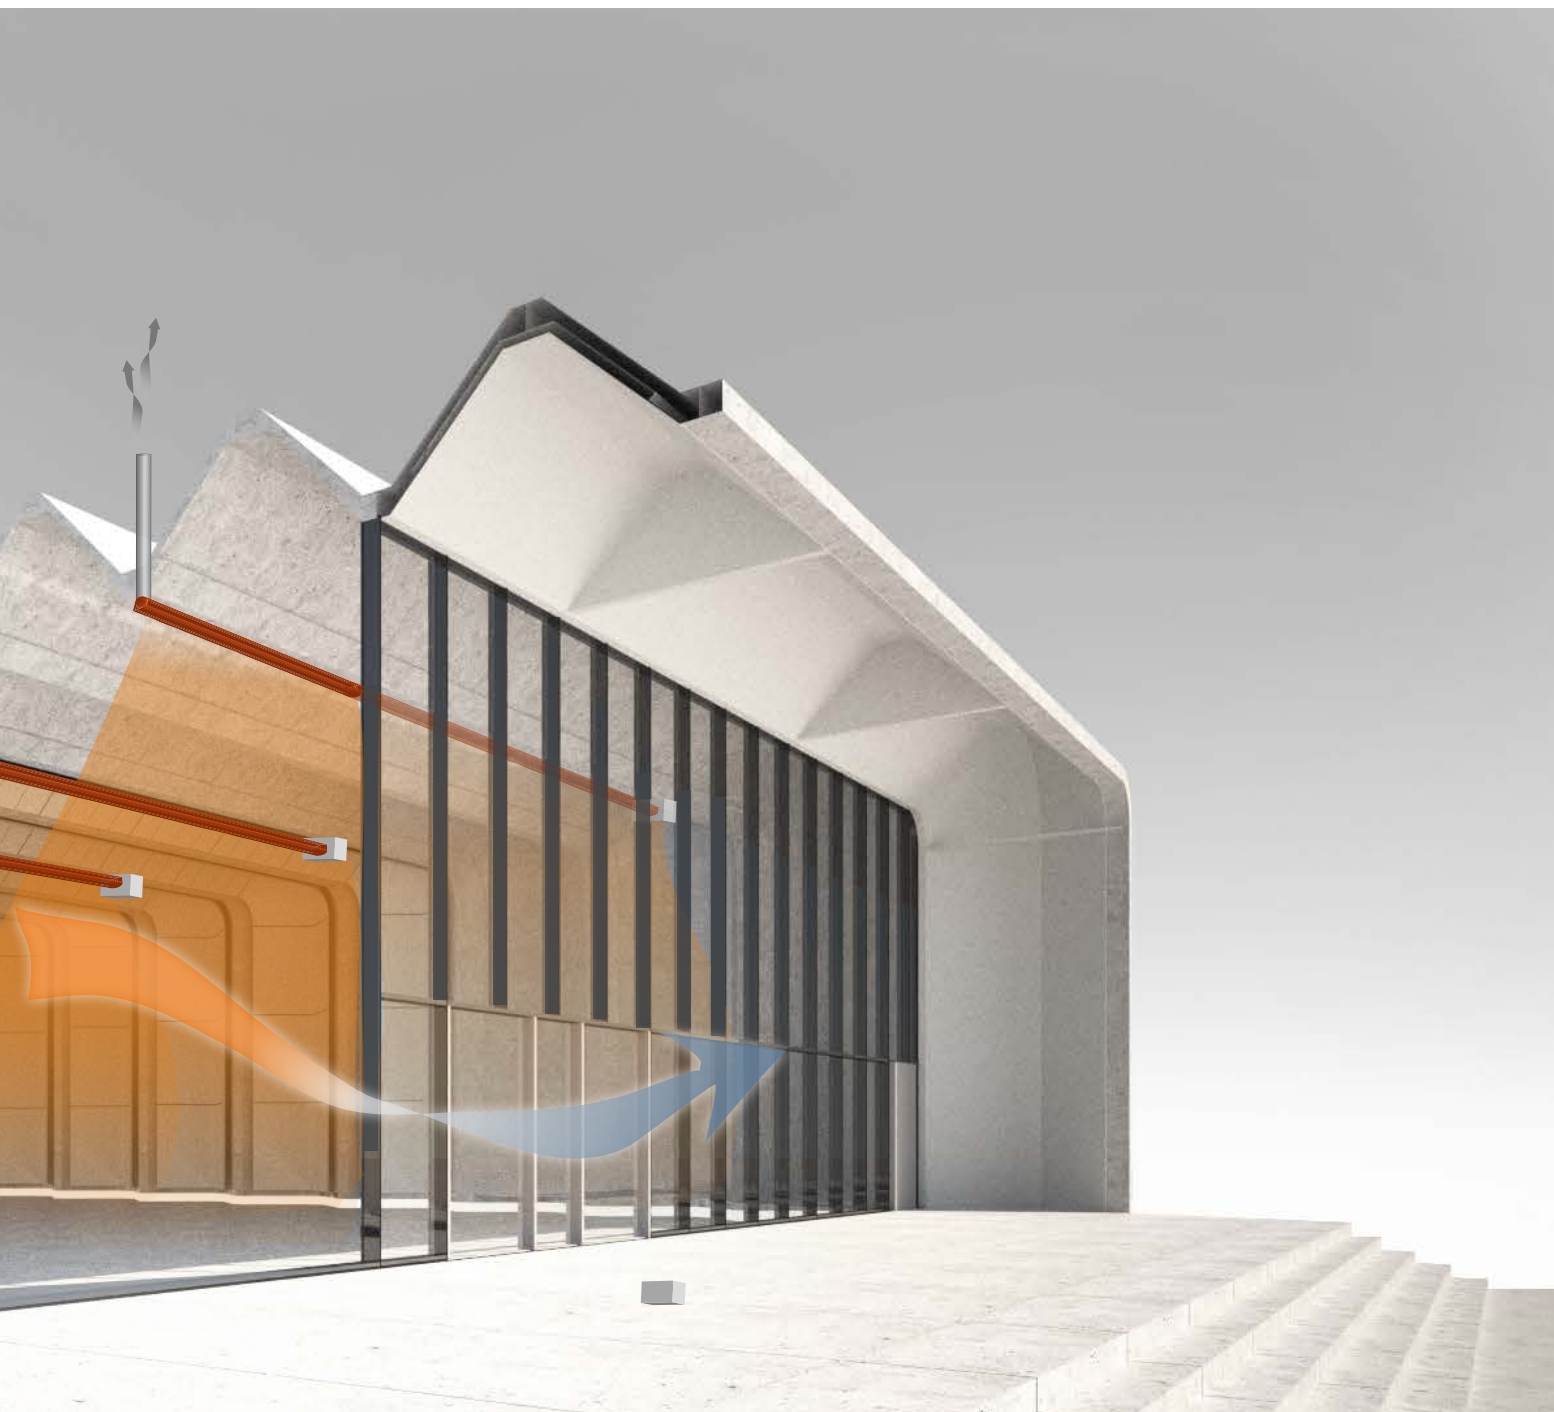
Gas Fired Radiant System

By utilizing a water-based system to deliver heating, the project could realize improved thermal comfort, acoustic performance, and pollution control all while having significant energy savings. The team proposes a gas fired radiant system installed in the ceiling plane. This will result in a high efficiency system with minimal interruption of the visual lines of the ceiling plane. Outside air can be delivered through the existing louver system in the perimeter walls during the winter months.

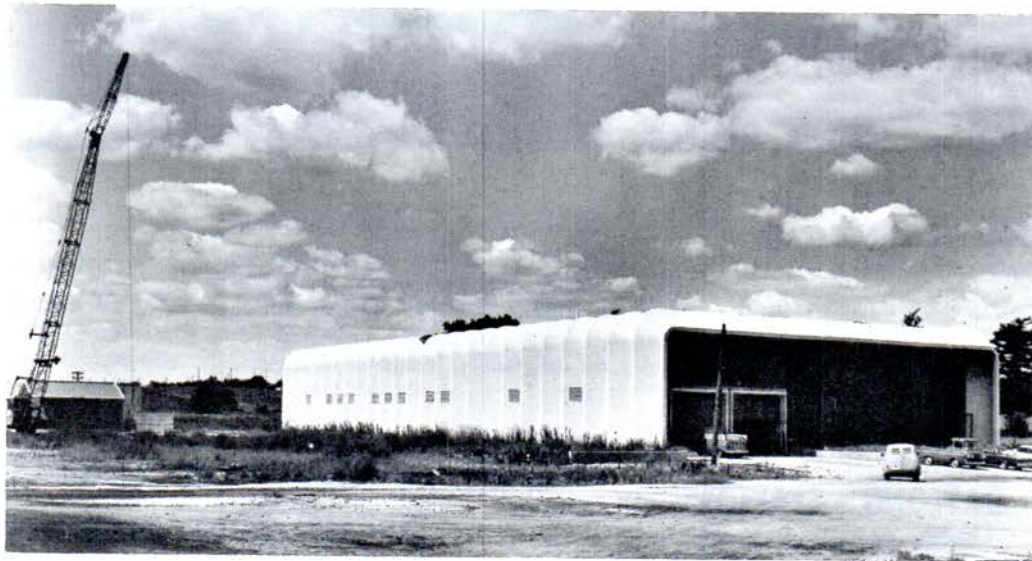
NEW LAUNDRY BUILDING

FRONT AND SIDE
VIEW OF NEW
LAUNDRY BUILDING.
CONTINUOUS-LINE
CONCRETE "RIBBING"
IN WALLS AND ROOF
MAKES ROOF SELF-
SUPPORTING WITH-
OUT THE USE OF
INTERIOR COLUMNS.
CONCRETE EXTERIOR
HAS BEEN SEALED
AND PAINTED AS ONE
OF THE LAST STEPS
IN CONSTRUCTION.

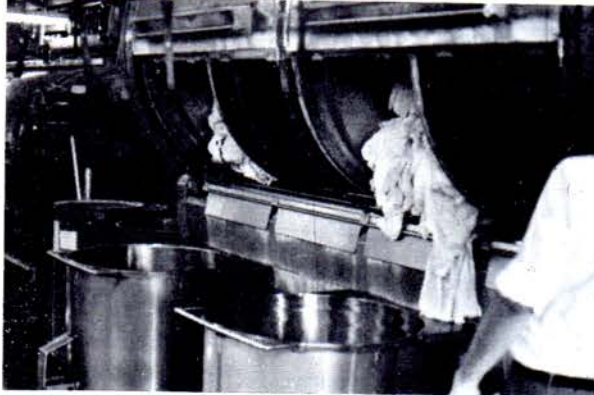
Mass production is the name of the game in the new ESH Laundry. Washers that stand taller than a man wash, rinse, and eject the clothes into the steel tubs (bottom center). The washers are loaded from the second floor through chutes. (ESH Photo)

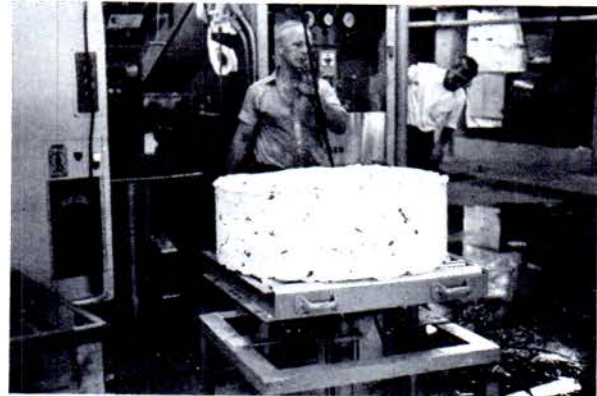
It might look like a birthday cake but it's really a tub full of wet wash that has been compressed in a special machine until all of the water is squeezed out. This "cake" is moved hydraulically since it is much too heavy for handling by hand. It is pushed into dryers that looked as if they were large enough to park a Volkswagen in. William Schwartz, now Acting Laundry Manager, operates the hydraulic controls. (ESH Photo)

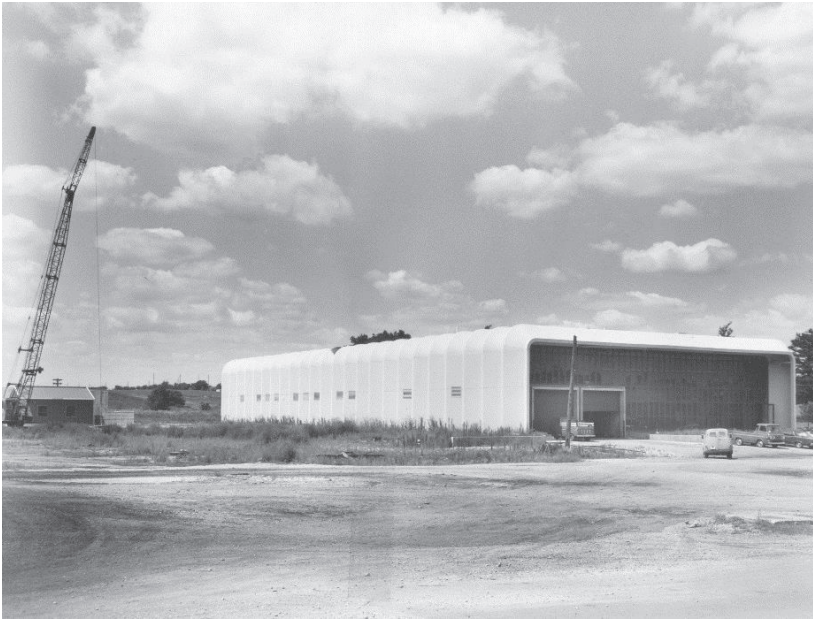
Figure 3. Laundry building during construction in 1966

The laundry building is rectangular in plan, measuring approximately 240 feet in the east-west direction and 110 feet in the north-south direction. The structure consists of twenty-four free-standing folded concrete plates that create portals. Painted steel louvers are installed through the concrete wall areas at each portal. Each portal is approximately 10 feet wide and spans 110 feet. The east and west ends of the building are enclosed with a recessed steel and glass curtain wall that spans from a concrete curb at grade to the underside of the end portals. The west curtain wall incorporates passage doors as well as 10 non-original aluminum frame double hung windows replacing curtain wall glazing. The west curtain wall incorporates two overhead doors as well as a passage door. The interior is generally open but incorporates a mezzanine level that extends the full length of the building along the north wall. An aerial view of the laundry building and a portion of the hospital complex are shown in Figure 1. A rendering of the building created during the design phase is shown in Figure 2. A view of the building under construction is shown in Figure 3. Overall views of the building exterior and interior are shown in Figure 4 through Figure 9.

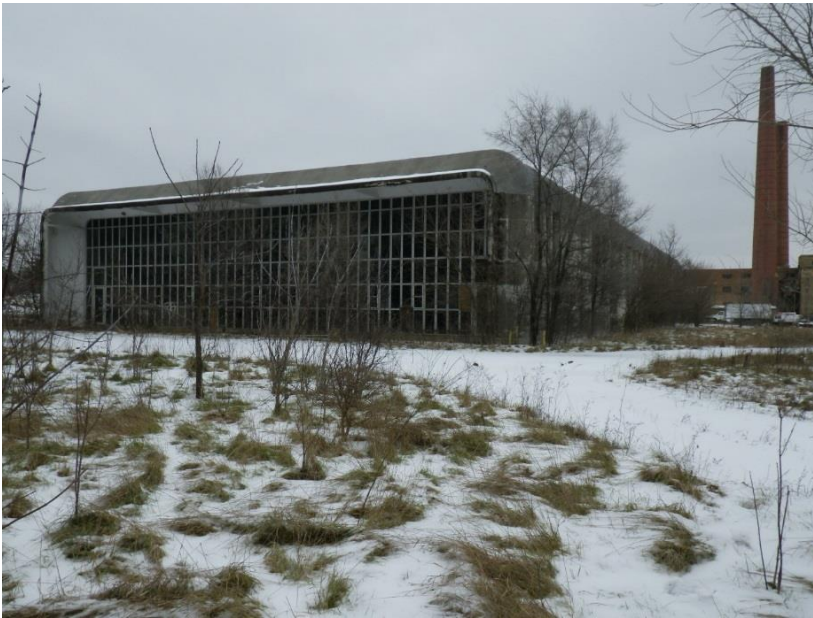
Figure 4. View of west facade

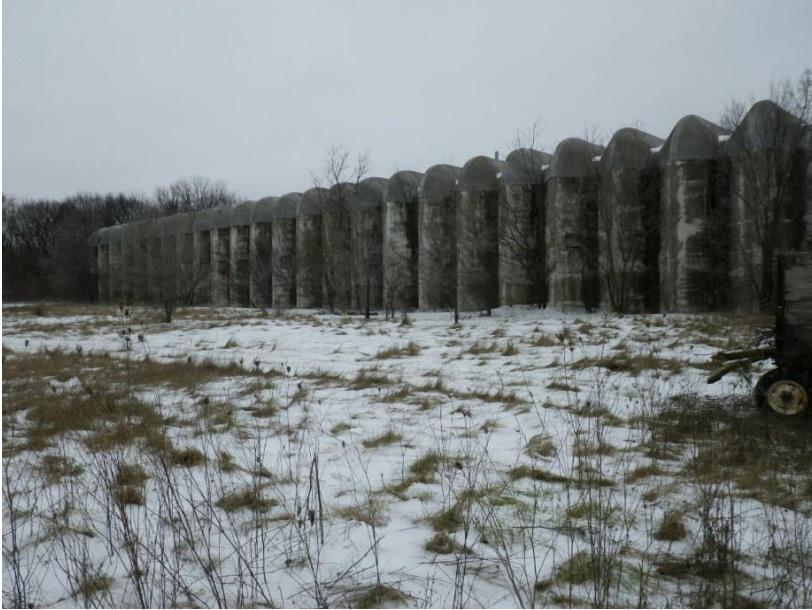
Figure 5. View of south facade

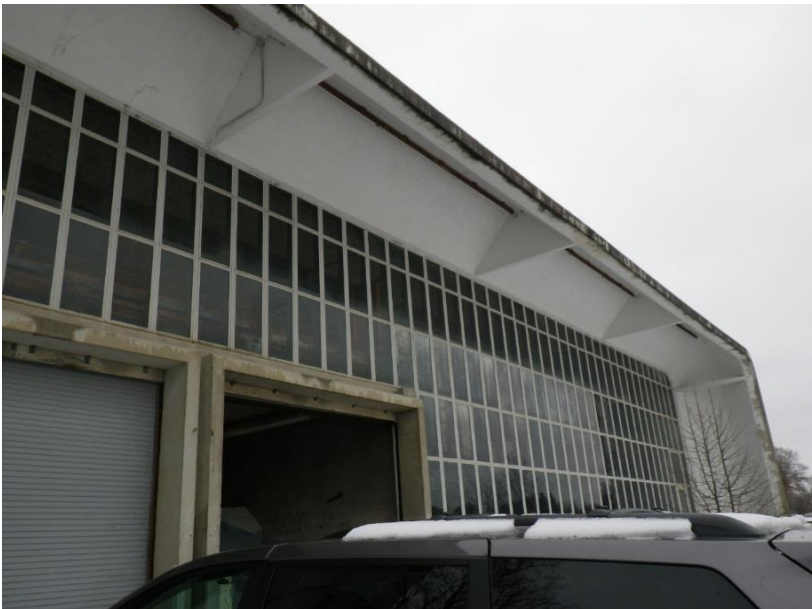
Figure 6. View of a portion of the curtain wall on the east facade

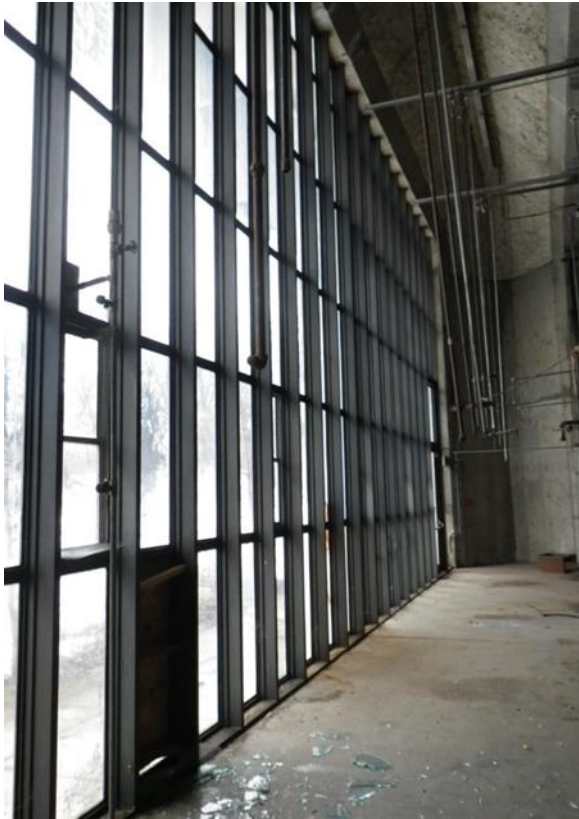
Figure 7. Interior view of west curtain wall area

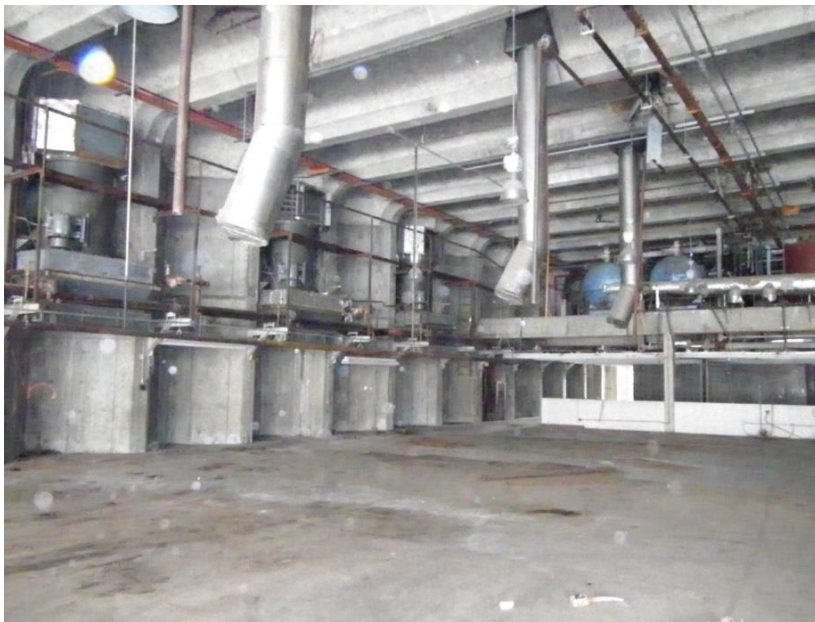
Figure 8. Interior view of laundry building

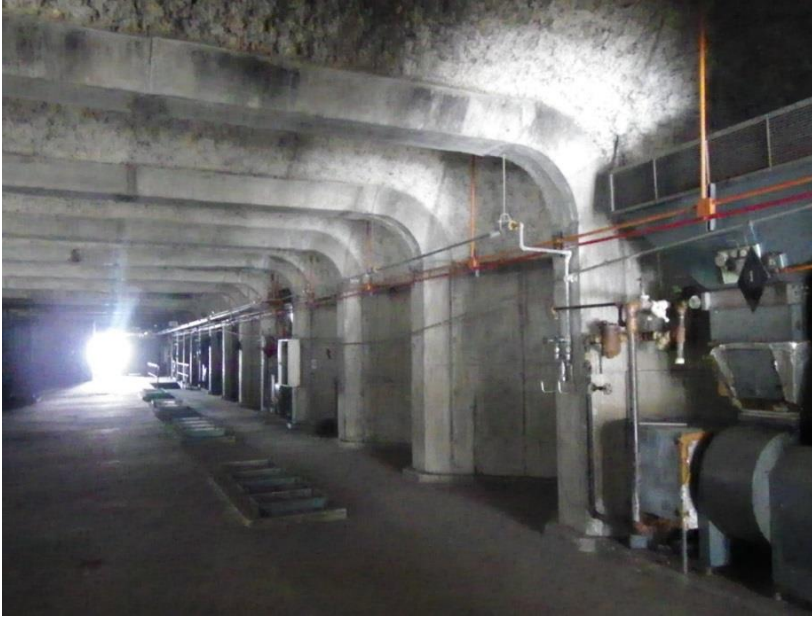
Figure 9. View of mezzanine level of building

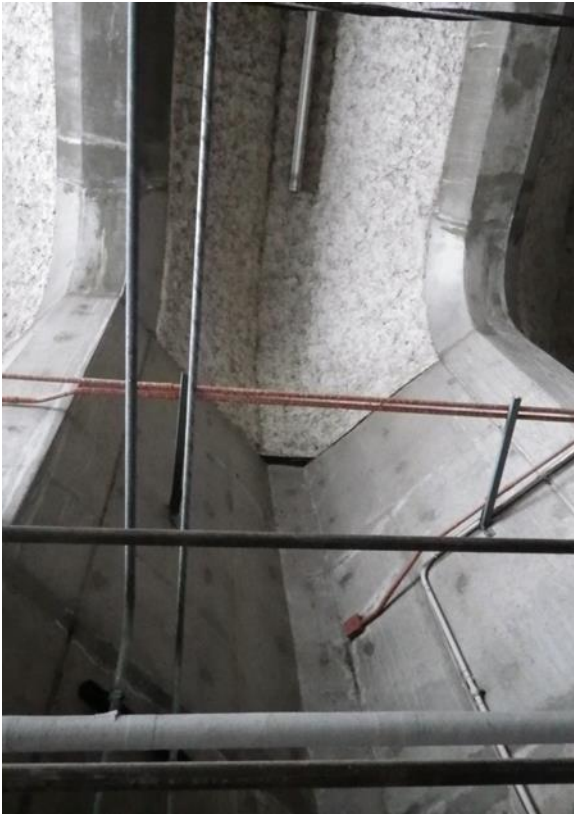
Figure 10. Detail of transition from vertical wall surface to horizontal/roof portion of portal

the vertical mullions. Steel frame fixed sashes, glazed with single pane 1/4 inch thick glass set with steel stops, are fastened into the vertical mullions and horizontal plates. The mezzanine is a reinforced concrete structure at the south end within the enclosure of the building. Views of various details of the building are shown in Figure 10 through Figure 11.

The bottom surfaces of the concrete plates that create the ceiling inside the building are coated with what appears to be an acoustical and/or insulation treatment (Figure 10). The remaining areas are the exposed concrete portals and slab-on-ground.

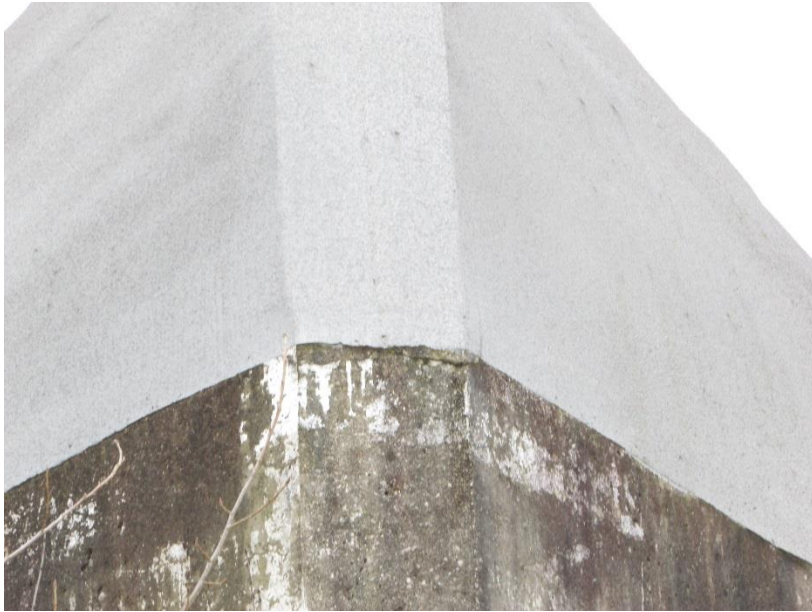
Figure 11. Transition from vertical to horizontal at exterior

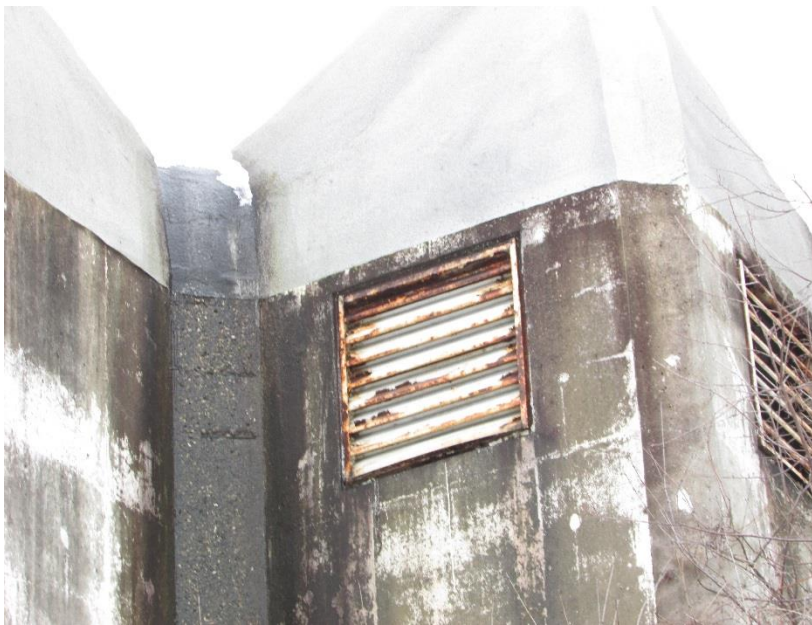
Figure 12. View of ridge between portal, as well as painted steel louver in wall

2. Corrosion was noted on all of the steel louvers installed through the concrete wall areas (Figure 12 and Figure 13).
3. Limited areas of cracking and spalling were noted in the exterior and interior portions of the folded plates (Figure 14 and Figure 15).

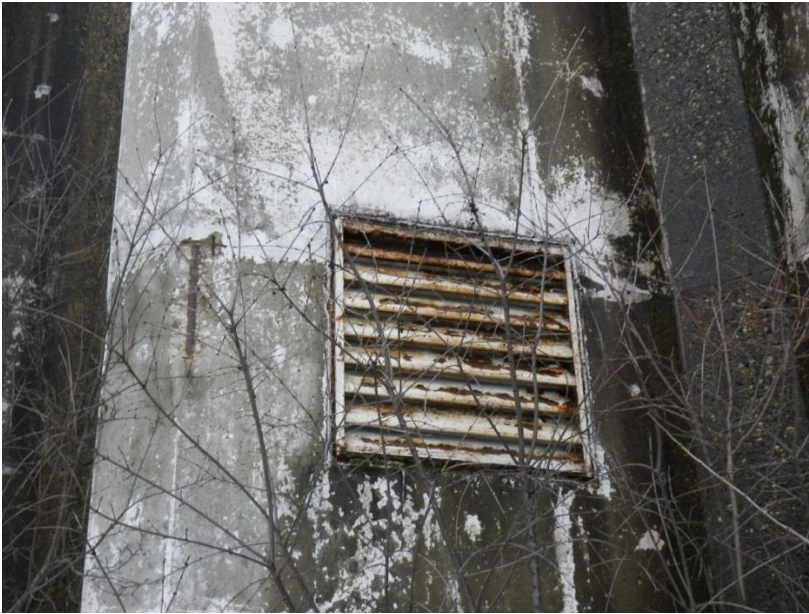
Figure 13. Louver in wall area

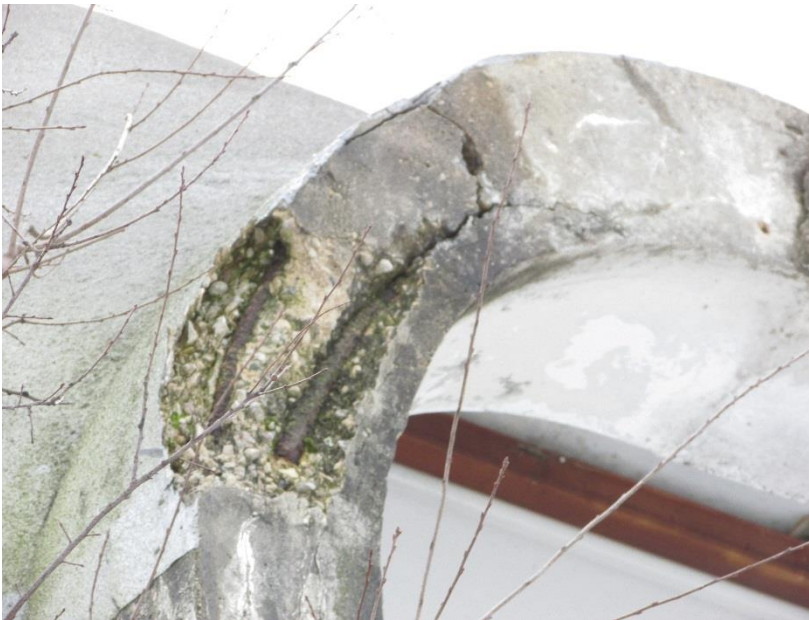
Figure 14. Spalled concrete at edge of end portal

1. Repair areas of cracked and spalled concrete on the interior and exterior of the portals.
 - Estimated cost: \$35,000 allowance
2. Remove the existing remaining coating on the exterior vertical surfaces of the concrete portals and install a breathable acrylic coating to minimize water infiltration. During this work, the concrete should be sounded to locate areas of delaminated concrete and make repairs as necessary. Also, as part of this work, trees and shrubbery close to the exterior walls should be removed.

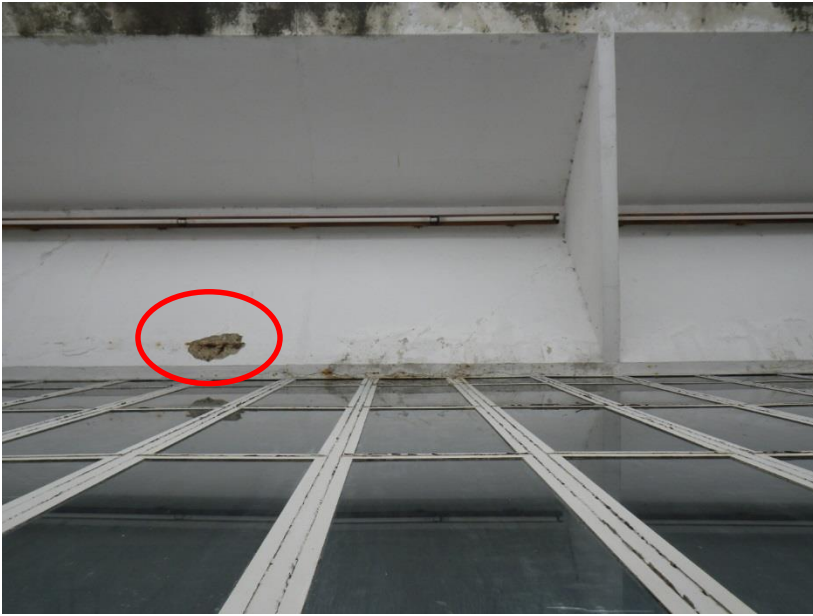
Figure 15. Spall in underside of overhanging portion of end portal on west facade

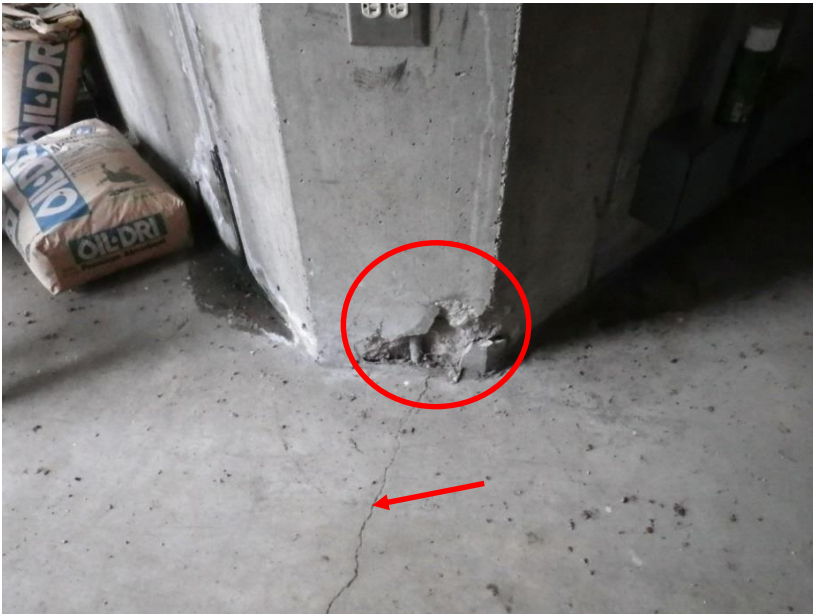
Figure 16. Spall at concrete at base of wall and crack in slab-on-ground

4. A few spalls were noted at the interface of the folded plates and the slab-on-ground (Figure 16) as well as isolated locations on the interior.
5. Surface corrosion and blistering and peeling paint were noted on the steel curtain wall mullions. The most significant corrosion was noted on the plate that was installed on the concrete curb at the bottom of the curtain wall (Figure 17 and Figure 18).

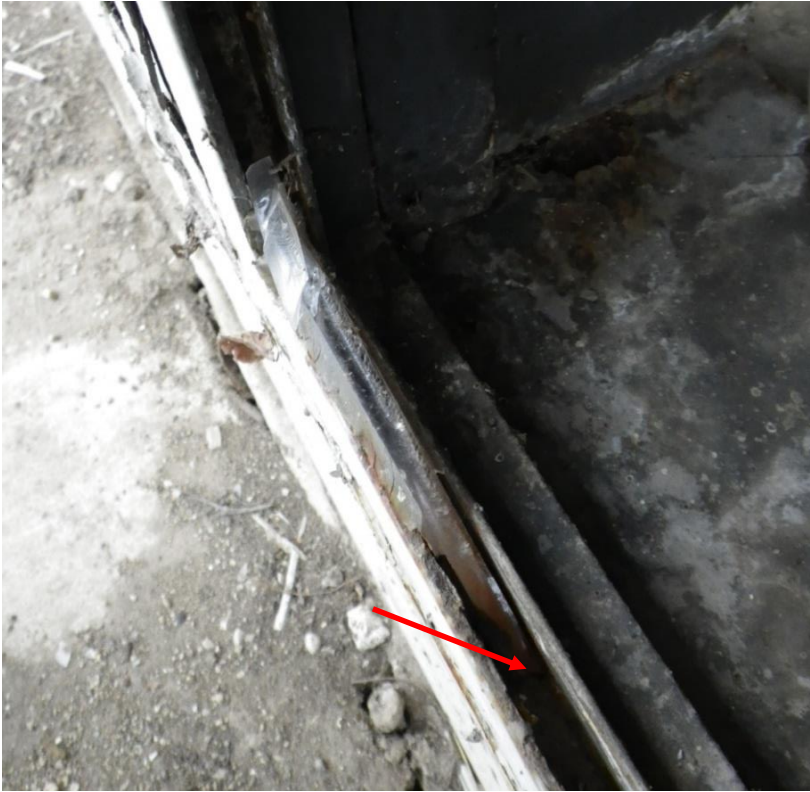
Figure 19. View of glazing pocket at broken lite in curtain wall at base. Note: no corrosion scaling is evident in the glazing pocket.

6. A few of the curtain wall lites are broken (Figure 19).
7. A liquid applied membrane appears to have been installed on the (roof) portion of the portals that span between the walls. Only limited areas were visible during our evaluation and no information regarding the material and when it was installed was available.

- Estimated cost: \$20,000 allowance
4. Remove all coatings from the curtain wall area and install a new high performance coating system. This should include removing the glass to enable the glazing pocket to be coated. Replace all broken or cracked glass in the curtain wall. Consideration could also be given to replacing the curtain wall with a new thermally improved system.

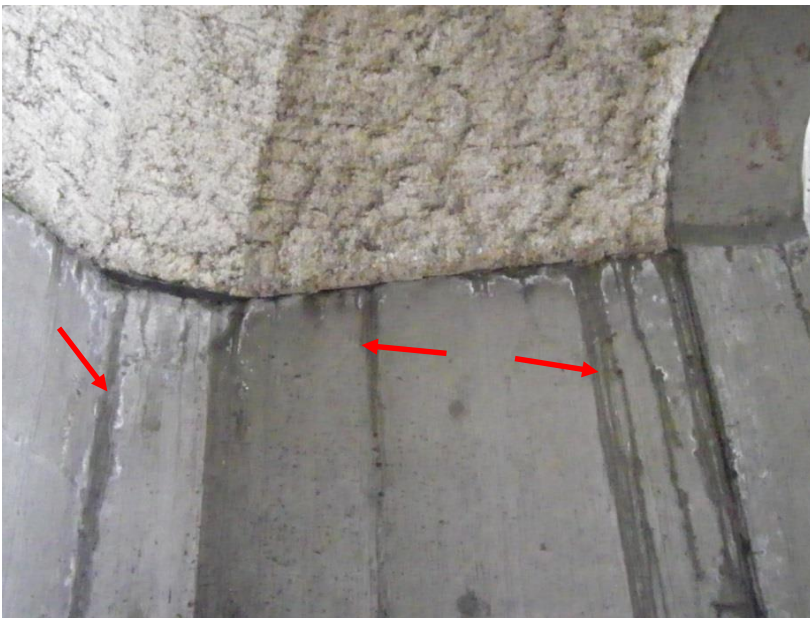
Figure 20. Indications of water leakage at transition between wall and ceiling area on interior

8. A few areas of water leakage were noted on the interior at the transition between the vertical and horizontal portion of the portal (Figure 20 and Figure 21). This joint appears to be a cold joint, but could not be definitively determined.

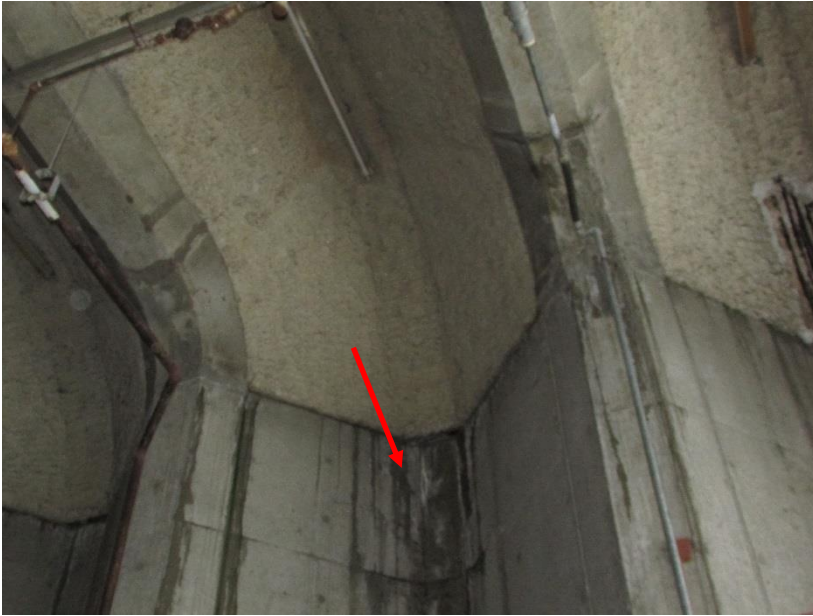
Figure 21. Indications of water leakage at transition between wall and ceiling area on interior

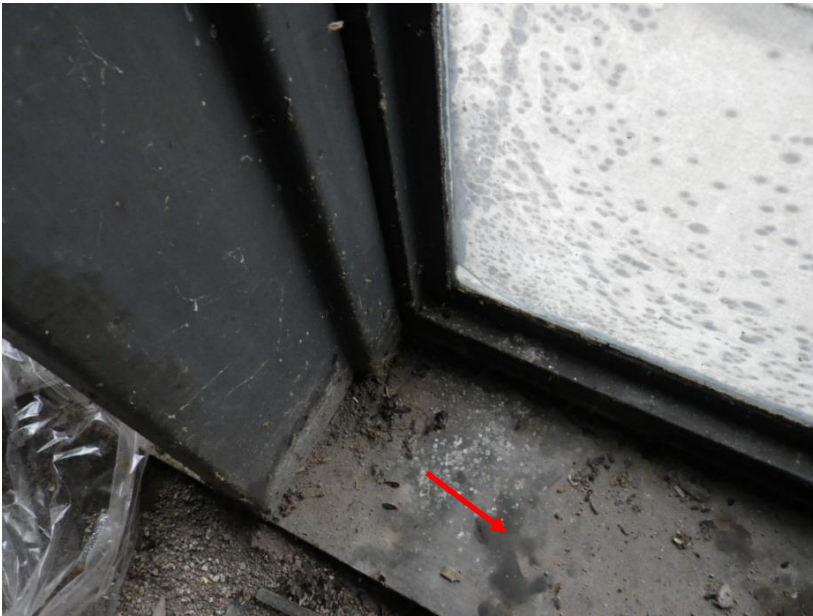
Figure 22. Water stains on bottom plate of curtain wall

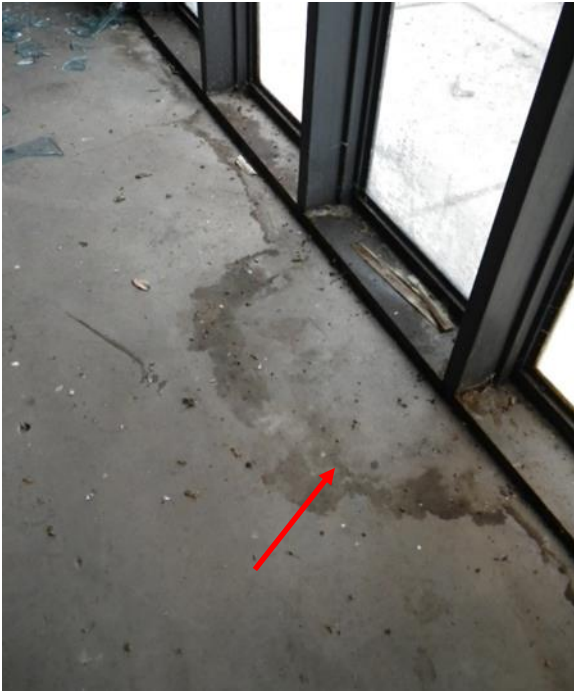
Figure 23. Indications of water infiltration and/or condensation on the slab adjacent to the curtain wall
