Preservation of an Historic Building Material

JOLIET-LEMONT

L I M E S T O N E

Landmarks Preservation Council of Illinois

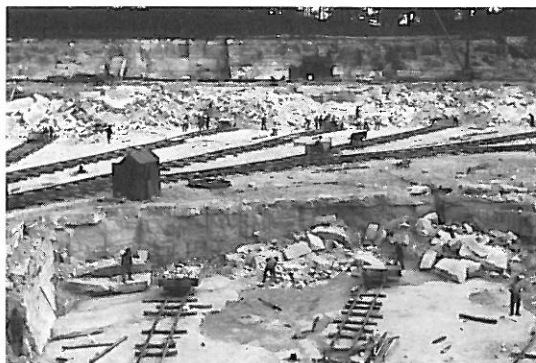
Western Stone Company, Joliet, 1907. Stone is quarried on several levels in this photograph taken by E.F. Burchard. Courtesy United States Geological Survey (Burchard, E.F. 454).

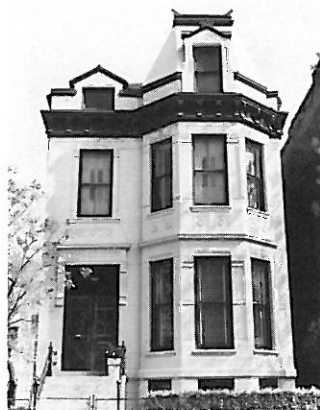
1880s townhouse on Chicago's west side, entirely faced with "Marble" (dolomite limestone). LPCI Photograph courtesy William L. Lavicka.

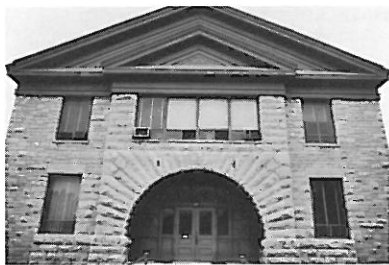
U.S. Steel headquarters building at Joliet Works. This Classical Revival monument employs rusticated, rough-faced Joliet stone and the true arch to convey solidity and dynamism. Courtesy Upper Illinois Valley Association.

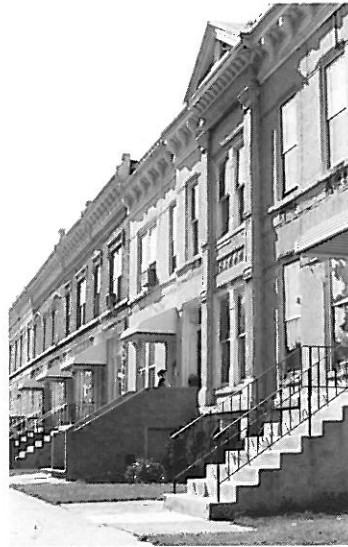
Joliet-Lemont stone rowhouses on West Bowler Street, Tri-Taylor Historic District, Chicago. LPCI photo by Mary Jane Keitel.

Row houses on West Bowler Street in Chicago's Tri-Taylor Historic District were constructed in the 1870s with Joliet-Lemont limestone panels attached to a brick wall. The cornice is ornamental sheet metal. The present condition of the limestone varies from house to house and sometimes from block to block. Wiss, Janney, Elstner Associates, Inc. photograph.

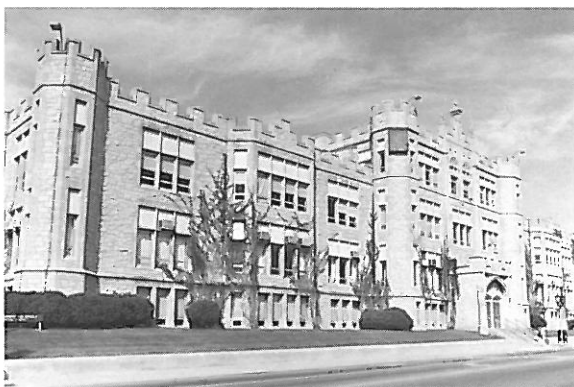
Joliet High School, designed in 1901 by Frederick S. Allen in a Gothic style using both local and Indiana limestone. Photograph courtesy Joliet Area Historical Society, by Nick L. Contos, all rights reserved.

Joliet's East Side Historic District contains two churches, two homes and a school built of local limestone in the 1890s. Architect Frank S. Allen built the Joliet Township High School (1900-01) with Joliet stone highlighted by the use of Indiana limestone for lintels, sills and quoins. Adam Groth Stone Company provided the stone for the school and for the landmark Public Library, which was designed by Daniel Burnham in 1903 and used granite trim to highlight the Joliet stone.¹⁹ By this date, however, Indiana limestone was becoming the preferred building material even in the quarry towns.

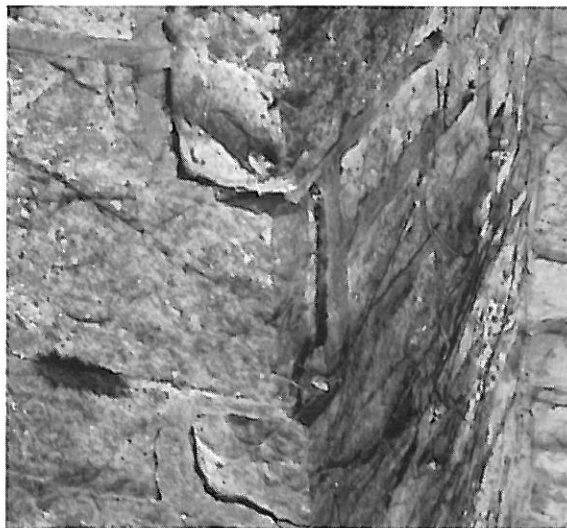
The limestone butresses at Christ Church in Winnetka have been damaged by the effects of freeze-thaw cycling. Pressure from the expansion of freezing water within the wall has caused the mortar joints to open up and step cracking to occur throughout the stonework. Photo by Harry Hunderman, AIA.

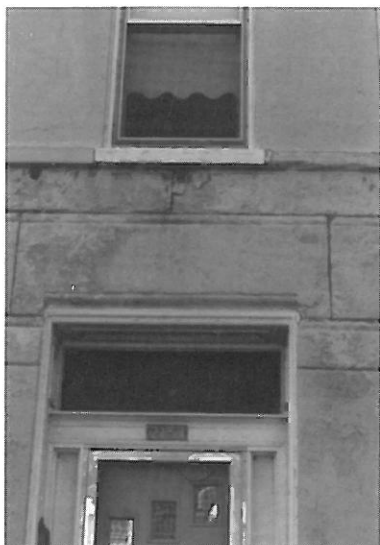
Deterioration is evident in the stone panels below a window sill course on this rowhouse. The window sill itself has been replaced, and the adjacent sill course shows spalling. Water collecting and passing through open joints in the sill to the stone panels below is likely the principal cause of deterioration. Wiss, Janney, Elstner Associates, Inc. photograph.

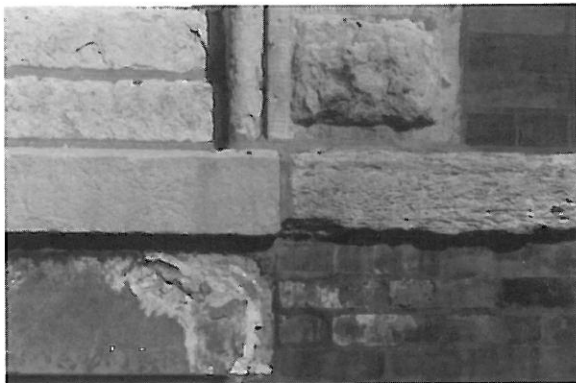
Efflorescence is visible on adjacent areas of these West Bowler Street rowhouses, which exhibit a remarkable range of conditions. At left, a limestone facade has an intact sill, while spalling and efflorescence have occurred below the sill where water has penetrated the wall. At right, a masonry facade with ornamental limestone sills and quoins reveals severe spalling and cracking on the stone sill and efflorescence on the brick wall below. Wiss, Janney, Elstner Associates, Inc. photograph.

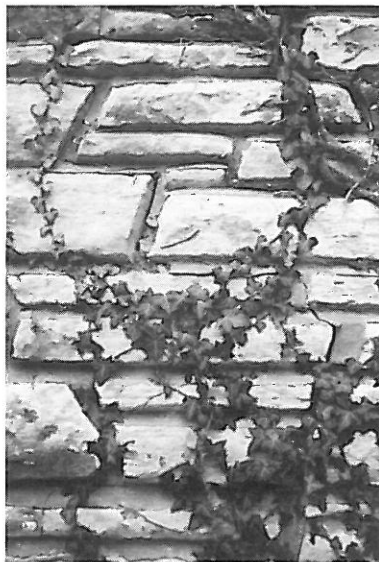
Certain types of ivy project needle-like probes into mortar joints and masonry. Growth of such ivy accelerates deterioration of the stone wall. Photo by Harry Hunderman, AIA.

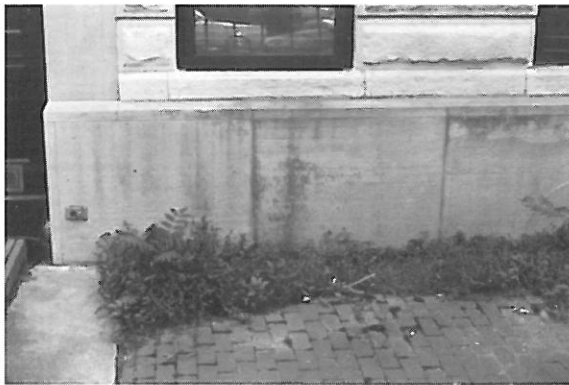
Discoloration of the lower stone walls of this Belden Street building in Chicago has been caused by rising damp and water entering through the sill joints. Conservation measures should address both elimination of the sources of water penetration and repair of the wall. Wiss, Janney, Elstner Associates, Inc. photograph.

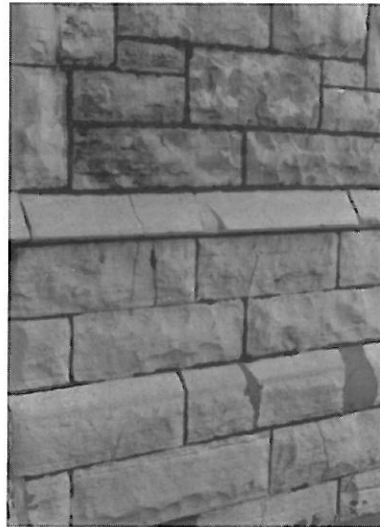
A detail of the tower at St. James Cathedral shows variation in color and texture of rusticated limestone blocks and the smoother sill course. Note localized cracking and old patches on this part of the wall. Much of the limestone was found to be in good condition, but open head joints and open joints along the top of the stone belt courses had led to water penetration and spalling of adjacent stone.

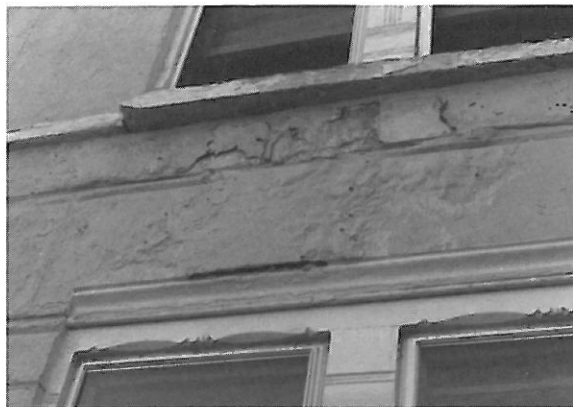
This rowhouse facade exhibits deterioration in an area of stone which has been painted. Improper use of coatings may contribute to the deterioration of limestone, since many paints are not vapor-permeable. Moisture is trapped within the stone substrate, contributing to damage from cyclic freezing and thawing. Common symptoms of this problem include peeling of the paint coating and spalling of the limestone. Wiss, Janney, Elstner Associates, Inc. photo.

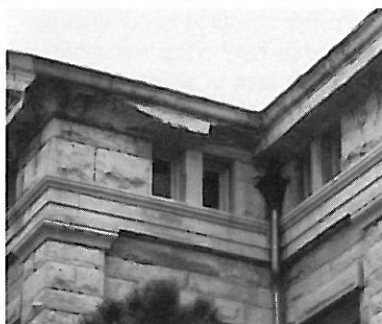
Cornice and upper wall at Rock Island Arsenal. Results of testing on treated samples indicated that conservation treatments significantly improve water absorption and compressive strength of the dolomite limestone. All photos courtesy ProSoCo, Inc.

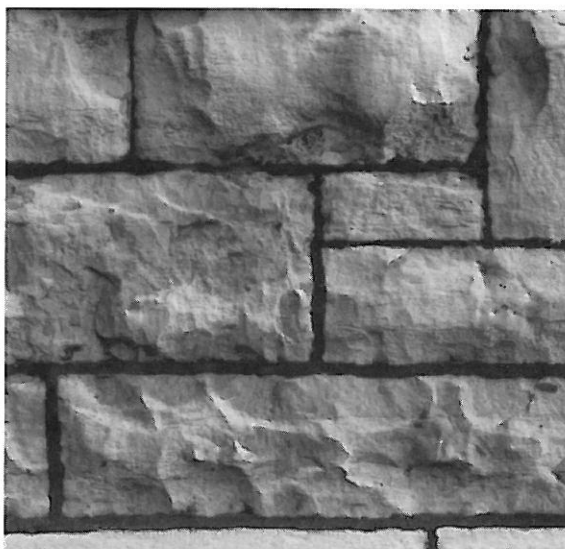
A detail of the tower wall at St. James Cathedral before restoration clearly shows the inappropriate repointing which had taken place in the past. The original joints were generally less than 1/8 inch wide, but repointing with a very dark mortar overran the joints by a large margin. Wiss, Janney, Elstner Associates, Inc. photograph.

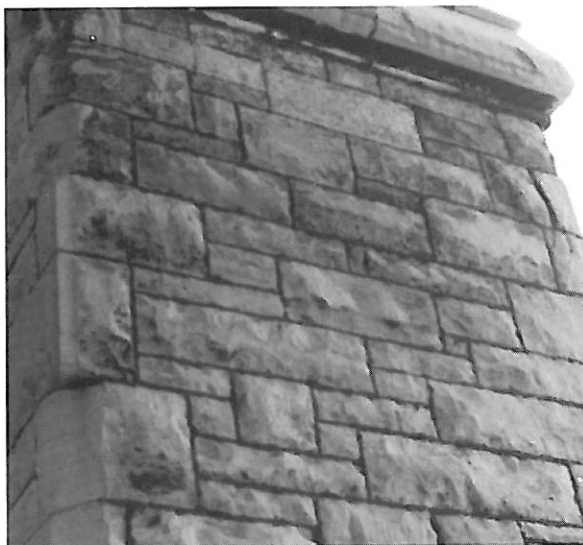
The blocks shown in this pier of St. James Cathedral were generally in good condition. Where blocks were found to be too severely deteriorated to restore, they were removed and replaced with a Niagara limestone that closely approximates the original Joliet-Lemont limestone.
